Technical Service Bulletin

Mazda North American Operations Irvine, CA 92618-2922

Subject:		
OIL SEEPAGE OR LEAKS AT ENGINE FRONT COVER	Bulletin No.: 01-008/24	
	Last Issued : 06/21/2024

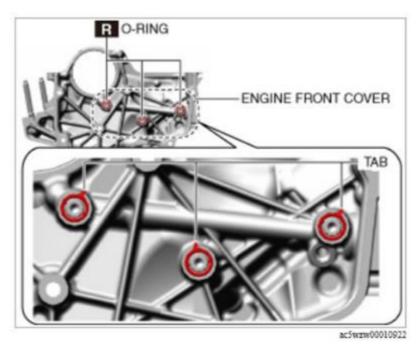
- Install the O-rings so that the tabs of the O-rings recede into the notches.
- DO NOT use any sealant on the O-rings.

4. Install new O-rings to the engine front cover.

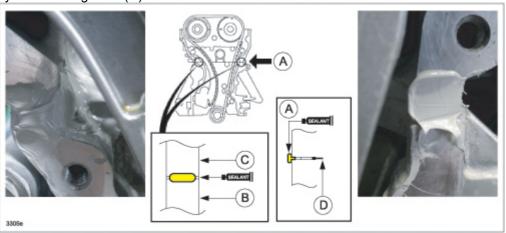
CAUTION: Apply the silicone sealant to the area (A) between the cylinder block (B) and head (C) so that it goes into the cylinder head gasket (D).

5. Apply silicone sealant (TB1217D or equivalent) to the engine front cover, as shown below.

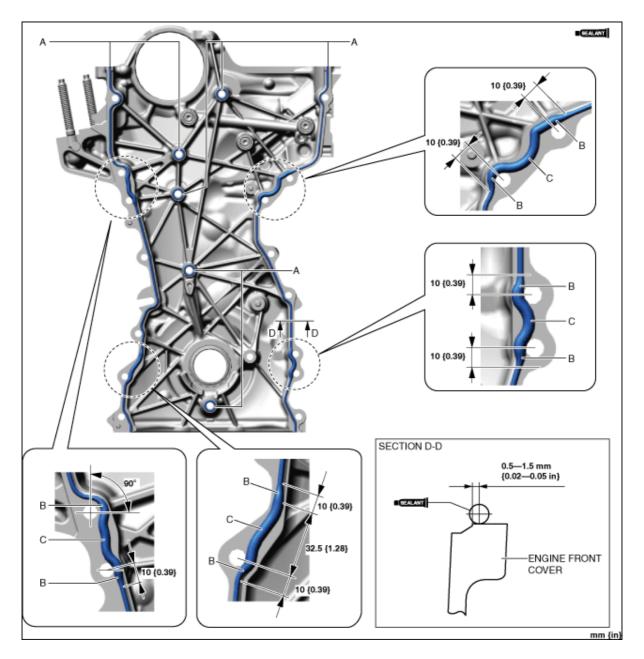
Bead thickness

A: 2—6 mm {0.1—0.2 in}

B: 4—6 mm {0.16—0.23 in}

C: 4—8 mm {0.2—0.3 in}

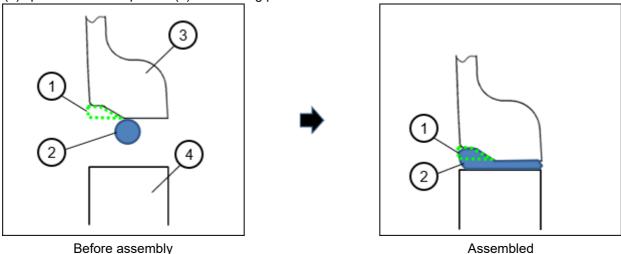
Sealant (2) spreads to the step bead (1) and sealing performance is ensured.

1	Step bead
2	Sealant (TB1217D or equivalent)
3	Front cover
4	Engine
