Subject: IN-VEHICLE NETWORK MALFUNCTION WARNING MESSAGE AND DTC B119F:01	Service Alert No.: SA-038/24
	Last Issued : 06/13/2024

2019-2023 Mazda3
2020-2023 CX-30
2021-2023 CX-5
2023 CX-50
2021-2023 CX-9
2022 MX-30

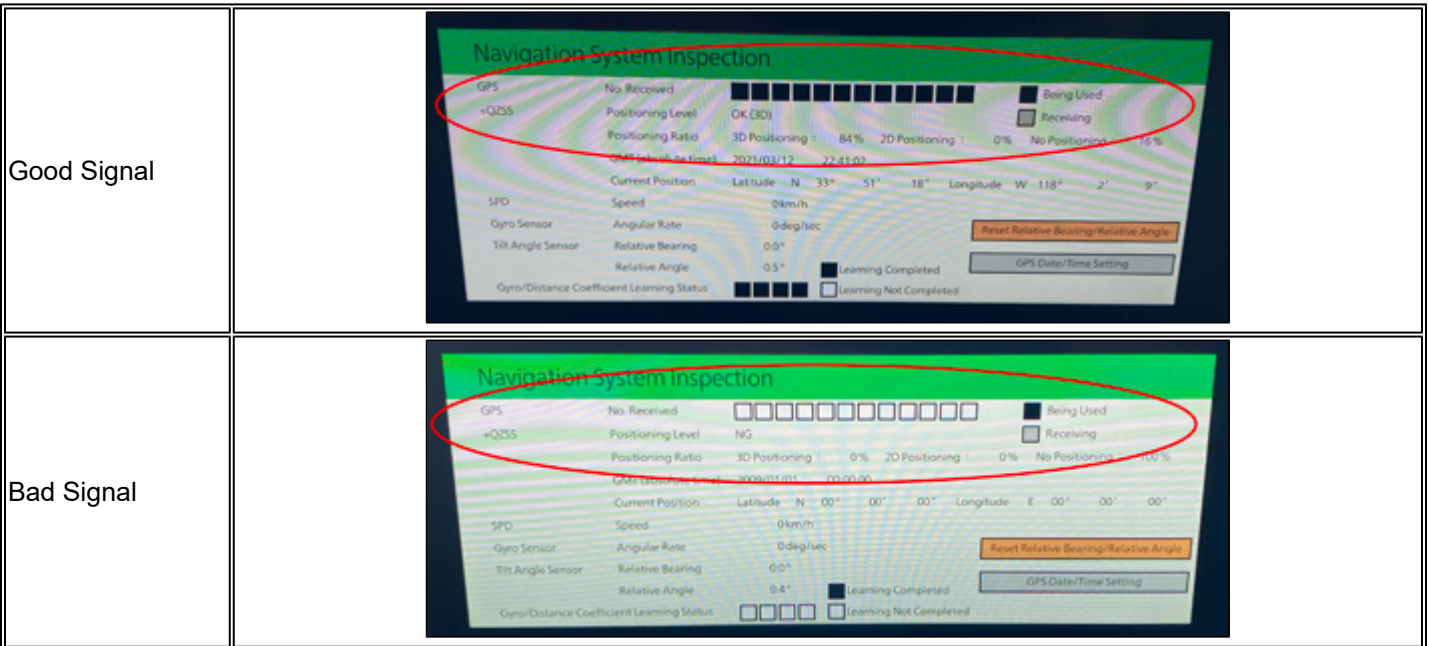
Does the vehicle receive a Good GPS signal? (Example of a good GPS signal below)

NOTE: Perform this step with a clear view of the sky.

Is the GPS signal good?

- **Yes:** Replace the TCU. See [SA-025/23](#)
- **No:** Go to next step.
