McLaren Artura Transmission Oil Leak Diagnosis Guide

Location: Powertrain / Hybrid

Topic: McLaren Artura Transmission Oil Leak Diagnosis Guide

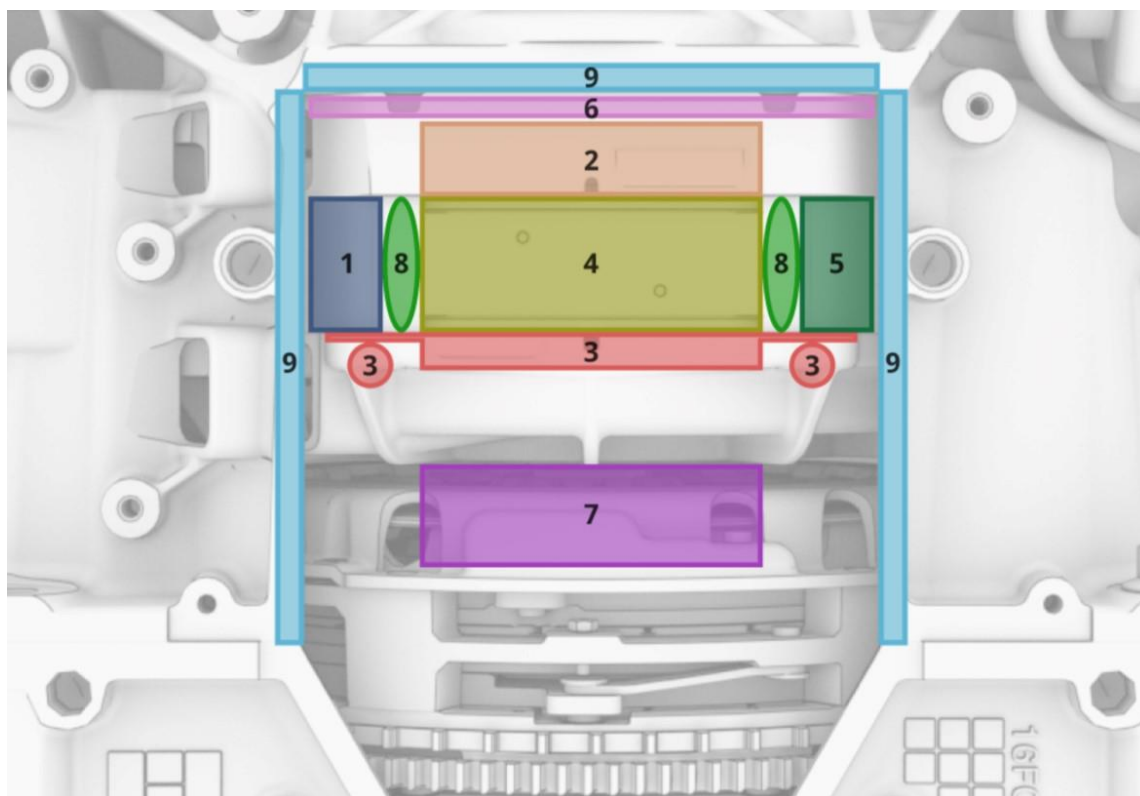
Location	Oil Types				
	Clear dielectric oil, no UV reaction	Yellow tinge dielectric oil, hint of UV	New transmission oil, golden, green UV reaction	New engine oil, green UV	Red grease
1 Dark Blue					
2 Orange					
3 Red					
4 Yellow					
5 Dark Green					
6 Pink					
7 Purple					
8 Light Green					
9 Light Blue

14. If leak continues post Cycle 5 please fill in table in accordance with the leak path map below, check dielectric oil level when vehicle has cooled down and attach table, dielectric oil level and all images to a TR
 If no leak present after overnight dwell period, no further action required.
