# Vibration or Rattle Noise From Right-hand Engine Mount

**Service Category** Engine/Hybrid System

YEAR(S)	MODEL(S)	ADDITIONAL INFORMATION
2020 - 2024	Corolla	VDS(s): B4MCE, B4MDE, B4MEE, M4MCE, M4RCE, P4MCE, P4RCE, S4MCE, S4RCE, T4MCE, T4RCE Engine(s): M20

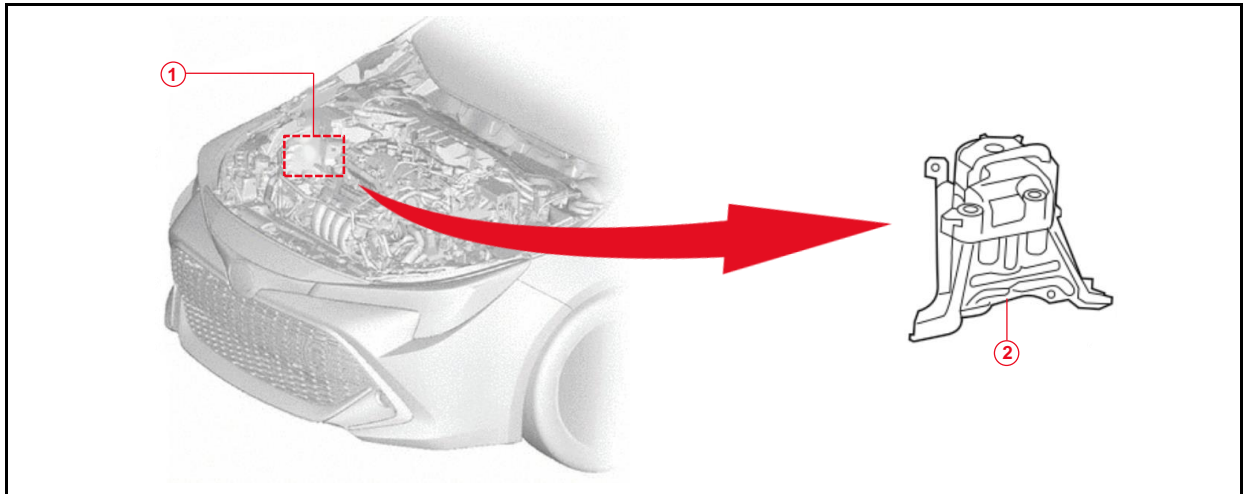
**Figure 1.**

2. Locate the right-hand engine mounting insulator sub-assembly.

<b>1</b>	<b>Location of the Right-hand Engine Mounting Insulator Sub-assembly</b>
<b>2</b>	<b>Right-Hand Engine Mounting Insulator Sub-assembly</b>

3. Remove the right-hand engine mounting insulator sub-assembly.

4. Install the NEW right-hand engine mounting insulator sub-assembly with the part number provided in the Parts Information table.
