Difficulty Starting Engine in Below Freezing Temperatures

Service Category Engine/Hybrid System

Section Starting

YEAR(S)	MODEL(S)	ADDITIONAL INFORMATION
2022 - 2024	Tundra

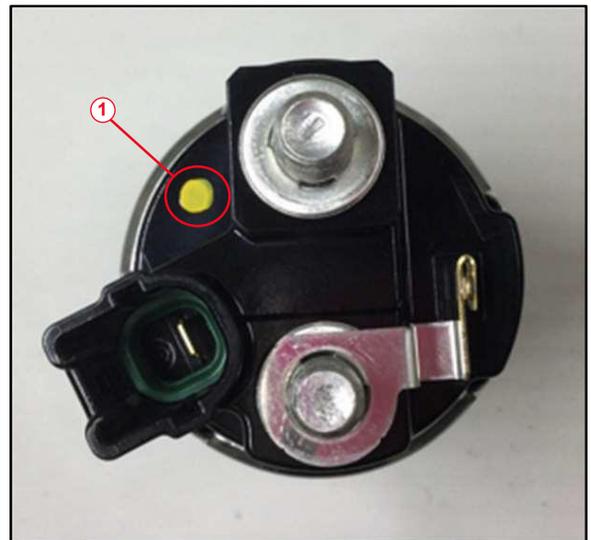
Figure 1. Main Switch Assembly

3. Is there a yellow marker on the main switch assembly?

1	Yellow Marker (Indicates Latest Part)
----------	--

- **YES** — Continue to step 4.
- **NO** — Go to step 5.

4. Reinstall the starter assembly.

This bulletin does NOT apply. Continue diagnosis using the applicable Repair Manual.
