Subwoofer Rattle or Buzz Noise

Service Category Audio/Visual/Telematics

YEAR(S)	MODEL(S)	ADDITIONAL INFORMATION
2023 - 2024	Sequoia HV	
2022 - 2024	Tundra, Tundra HV

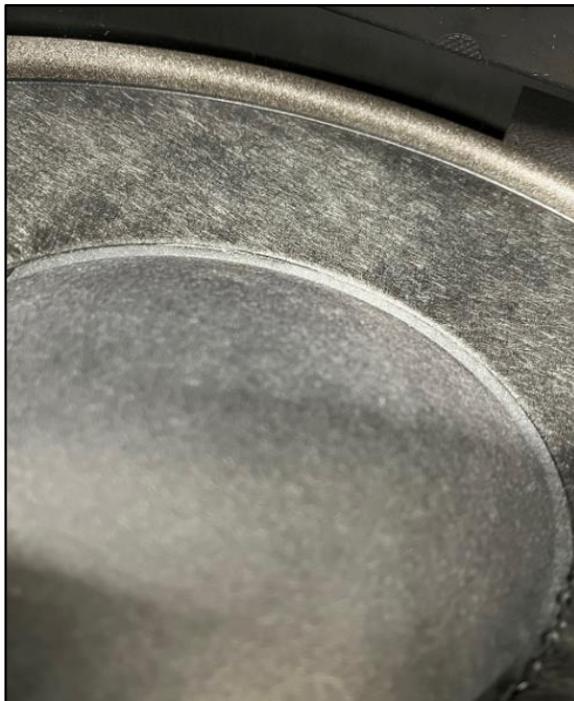
Figure 1. Previous Speaker Cone

Some 2022 – 2024 model year Tundra, Tundra Hybrid, and 2023 – 2024 model year Sequoia Hybrid vehicles, equipped with a JBL® premium sound system, may exhibit a rattle or buzz noise when listening to music coming from the subwoofer located in the rear left luggage area of the vehicle. This can be caused by exposure to certain operating environments with high humidity levels. To improve the subwoofer's performance in humid environments, Toyota has revised the speaker cone material and shape. The condition can be resolved by replacing the subwoofer assembly with box. Follow the Repair Procedure in this bulletin to address this condition.
