Technical product information

Topic	Rear screen sunblind operational issues
Market area	Bentley: worldwide (2WBE)
Brand	Bentley
Transaction No.	2070643/5
Level	EH
Status	Approval
Release date

New Flying Spur

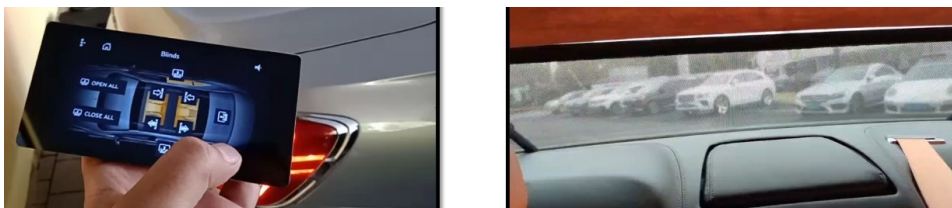
Figure 1

- Attach a clear video and photographs of the failure mode to a new or existing DISS query (see examples in Figure 1)

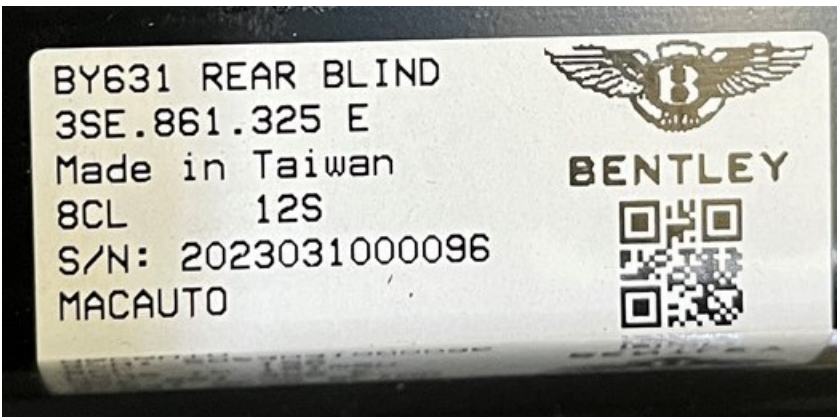
NOTICE
In the event permission was given to replace the rear sunblind assembly (via DISS) please attach a photo of the original rear blind assembly label as shown in Figure 3

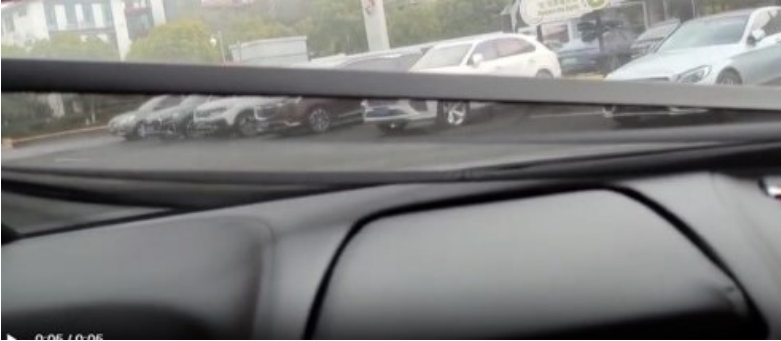
Figure 4

[Rear blind is detached on one side \(Figure 4\)](#)

NOTE: In this scenario (rear blind detached) the rear blind assembly must be replaced

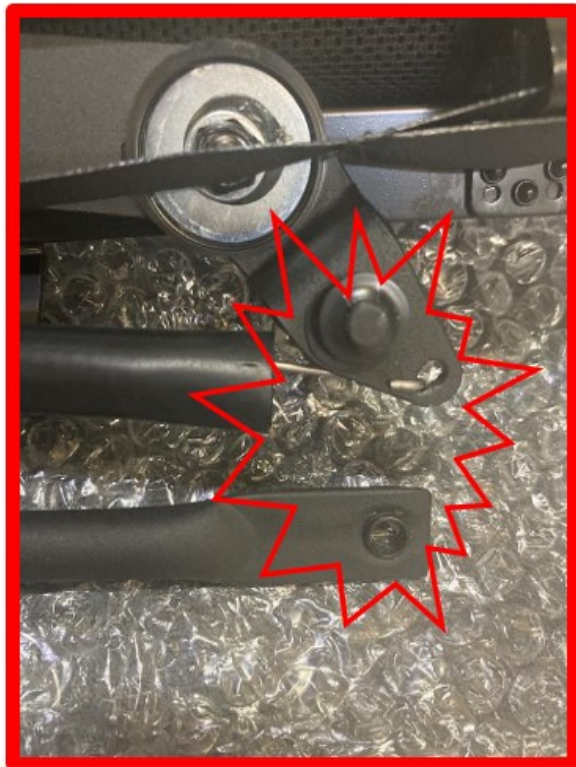
- Referring to Figure 5 - Confirm if the rivet and star washer is fitted / secure

NOTE: Figure 5 shows the rivet and star washer detached

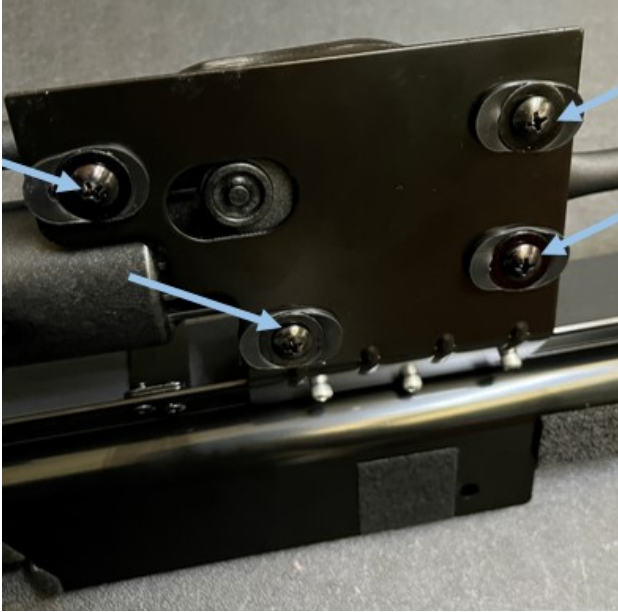
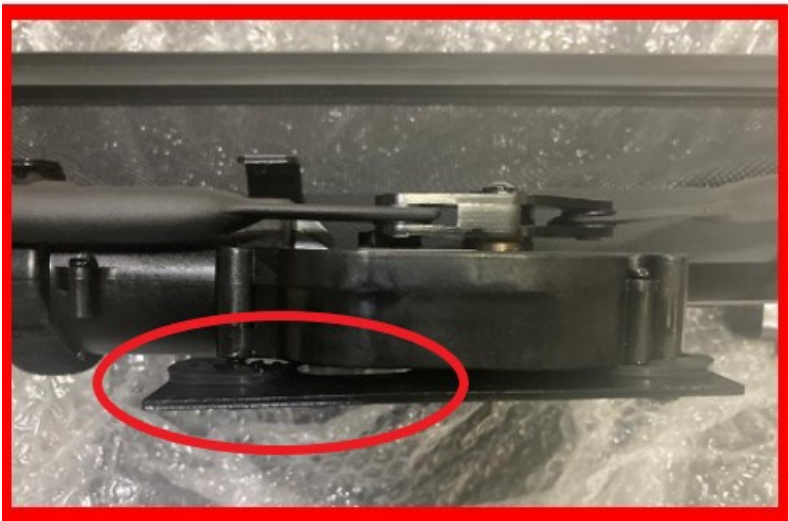
[Gearbox screws loose \(Figure 6 and Figure 7\)](#)

NOTE: Figure 6 and Figure 7 show loose gearbox screws (not secured to 2.5Nm)

The following may also be evident which confirms the gearbox screws are loose:

Witness marks on the mounting surfaces

Gap(s) between the motor and mounting plate

NOTE: Should the gearbox screws be loose the rear blind assembly must be replaced - **DO NOT attempt to secure the fixings**

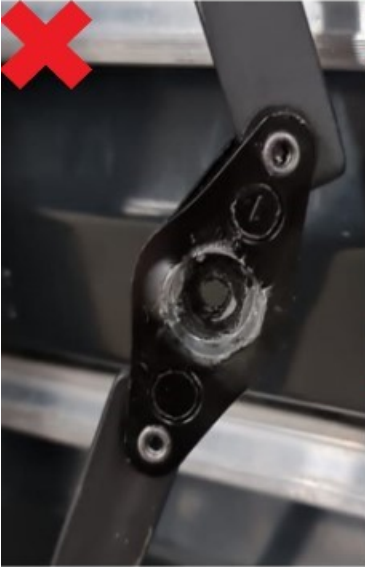
In the event the rotator plate is NOT OK as shown in the examples in Figure 9 and Figure 10, the operative should replace the rear blind assembly

- Reconnect the rear blind electrical connection
- Attempt to operate the blind
- If the motor shaft spins the issue is the rotator plate Jamming - Replace the rear blind assembly as described within Rep.Gr 70
- If the motor shaft does not spin the issue is the gearbox jamming - Replace the rear blind motor as described within Rep.Gr 70

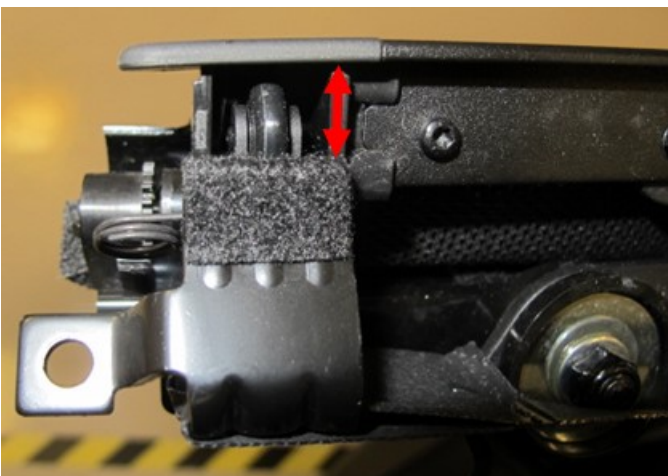
Figure 11

Hint: Once the new blind motor has been installed the operative may notice the blind has raised / not flush (Figure 11). This is related to the motor spindle position which has been set by the motor supplier. Once the blind assembly is refitted and operated (as described) the blind will close to the correct / flush condition
