Instrument Panel Garnish Trim Loose/Detached From Dashboard

Service Category Vehicle Interior

Section Interior Panels/Trim

YEAR(S)	MODEL(S)	ADDITIONAL INFORMATION
2023 - 2024	RX350, RX350H, RX500H	WMI(s): 2T2, JTJ
2024	RX450H+	WMI(s): JTJ

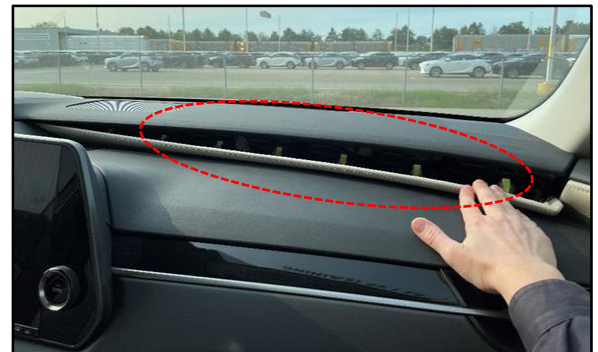
Figure 1.

Some 2023 – 2024 model year RX 350, RX 350h, and RX 500h and 2024 model year RX 450h+ vehicles may exhibit a condition where the instrument panel garnish trim located above the glove box becomes loose/detached from the instrument panel dashboard. This condition is more prevalent in warmer/rough terrain regions due to inadequate retention of the garnish clips. Follow the Repair Procedure in this bulletin to address this condition.

1. Confirm the condition exists.
Does the vehicle exhibit a loose/detached garnish trim appearance as shown in Figure 1?

Poor retention is more noticeable in the center portion of the garnish trim.

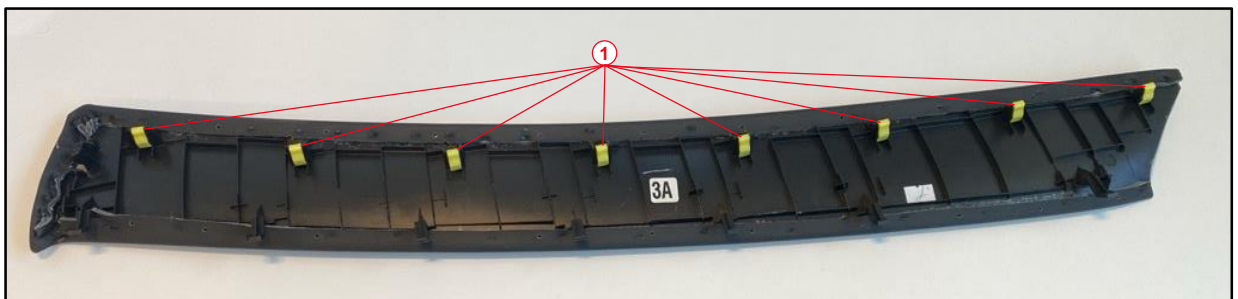
Figure 2. No. 2 Instrument Cluster Finish Panel Garnish

2. Disassemble the No.2 instrument cluster finish panel garnish. Refer to TIS, applicable model and model year Repair Manual:
 - [2023 – 2024](#) RX 350, RX 350h, RX 450h+, and RX 500h:
Vehicle Interior – Interior Panels / Trim – Instrument Panel Safety Pad – Removal
3. Locate the eight yellow retaining clips on the No. 2 instrument cluster finish panel garnish trim that need to be reworked.
