# Tapping/Ticking Noise Near B-Pillar Area and Seat Belt Anchor Point

YEAR(S)	MODEL(S)	ADDITIONAL INFORMATION
2022 - 2024	Camry, Camry HV

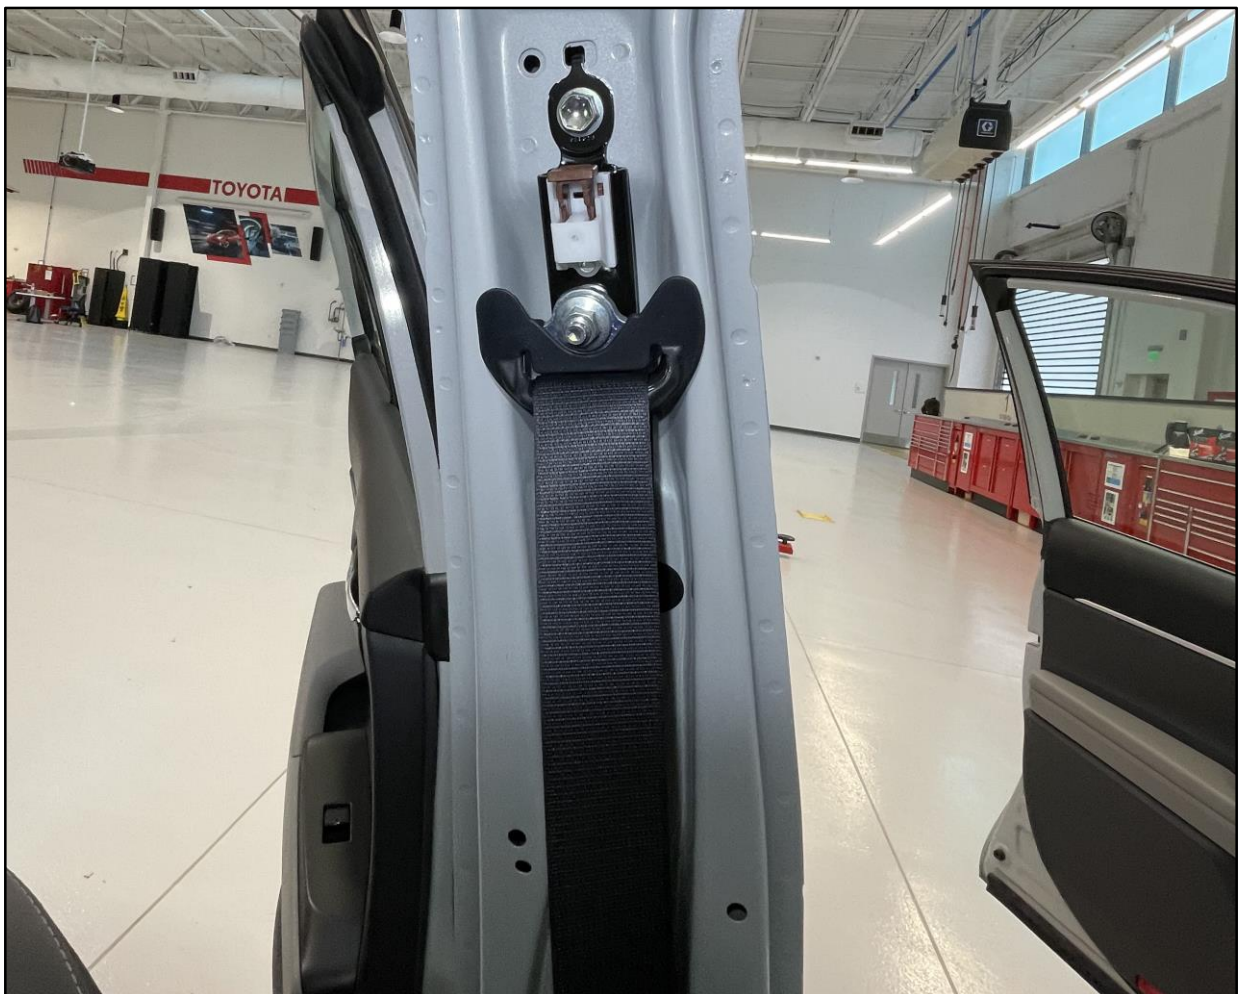
**Figure 1. B-pillar After Removing Scuff Plate, Garnishes, and Weatherstrip**
