Field campaign

| Topic | Software update to 0042 / 07D2 (Driver door control module) and 0052 / 07D3 (Passenger door control module) - SC24/16 |
| Campaign number | ED09 |

Bentayga Extended Wheel Base

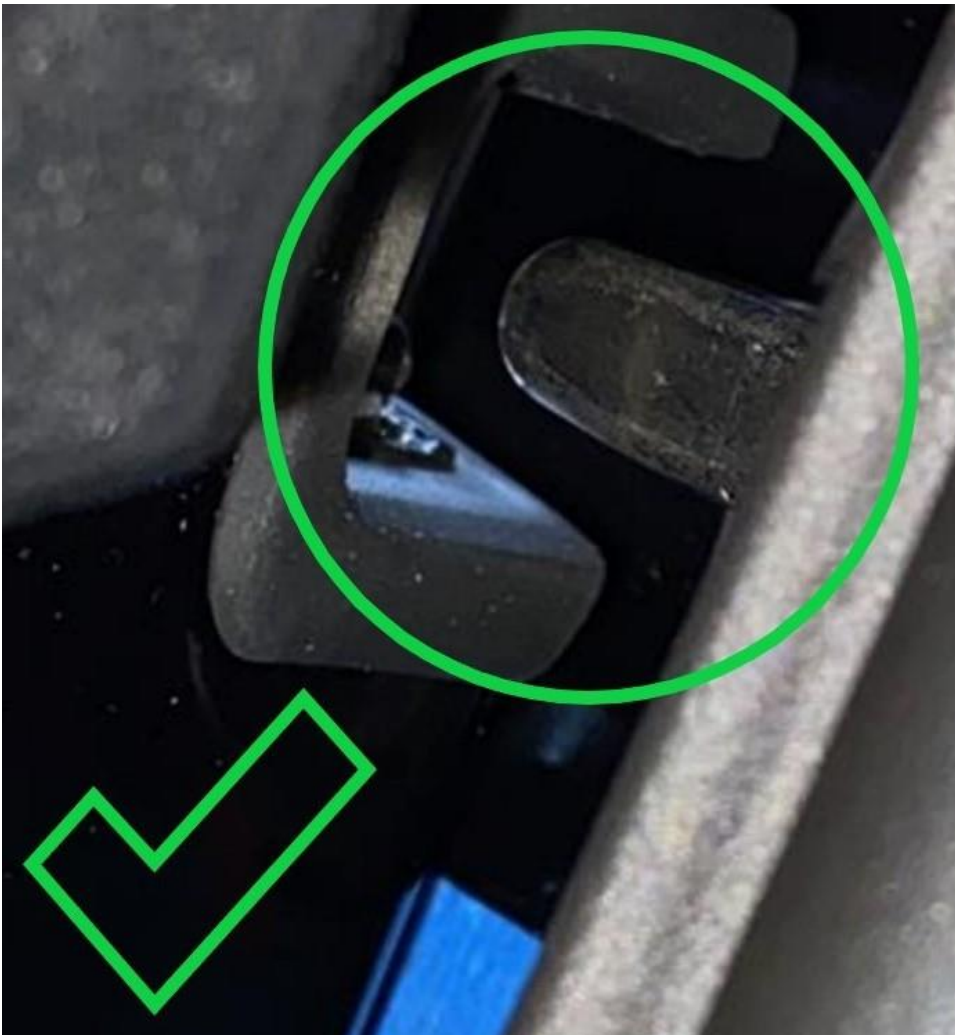
Before proceeding with the instructions the operative must first ensure the left and right hand rear door strikers are centrally aligned to the latch as shown in Figure 1

In the event that one or both rear door strikers are not centrally aligned the operative must take a photograph confirming that one or both of the strikers are not aligned, the operative must then proceed to align the strikers as detailed below before proceeding
