Technical product information

Topic	Rattle from the MMI switchpack
Market area	Australia E04 Bentley rest Asia and Australia (6E04),China 796 VW Import Comp. Ltd (Vico), Beijing (6796),Germany E02 Bentley rest Europe (6E02),Japan E03 Bentley Japan (6E03),Korea, (South) E08 Bentley South Korea (6E08),United Arab Emirates E06 Bentley Middle East and Africa (6E06),United Kingdom E01 Bentley UK (6E01),United States E05 Bentley USA and rest America (6E05)
Brand	Bentley
Transaction No.	2074228/1
Level	EH
Status	Approval
Release date

New Continental GT/C and New Flying Spur

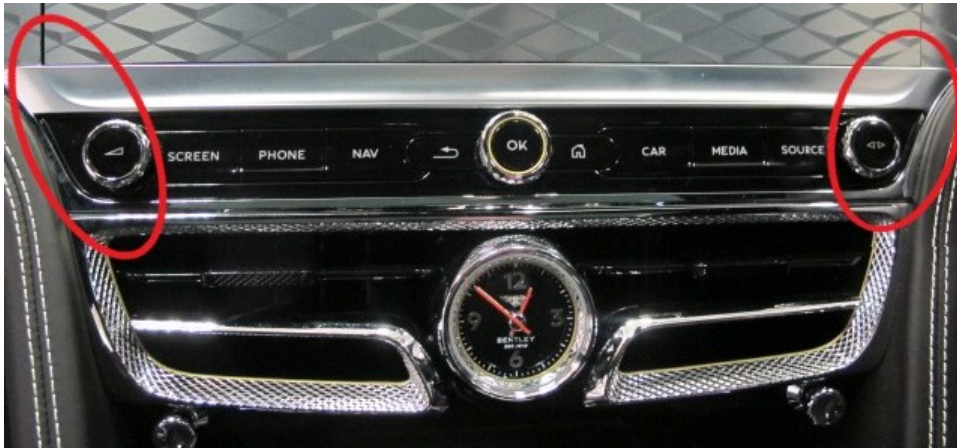
Rattle from the MMI switchpack at the locations shown in Figure 1

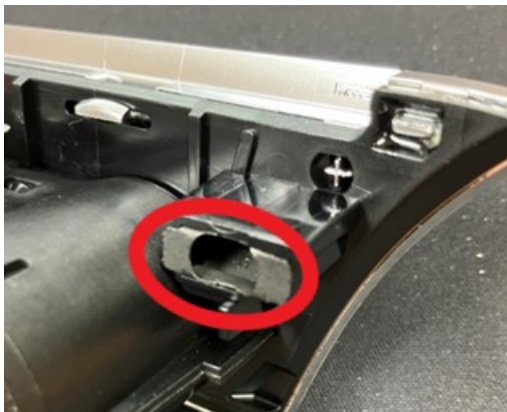
The noise may be from the left and / or right hand metallic clip(s) as shown in Figure 2

Hint: For clarity the left hand side clip is shown although the right hand side is the same
