Technical product information

| Topic | DTC P0B2500 logged within address 0021 (Battery Energy Control Module 2) - Dynamic ride system warning visible |
| Transaction No. | 2068946/8 |

DTC P0B2500 logged within address 0021 (Battery Energy Control Module 2) - Dynamic ride system warning visible

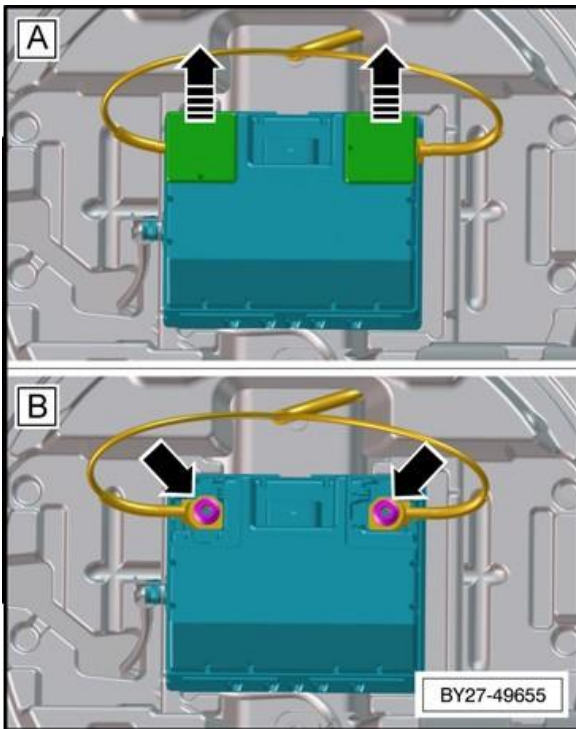
Figure 1

Possible internal fault with the super capacitor

- 1) Referring to Rep.Gr 27 - Deactivate the 48 volt system - Refer to 48 volt system - To activate and deactivate
- 2) Referring to Rep.Gr 27 - Check the security of the super capacitor positive and negative terminals (Figure 1) as follows:
 - Remove the caps (A) from the terminals
 - Check the security of the positive and negative terminals (B) are as described within Rep.Gr 27
 - In the event that one or both terminals were not tightened to the correct torque as Rep.Gr 27, the operative must tighten the terminal(s) to the correct torque as detailed within Rep.Gr 27 - Super capacitor

In the event one or both terminals required tightening to the correct torque (found to be not initially secure) the operative must feedback the findings via DISS
