WHISTLE NOISE FROM REAR DOOR AREA

Range Rover

- 23-24MY Range Rover (L460)
- 23-24MY RR Sport

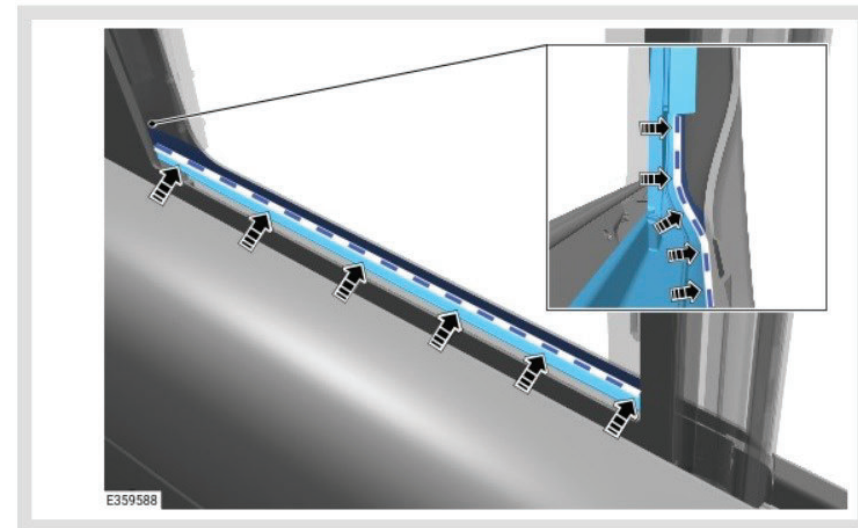
- A customer may report a whistle type noise from the rear side door quarter glass area with climate control fan speed set at 4 or above.

- This may be caused by air leaking between a gap between the rear door quarter glass and the rear door trim panel.

- TSB JLRTB02124NAS has been published to address this concern.
- The repair will consist of sealing the gap with a butyl sealant ribbon, 3M 08612 or equivalent that is locally sourced.
