## Noise From Fan Motor

Topic number	LI83.10-P-075602
Version	2
Function group	83.10 - Ventilation
Date	6/6/24
Validity	H247 left-hand drive vehicle
Reason for change	Remedy change

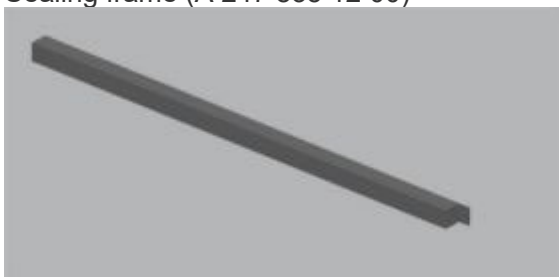
Sealing frame (A 247 835 12 00)

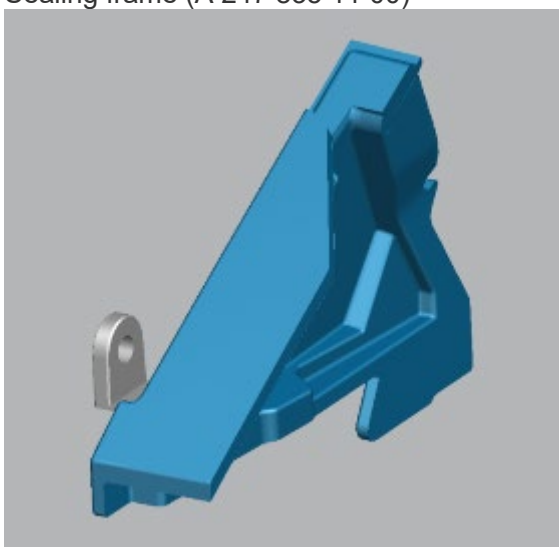
Sealing frame (A 247 835 11 00)

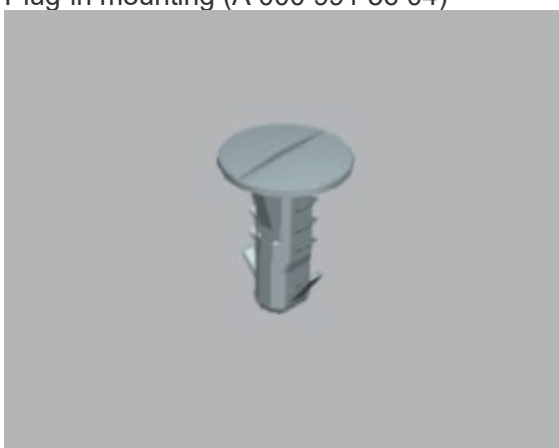
Plug-in mounting (A 000 991 56 04)

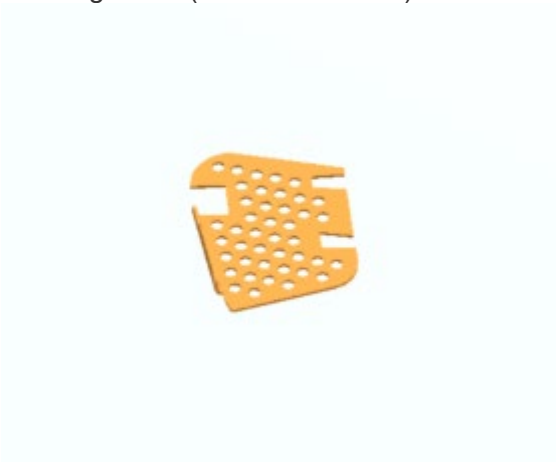
Housing cover (A 247 830 95 03)

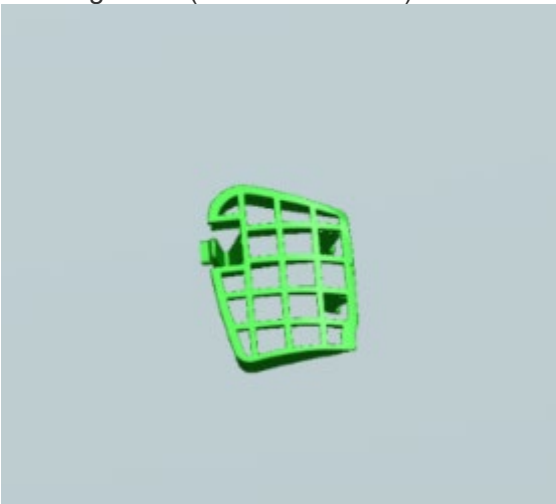
Housing cover (A 247 830 63 03)
