STAR ONLINE PUBLICATION

Case Number: S2423000033

Release Date: July 2024

Symptom/Vehicle Issue: Water Leak From Front Door. Water On Front Floor.

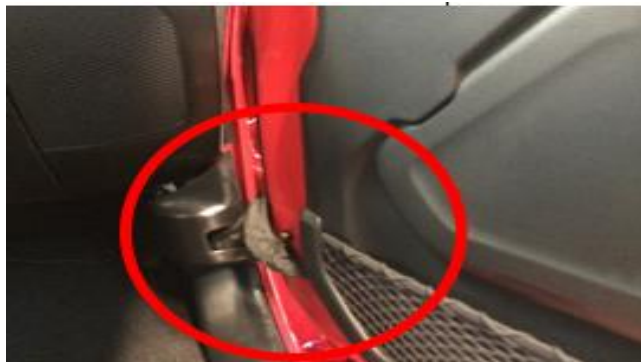
Door Harness Trapped In Door Jamb.

Discussion: Inspect the front door check strap/wiring harness for correct routing. Inspect the door weatherstrip for kinking or damage at the check strap area. First, begin with correcting any door harness routing issues. Bend the harness away from the door jamb so that the harness bends inboard as the door is closed. Once corrected, close the vehicles doors. Use a shower head on a pole or a hose with open flow and perform a water leak test on the door by arcing the water onto the a pillar area. Inspect inside using a bright LED flashlight for leaks. If a leak remains at the area the door harness was trapped in the jamb, replace the door seal and perform another leak test.
