Service Bulletin

Bulletin No.: 23-NA-197

Subject: Noise from Transmission Area, Malfunction Indicator Lamp (MIL) Illuminated – Multiple DTCs Set

Brand:	Model:	Model Year:		VIN:		Engine:	Transmission:
		from	to	from	to		
Chevrolet	Corvette	2020	2024	—	—	—	M1L, M1M

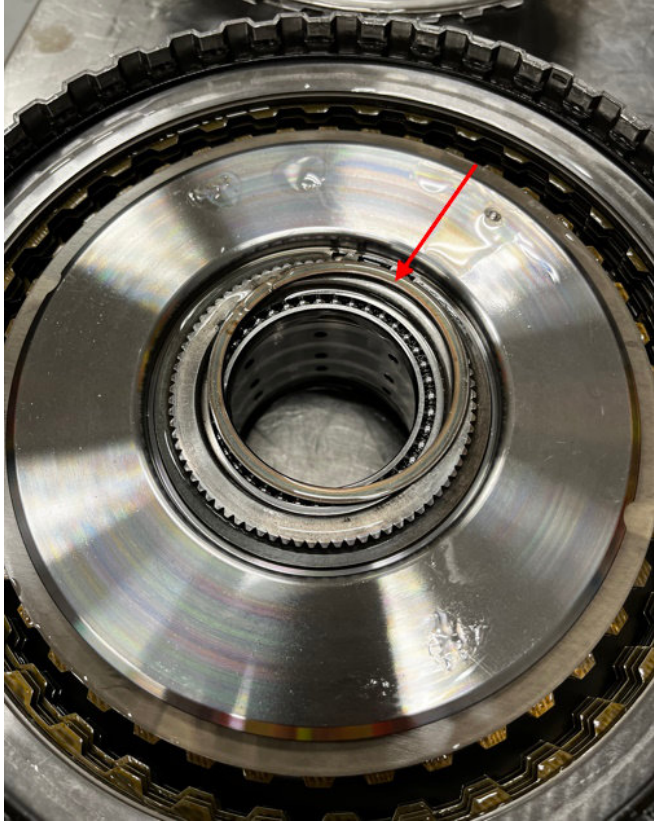
<p>This condition may be caused by a dislodged snap ring in the direct clutch assembly. 6444881</p> <ul style="list-style-type: none"> - One or more pressure DTCs may set due to the valves sticking in the Main Control Valve (MCV) Body, due to debris. - The direct clutch can contact the fluid tubes, stator shaft and/or the transmission housing.
<p>Correction</p>	<p>Note: Before proceeding, refer to bulletin 23-NA-176 to check the park position with GDS for the measurement that would fail the transmission. Refer to the Service Procedure below.</p>

- Direct Clutch snap ring failure and no DTCs current:
 - ⇒ Replace the direct clutch and stator. Refer to *Stator Shaft Replacement*.
 - ⇒ Remove the transmission pan and clean debris from magnets. Replace the sump and the canister filter elements.
- Direct Clutch pump gear noise:
 - ⇒ Replace the direct clutch, stator, and pump gear. Refer to *Stator Shaft Replacement* and *Automatic Transmission Fluid Pump Drive Gear Replacement*.
 - ⇒ If debris is witnessed, remove the transmission pan and clean debris from magnets. Replace the sump and canister filter elements.
- Direct Clutch Snap Ring Diagnosis and MIL with pressure DTCs:
 - ⇒ Replace the direct clutch and stator. Refer to *Stator Shaft Replacement*.
 - ⇒ Remove the transmission pan and clean debris from magnets. Replace the MCV (Main Control Valve). Replace the sump and the canister filter elements.

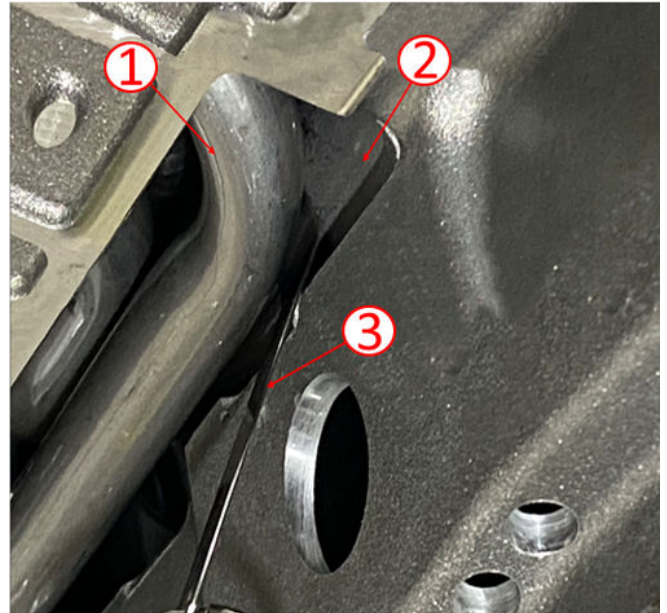
6444679

Inspect the direct clutch for failure by making the measurement below.

1. Remove the MCV. Refer to *Control Valve Body Replacement*.
2. Utilizing a feeler gauge (3), inspect the clearance between the direct clutch (2) and fluid tube (1).
 - ⇒ If clearance is 0.5 mm, proceed to direct clutch pump gear noise.
 - ⇒ If clearance is 0 mm with obvious contact, Refer to *Direct Clutch Replacement*.

Note: If the direct clutch is seized onto the stator housing, the transmission will need replacement.

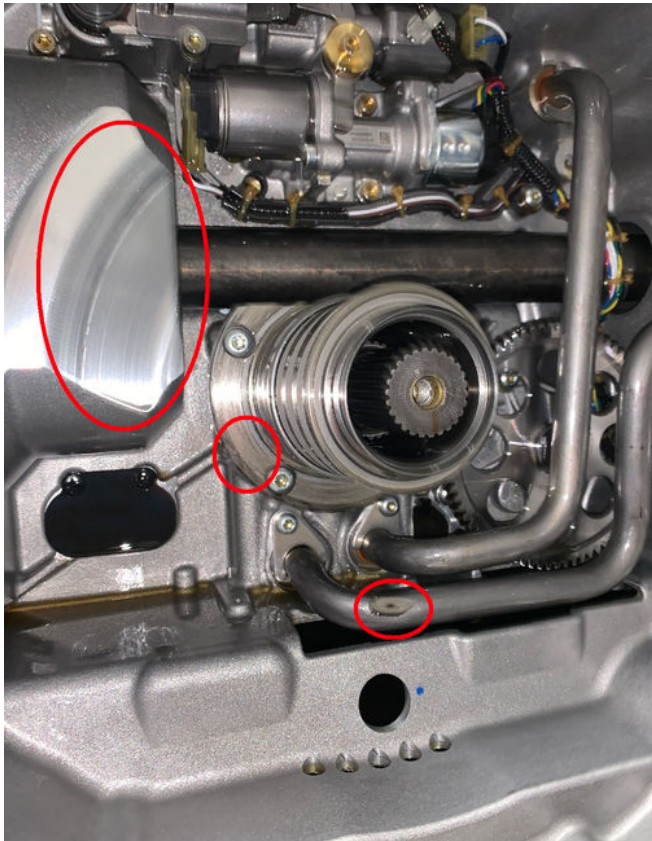
Important: Light damage to the housing caused by the direct clutch contact, will not require replacement. The graphic above depicts areas of concern.

Note: The direct clutch and stator housing will need replacement as the causal part.

- If the direct clutch can be removed easily but has contacted the pipe and stator, replace said parts as needed. Refer to SI.
