# 42-080 ABS Wheel Speed Fault Code Correction for MBSP Equipped Vehicles

## TSB-42-080-FTL

► New Cascadia

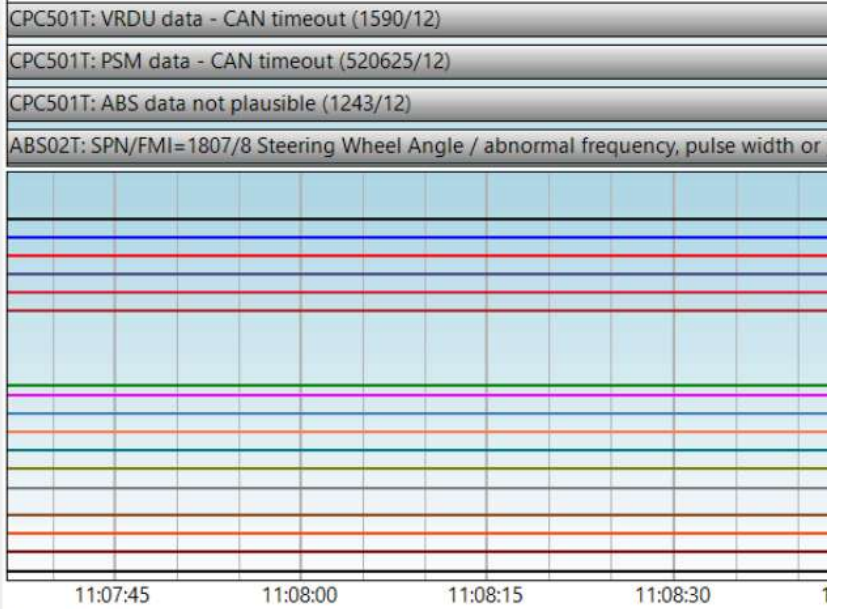
Fig. 1, DiagnosticLink Wheel Speed and Relative Speed Signals

13.  During the test drive, monitor the wheel speeds using DiagnosticLink and ensure that the ABS module and all J1939 connections are active. Do the wheel speeds appear erratic, spike up, or show readings when the vehicle is stationary? It is recommended to refer to the chart instead of the ABS tab/panel. See Table [Wheel Speed Chart Signals 4](#) and Fig. [1](#) for the charting selections in DiagnosticLink.

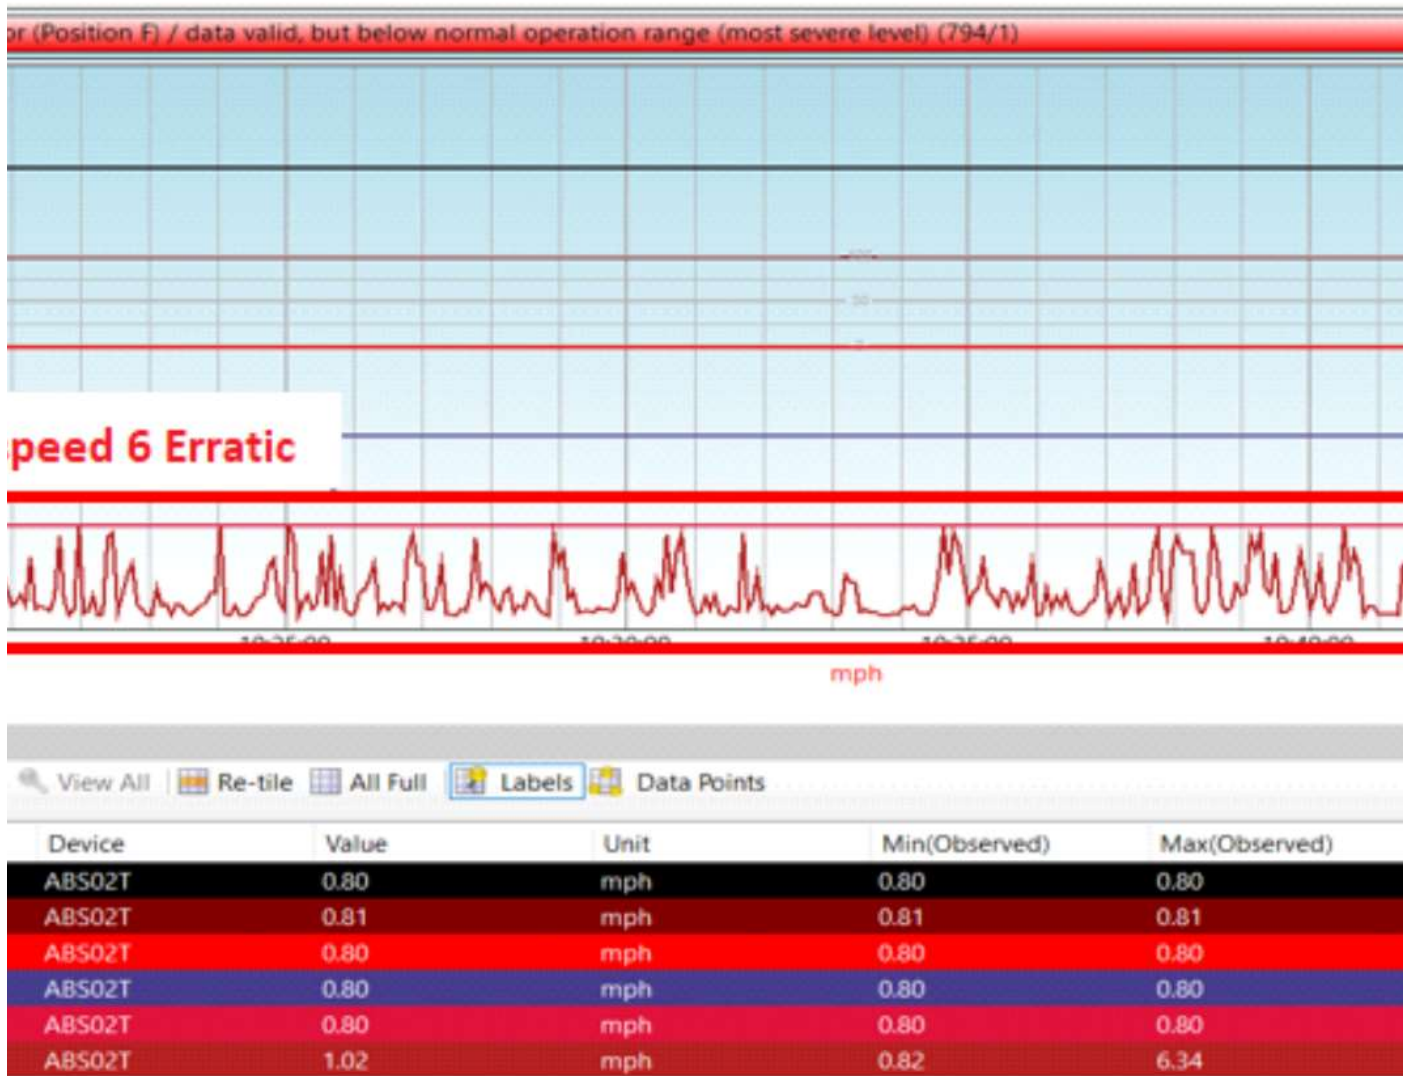
Fig. 2, DiagnosticLink Signal Traces

14.  See Fig. [2](#) for the traces of the selected wheel speed and relative speed signals. Note the erratic signal on wheel speed 6.

- a.  If the readings are erratic regardless of location, or if the issue only happens in damp or wet conditions, install the individual overlays for all four rear wheel ends. See Table [WABCO Harness Part Numbers 5](#) for length and part number of WABCO harnesses.
