# Oil cooler Lines disconnecting

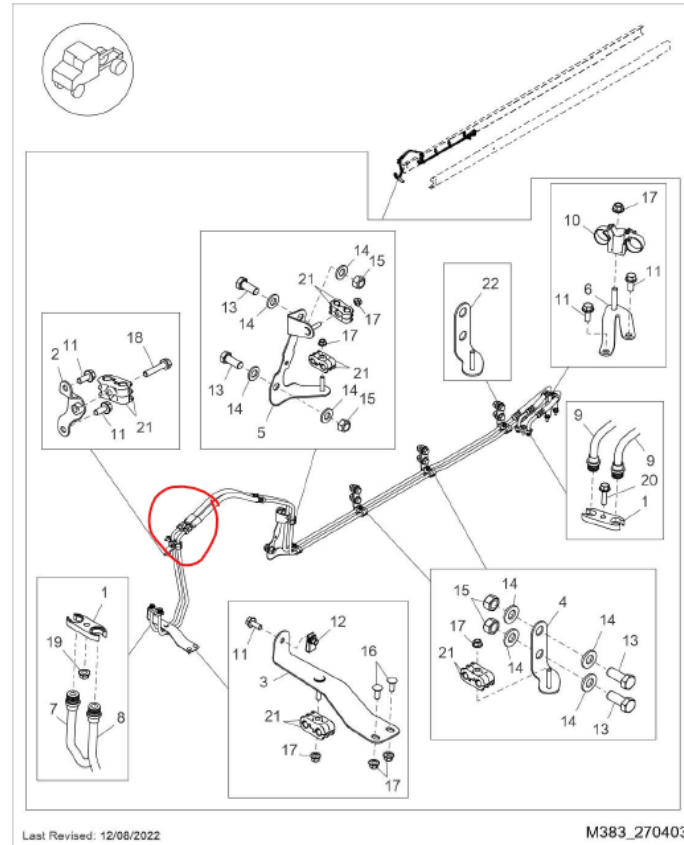
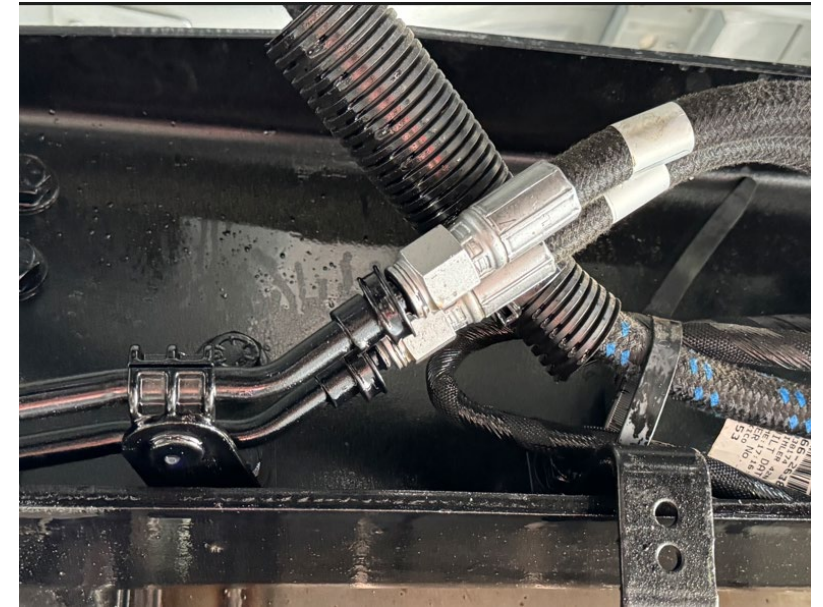
- CSC has received several cases of Oil cooler lines leaking at forward connection near radiator.
- Units involved have been Low mileage and prior to in service.
- Several have been discovered during PDI.
- Freightliner Quality is aware of the issue and investigating.
- Issue is in discovery phase at this time with limited information available.
- Example pictured far right shows location of disconnected line. It appears the retaining clip cover is not in the correct location resulting in line coming loose.
- Circled area in pic to the right is the area of concern.
