# Service Bulletin

Bulletin No.: 24-NA-102  
Date: June, 2024

**Subject:**            **Advanced Park Assist Non-functional**

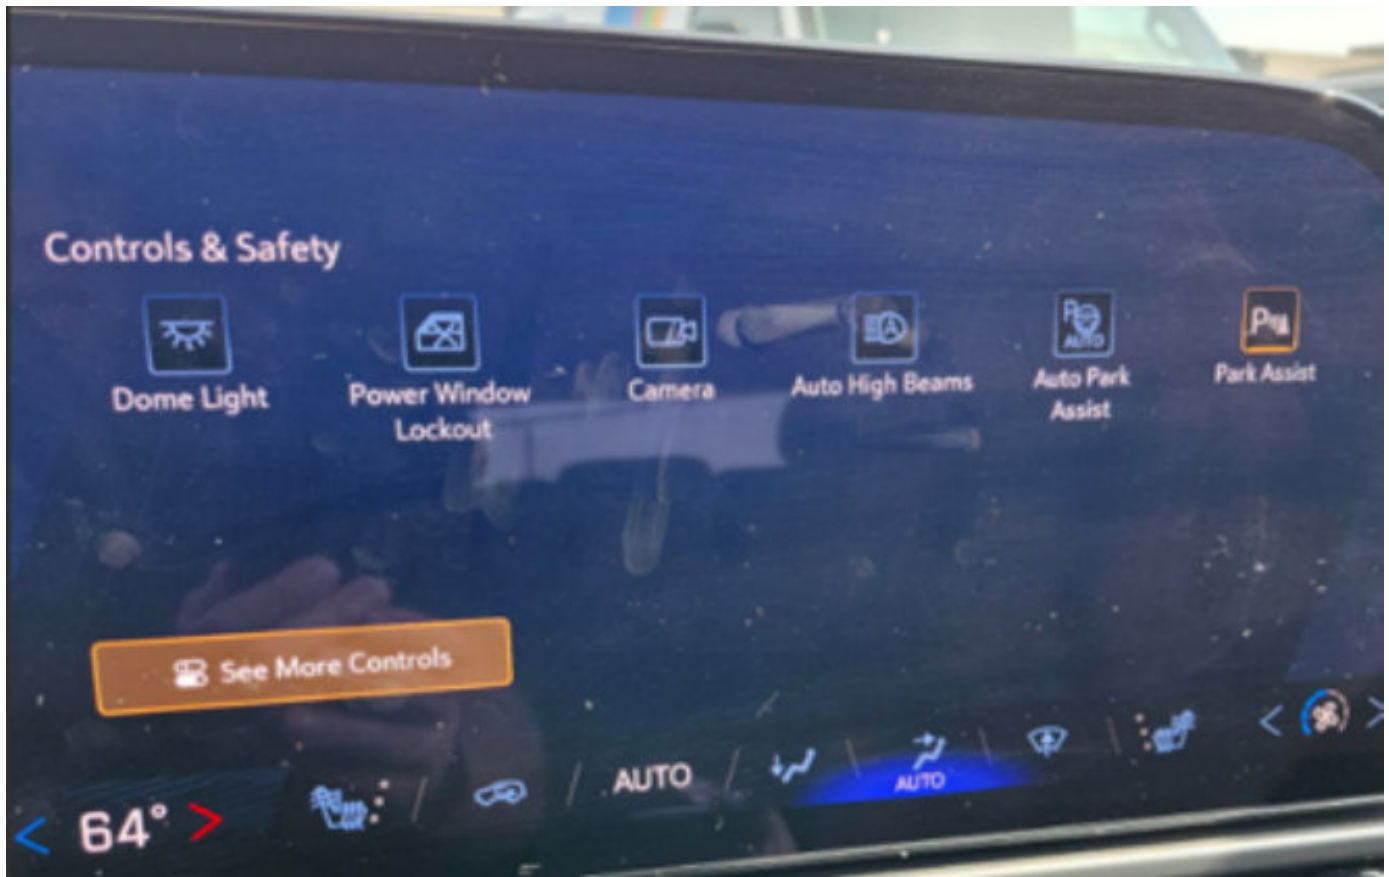
6665123

| Condition | Some customers may comment that whenever they press the Advanced Park Assist button on the infotainment screen, nothing happens. |

Visuals below show where the feature is located on the display screen:

| Correction | Reprogram the Radio for the latest software. Advanced Park assist (APA) is only available on Super Cruise enabled vehicles.<br>USB programming will not be required, only SPS programming. This will correctly remove the feature from the display. |

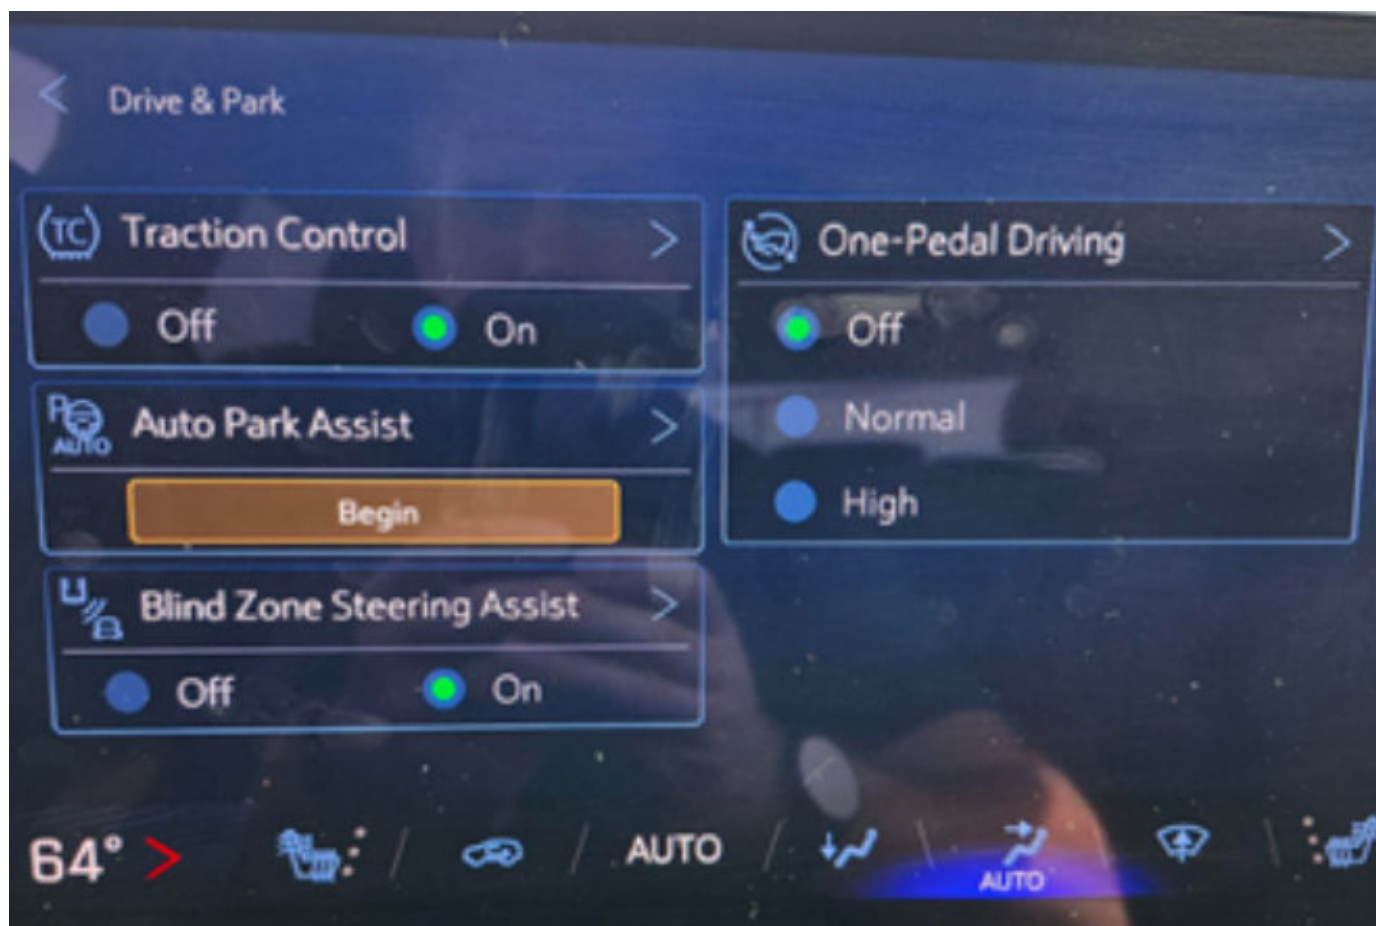
6665122

The driver may select the “begin” tab and nothing happens. If you encounter a vehicle with the above concern, re-program the BCM and VCU modules to the latest software level.
