| ELE | 2024MY EV9 (MV) |
| 339 (Rev 1, 7/10/2024) | June 2024 |

TECHNICAL SERVICE BULLETIN

SERVICE ACTION: ICCU-VCU S/W UPGRADE FOR EWP OPERATION AND ICCU REPLACEMENT (SA570)

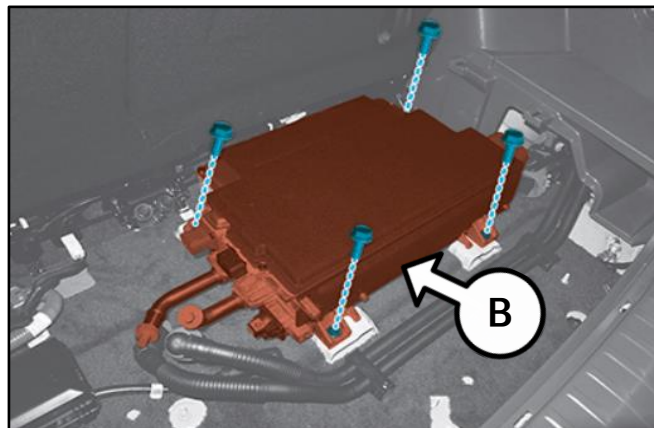
This bulletin provides information to improve the Electric Water Pump (EWP) operation logic when the EV battery is being charged with a Level 1 or Level 2 (120-240 Volt) AC charger on certain 2024MY EV9 (MV) vehicles produced from September 25, 2023 through January 11, 2024. A disparity may occur between the actual temperature and sensed temperature of the Integrated Charging Control Unit (ICCU) during high-current AC charging, predominantly in cold weather environments. If this condition occurs, the ICCU may become damaged and exhibit a MIL 'ON' with the DTC(s) listed below, resulting in a stopped charging session and inability to charge using Level 1 or 2 AC chargers; however, the EV battery can still be charged using Level 3 DC fast charging, and the vehicle's drivability is unaffected. This software upgrade may also be available via Over The Air (OTA) through Kia Connect if it has been activated. Follow the procedure outlined in this publication to inspect and upgrade the Vehicle Control Unit 'VCU' software logic for the EWP and, if any of the related DTCs are stored, replace the ICCU assembly. Before conducting the procedure, verify that the vehicle is included in the list of affected VINs.

3. Replace the Integrated Charging Control Unit (ICCU) (B) by referring to "Battery Control System → High Voltage Charging System → Integrated Charging Control Unit (ICCU) → Removal and Installation" in the applicable Shop Manual on KGIS.

Note: The 'ICCU Fuse' does not require replacement.

Tightening torque for bolts:
16.6 - 19.5 lb.ft (22.6 - 26.5 N.m)
