Service Bulletin

Bulletin No.: 24-NA-101

Subject: 60/40 Seat Position Gap

Brand:	Model:	Model Year:		VIN:		Engine:	Transmission:
		from	to	from	to		
Cadillac	XT5	2022	2024

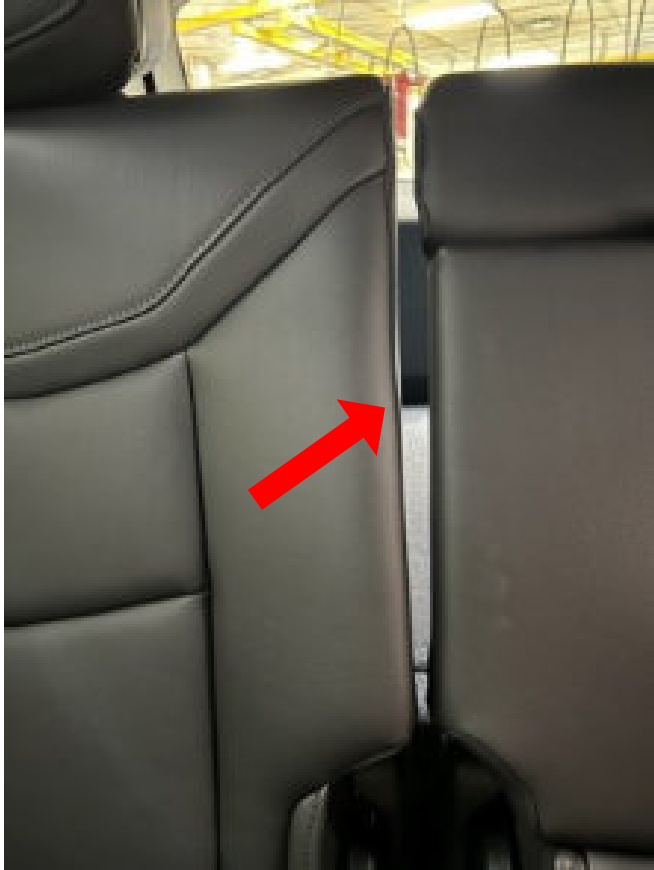
<p style="text-align: right; font-size: small;">6665085</p> <p>Some customers may comment on a gap between the 40% rear seat and 60% rear seat.</p>
------------------	---

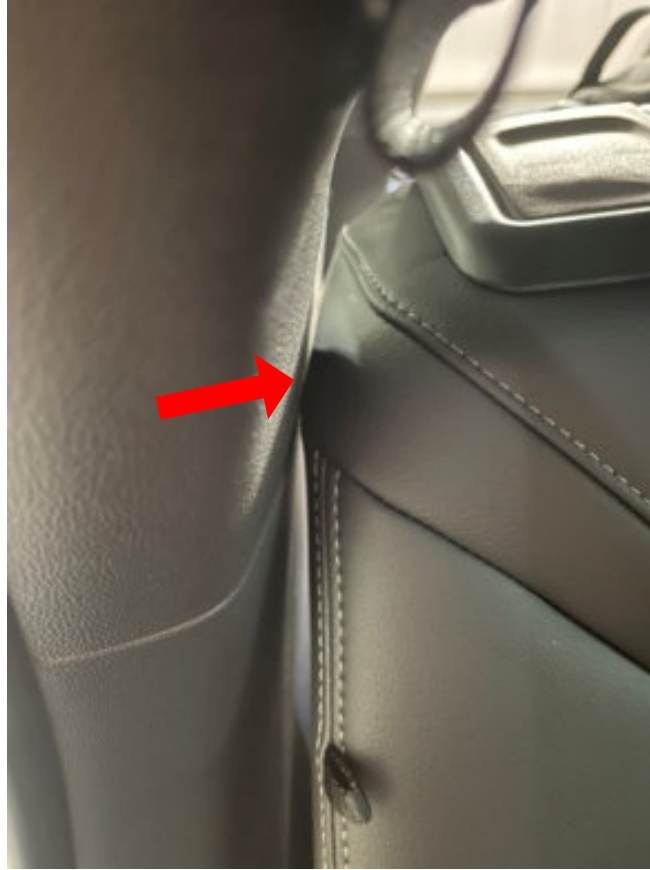
6665086

As well as a possible noise from the seats rubbing against the rear panel.

Cause	The causes of the condition may be the floor pan design can cause both seats to lean away from the other, creating a gap.
Correction	Add washer shims and bolts to the rear outer legs of the seats to seal the gap. Note: Use steel washers, they must be the same diameter as the track spacer and the shape of the bottom side of the track. Use 1mm thick steel washers with increments up to 4mm max thickness can be used to adjust the seats.

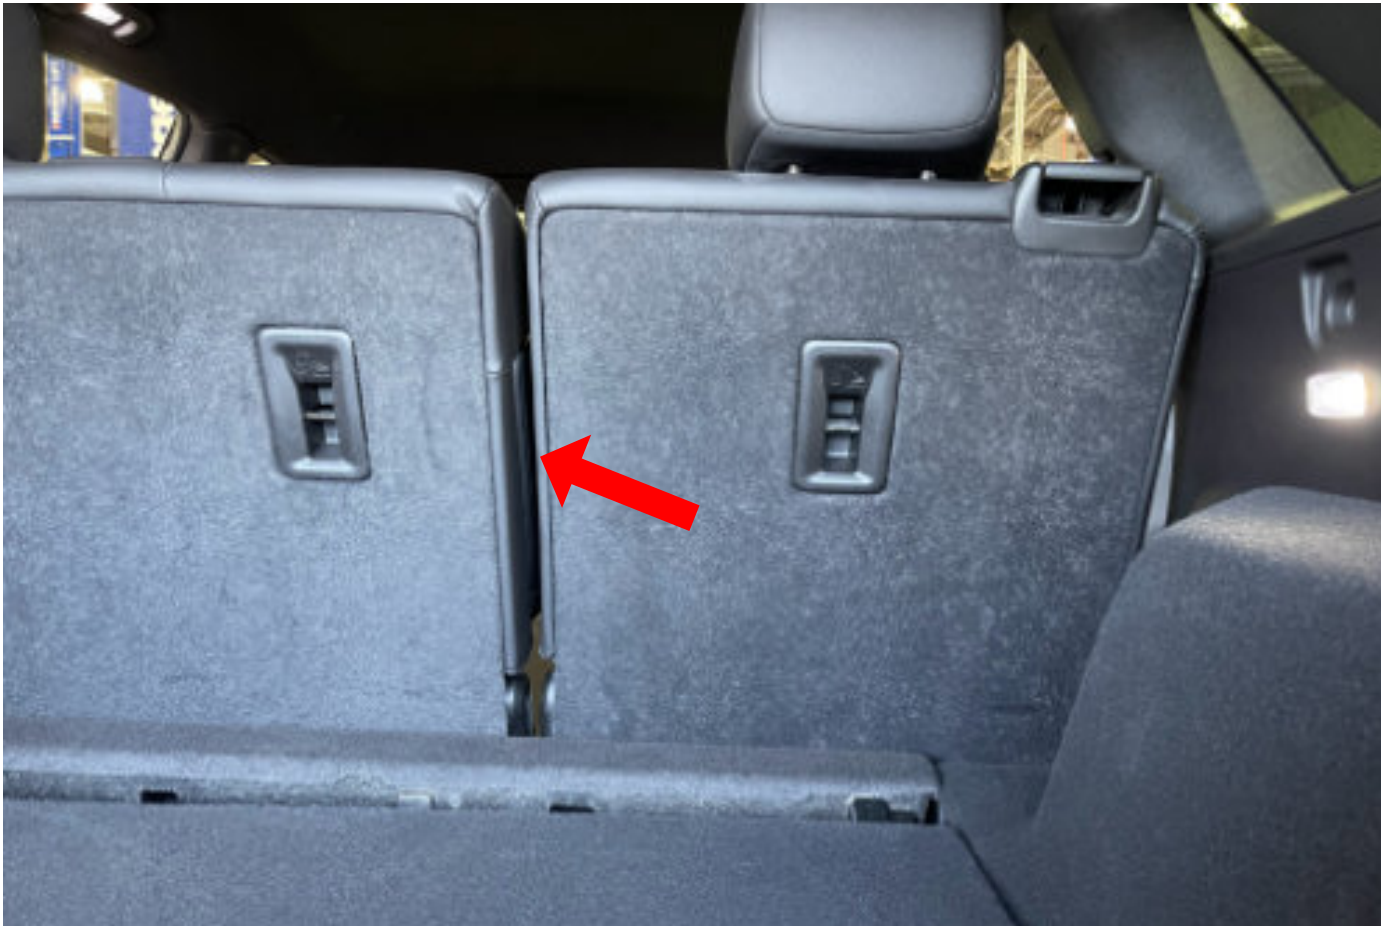
6664370

1. Visually inspect the rear seat to view the gap.
