Service Bulletin

Bulletin No.: 24-NA-109

Subject: Rattle/Vibration Noise from Window Switch Area or Storage Area of Front Door Panel

Brand:	Model:	Model Year:		VIN:		Engine:	Transmission:
		from	to	from	to		
Chevrolet	Colorado	2023	2023	-	-	All	All
GMC	Canyon

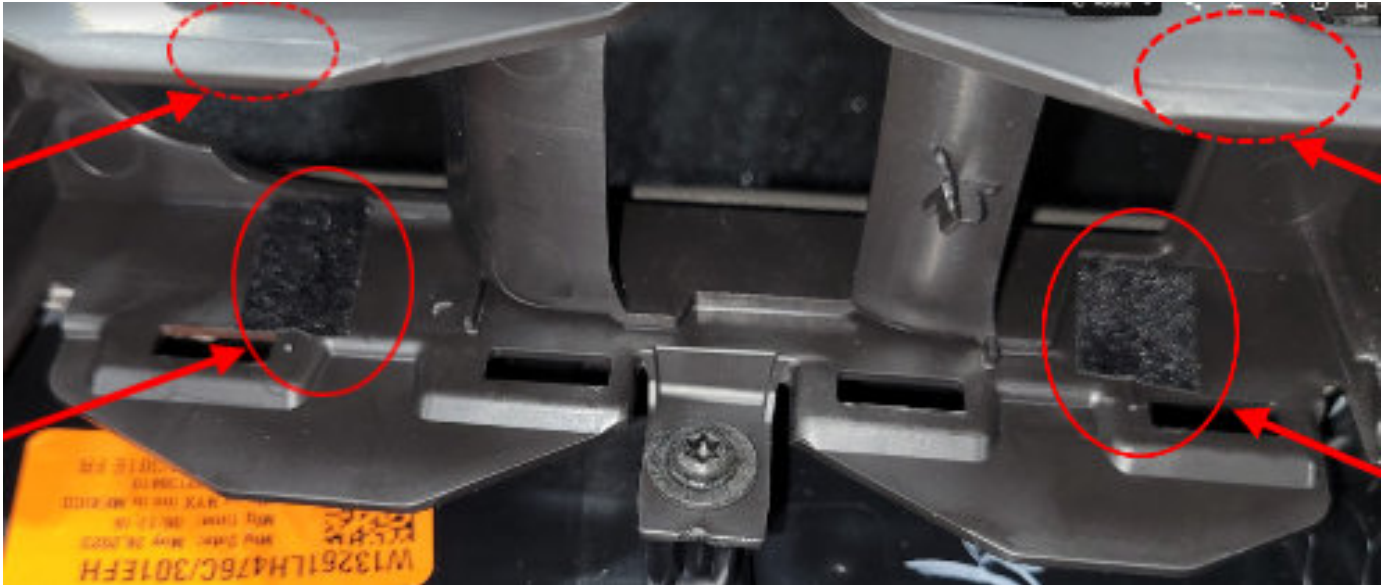
6676672

Driver Door Main Repair to Window Switch

1. Remove driver window switch and add 4 pieces of flock tape over ribs as shown. Refer to *Front Side Door Window Control Switch Replacement* in SI.

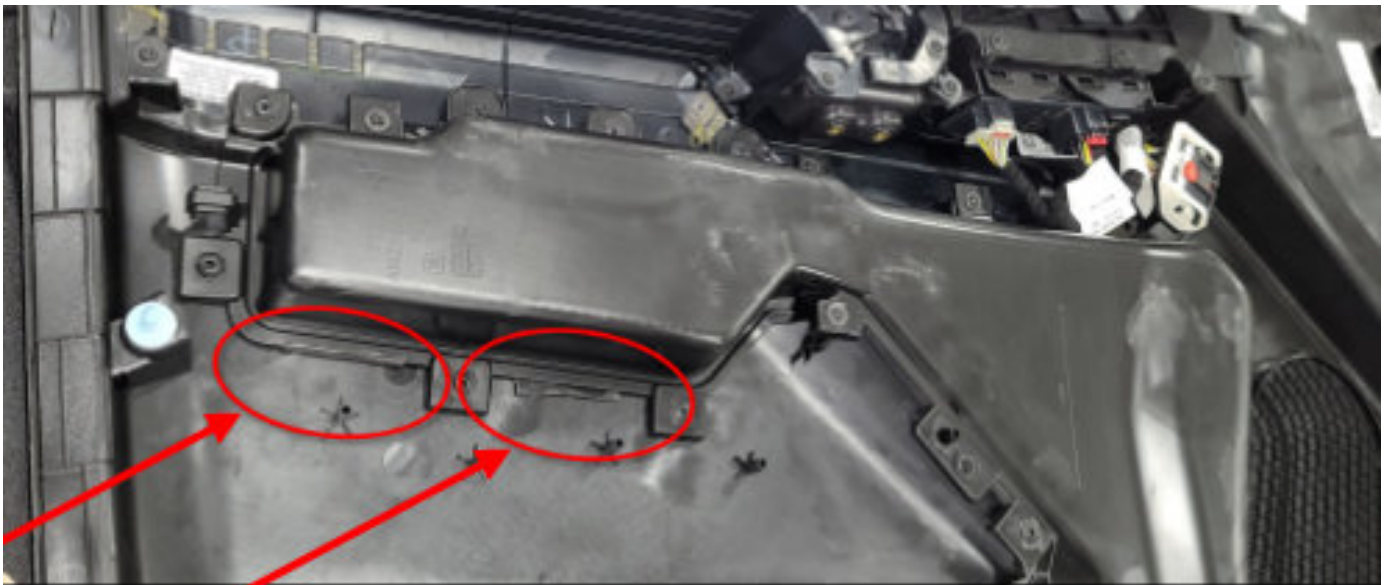
6676673

Under Armrest Storage Bin Added Tape

1. Add flock tape to the two locations shown above.
