Service Bulletin

Bulletin No.: 24-NA-108

Date: June, 2024

Subject: Radio Software Version V171 Update

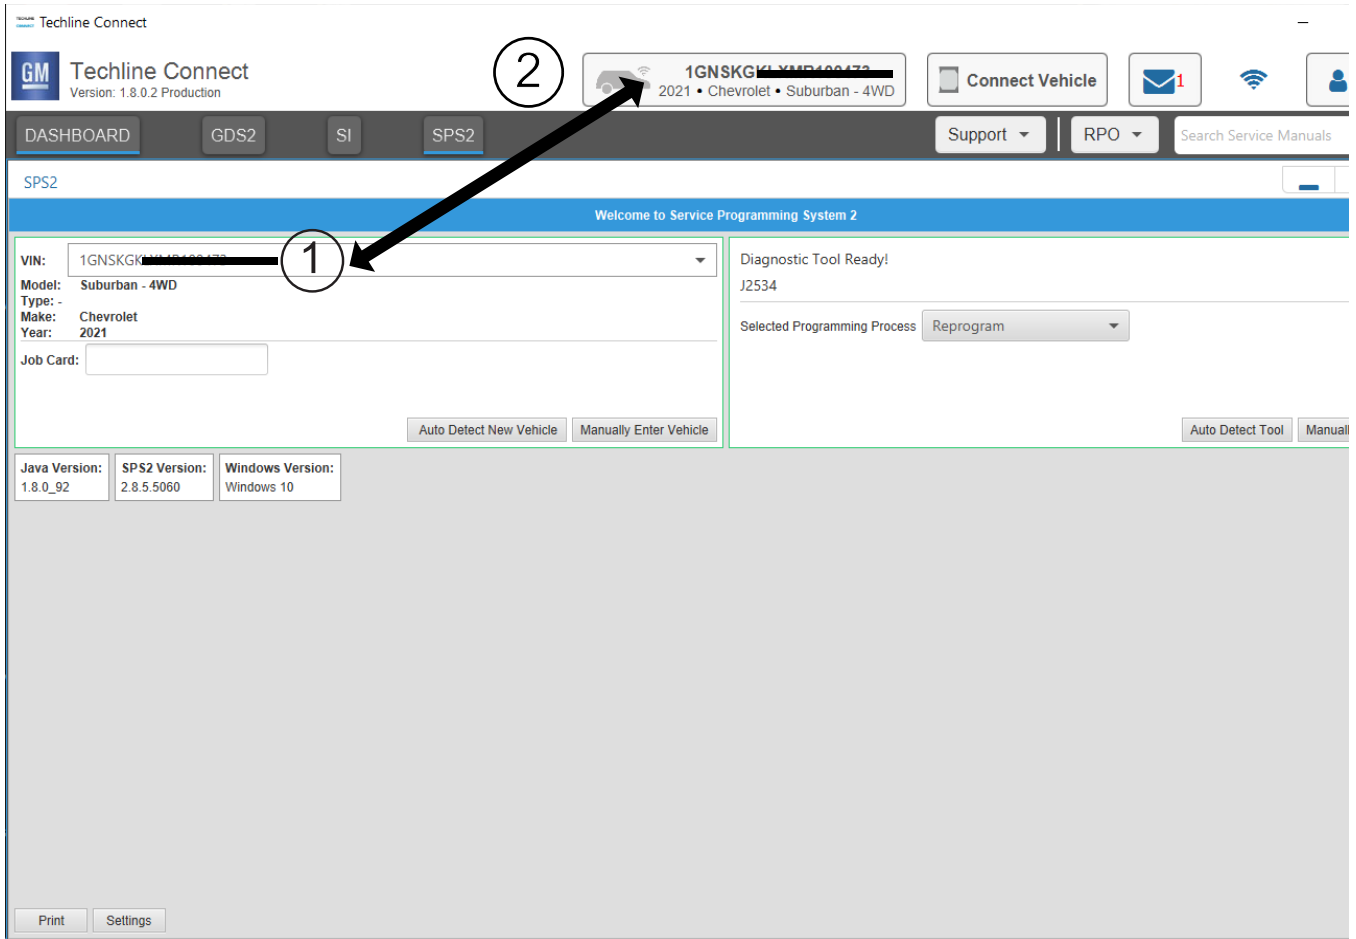
5743643

Caution: Be sure the VIN selected in the drop down menu (1) is the same as the vehicle connected (2) before beginning programming.

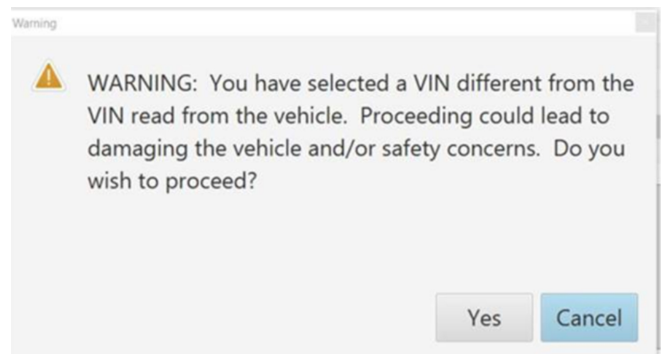
5877000

Important: If the vehicle VIN DOES NOT match, the message below will be shown.

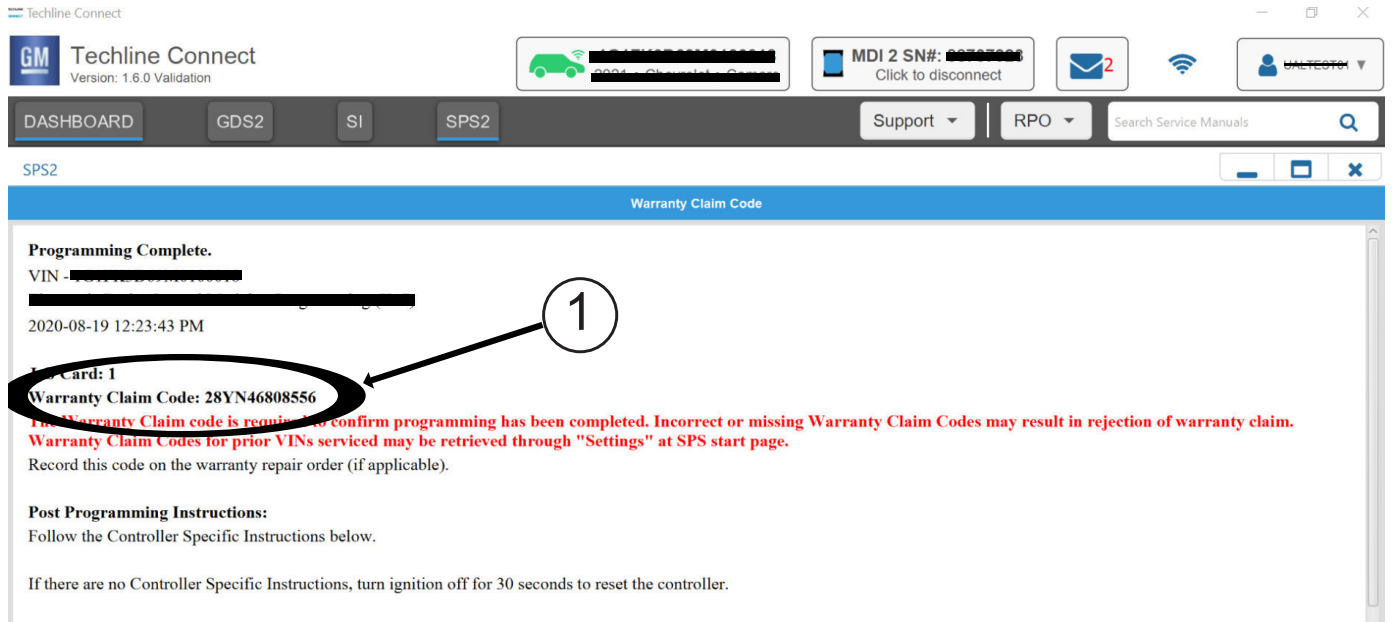
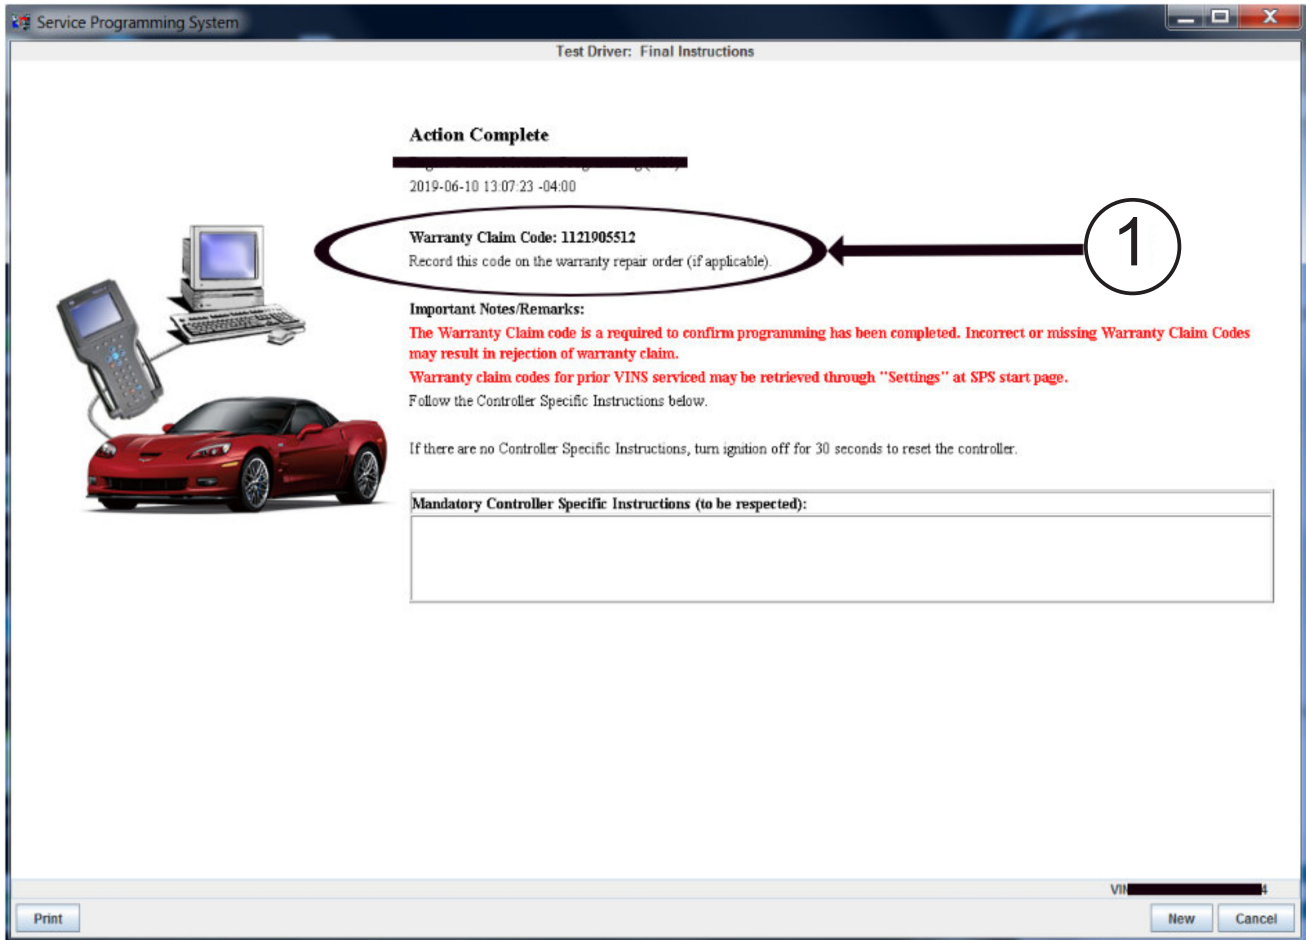
5431209

Note: The screenshots above are an example of module programming and may not be indicative of the specific module that is being programmed. Module selection and VIN information have been blacked out.
Important: To avoid warranty transaction rejections, you **MUST** record the warranty claim code provided on the SPS Warranty Claim Code (WCC) screen shown above on the job card. Refer to callout 1 above for the location of the WCC on the SPS screen.

- Record the SPS Warranty Claim Code on the job card for warranty transaction submission.
