Service Bulletin

Bulletin No.: 21-NA-268

Subject: Information on Crank No Start or Extended Crank, Malfunction Indicator Lamp (MIL) Illuminated, Possible Increased Brake Pedal Effort – DTC P0014, P0017, P0365 and/or P0366 Set

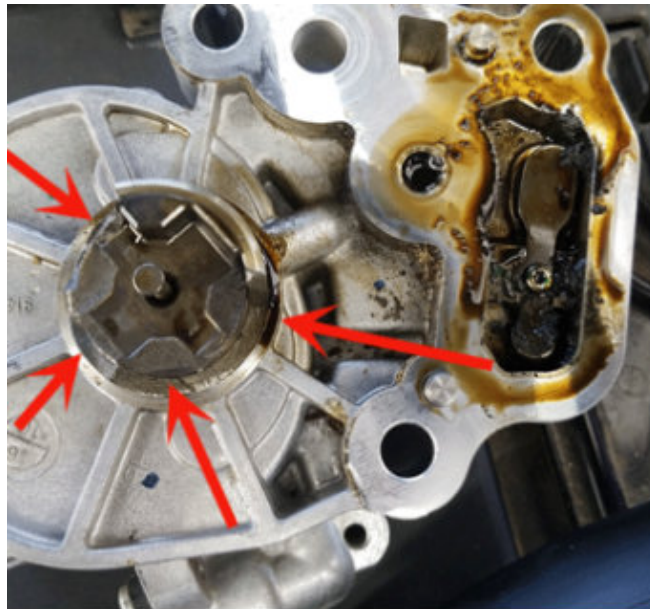
5921667

⇒ During disassembly, the vacuum pump drive lugs should also be inspected for damage (Photo above shows damaged vacuum pump drive lugs).

If you find the vacuum pump drive lugs are broken and/or the exhaust camshaft reluctor is out of position, then replacement of the exhaust camshaft and vacuum pump will be required.

Note: If needed, it will also be necessary to locate and remove the broken vacuum pump drive lugs and other metal debris during repairs.

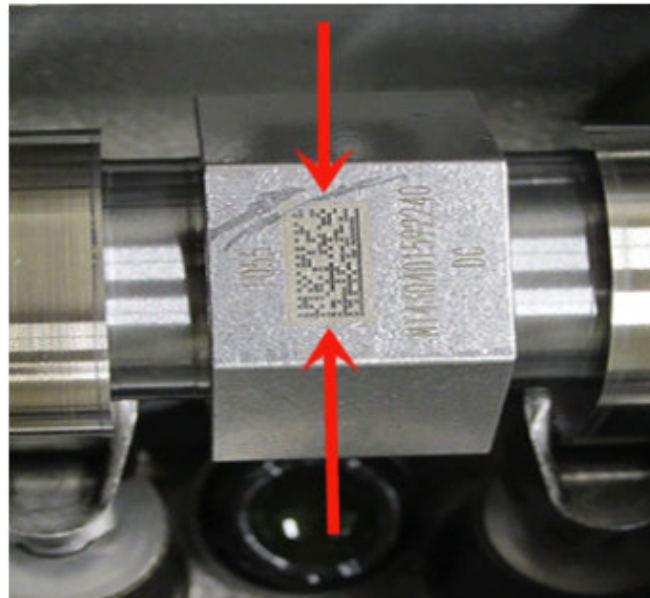
5921669

⇒ Rotate the exhaust camshaft to position the 2D matrix marking on the camshaft hex in the 12 o'clock position (Reference the graphic above for 2D marking).

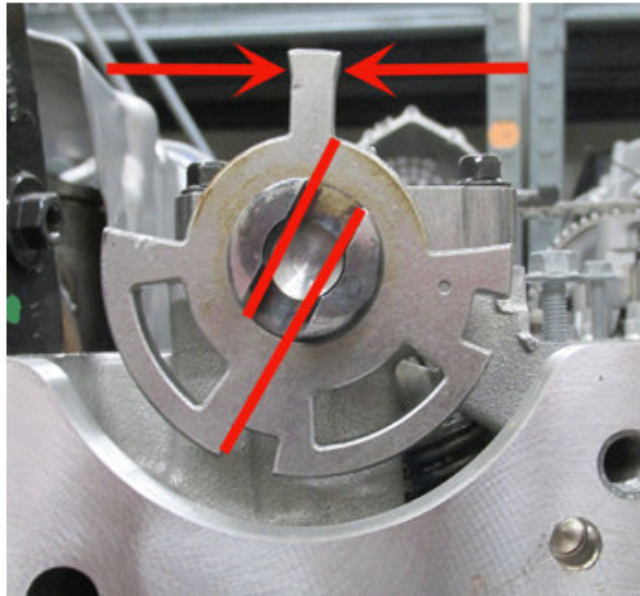
5921666

⇒ Once the exhaust camshaft 2D matrix has been positioned at 12 o'clock, verify the small tang located on the camshaft reluctor ring (Arrows above showing tang on reluctor) is in-line with the 2D matrix marking.

Important: If the reluctor is out-of-phase, inspect the exhaust camshaft position actuator dowel pin for damage.

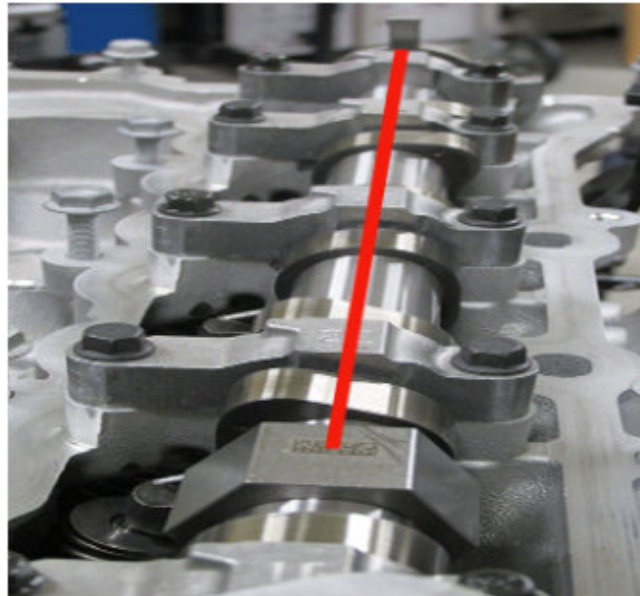
5921670

Also shown are additional reference points used to verify exhaust cam reluctor orientation to camshaft.

Proper relationship between the 2D matrix marking and the small tang on exhaust cam reluctor wheel.
