GENERAL MOTORS
DCS6943
URGENT - DISTRIBUTE IMMEDIATELY

Subject: N242446680 - Service Update
Transmission Solenoid Improperly Torqued

Models: 2024 Cadillac CT4
2024 Chevrolet Colorado

N242446680 Transmission Solenoid Improperly Torqued

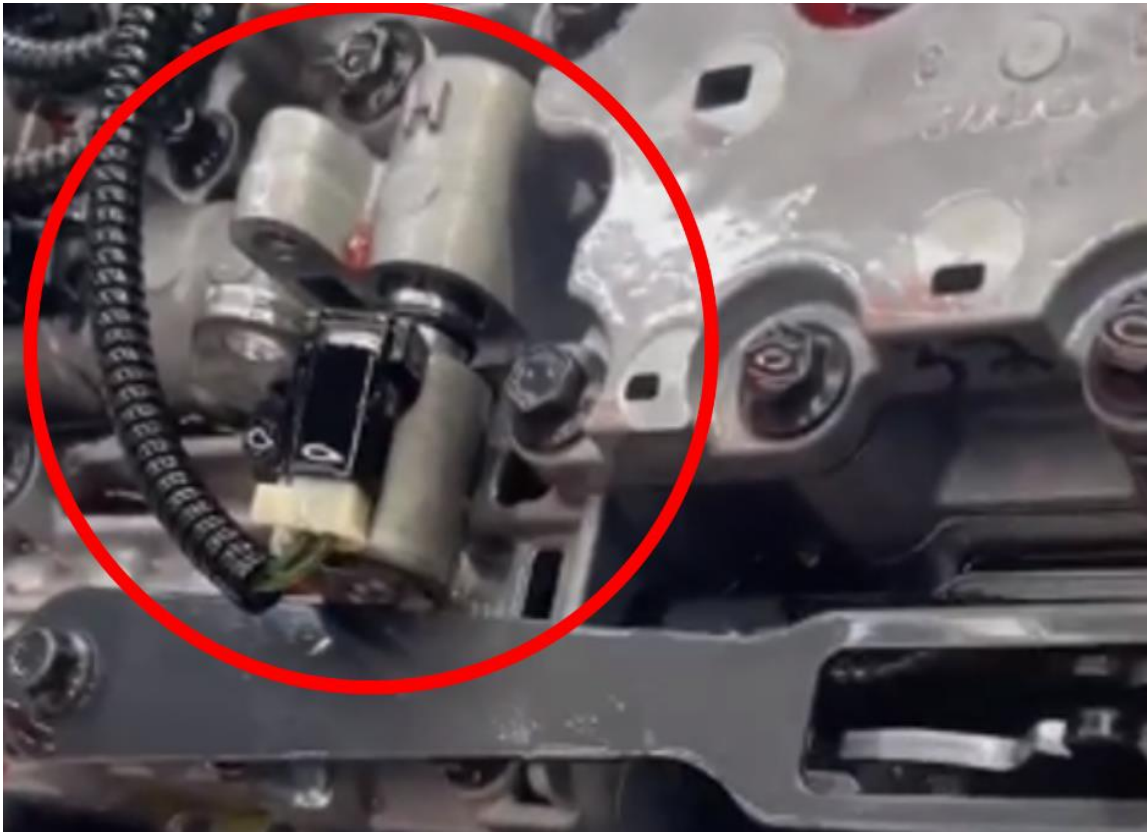
6681188

Condition	Certain 2024 model year vehicles may have a condition in which the transmission valve body solenoid retaining bolt was not properly torqued.
Correction	Dealers will torque the control valve solenoid bolt to specification.

2. Locate the H bore solenoid valve adjacent to the shift detent spring, illustrated above.
3. Torque the H bore solenoid bolt to 9 nm (80 in lb).
4. Reinstall the transmission fluid pan. Refer to *Automatic Transmission Fluid, Fluid Pan, and/or Filter Replacement* in SI.
5. Fill transmission fluid and set fluid level. Refer to *Transmission Fluid Fill Procedure* in SI.
