STAR ONLINE PUBLICATION

Case Number: S2323000042

Symptom/Vehicle Issue: Right Rear Door Ajar Light On. Metal Clunk Or Ting Noise From Door Latch Area.

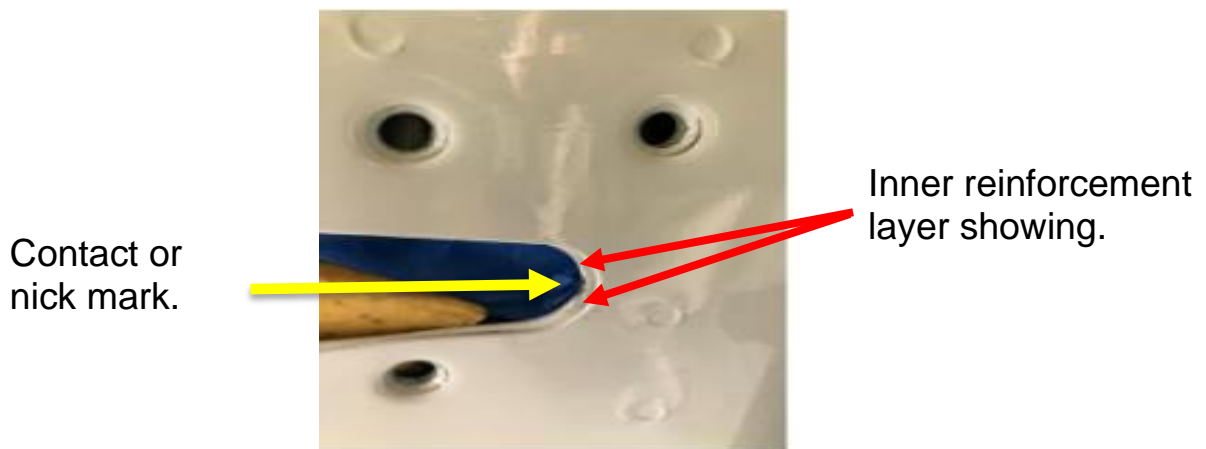
Customer Complaint/Technician Observation: Inspection of the door latch “fish mouth” may show striker contact marks in the radius of the mouth. Inner door reinforcement may show an overlap with the door outer shell at the radius.

Discussion: If the condition and metal contact match the above image the overlap will need to be ground even with the door outer layer. Review the below steps to provide striker clearance.

2. Apply masking tape to protect the door other than the radius of the fish mouth area of the latch hole. Using a rotary burr tool such as a carbide or a cone shaped grinding stone on a rotary tool (air or electric) carefully grind the inner latch reinforcement at the radius to match the door outer layer. Once complete, using a vacuum and compressed air remove the debris from the area.

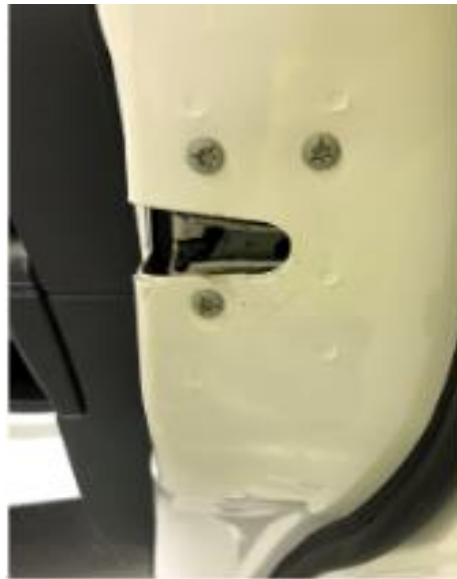
Finished Repair.

3. Clean the surface with grease and wax remover. Using single step primer 04443633AC or equivalent apply to the exposed metal areas in the radius. Allow to cure according to product instructions.

4. Using a touch up pen color matched to the vehicle, apply the color to the primed area. Follow touch up pen application instructions.
5. Remove masking tape and install screws for the latch.
