STAR ONLINE PUBLICATION

Case Number: S2423000002

Symptom/Vehicle Issue: 2nd Row Seat Does Not Fold Using Easy Entry Handle.

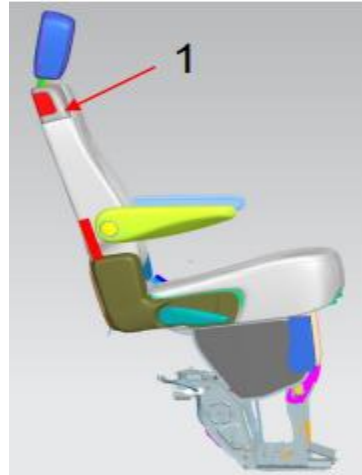
Fig 1.

2. Check for handle looseness. Does the handle rotate freely and spring back into position? Remove the screw behind the handle and remove the Easy Entry handle bezel (Fig1). Go to Step 3. If the handle is stuck or has high effort to rotate, go to step 6.
3. Check and confirm the cable barrel end fitting (Fig 2) and handle return spring (Fig 3) are connected as shown in the pics. If the cable or spring is not installed as shown in Fig 3, inspect them for damage. If no damage is present, reinstall the cable/spring. If there is damage, order and replace the Easy Entry handle assembly as per service procedure.

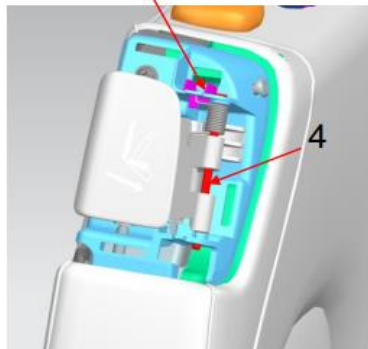
Fig 4.

4. Confirm the pin is in place (Fig 4) and there is no gap between the pin head and the housing. If the pin is not installed as shown in Fig 4, replace the Easy Entry handle assembly as per service procedure.

Check for gap between pin head and housing?

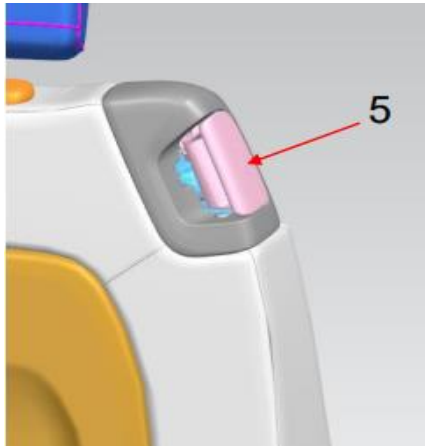
Fig 5.

5. Confirm that rotating the handle pulls the cable out and handle returns to its home position (Fig 5) when the handle is released. If handle is stuck or high effort to rotate, continue with step 6 through 8.

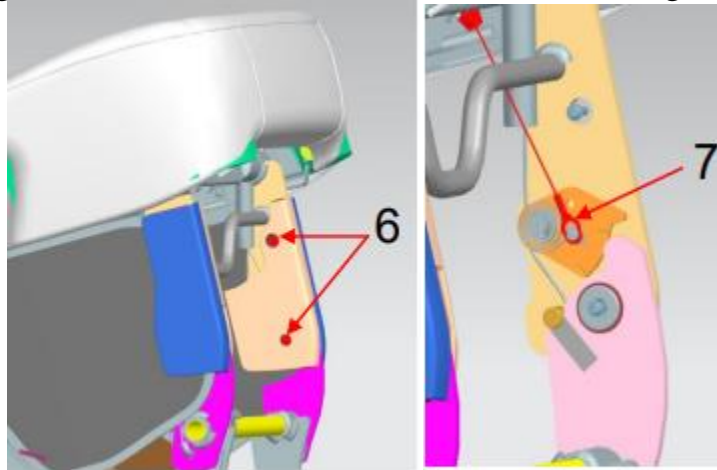
Fig 6 and 7.

6. Remove the front leg plastic shield by removing the 2 screws (Fig 6) on each of the legs.

7. Check and confirm that the cable eyelet end fitting (Fig7) is attached to the rivet pin on both legs. If either of the cables are not connected inspect for cable damage. If no damage is present, reinstall the end fitting securing the cable onto the rivet. If there is cable damage, order and replace the riser as per the service procedure.
8. Check and confirm that the cam (Fig 8) rotates when the easy entry handle is rotated (both cams should rotate on each leg). If the cams do not rotate, add some white lithium grease to the cam pivot (8a) and contact surface (8b) and rotate it a few times manually to spread the grease.

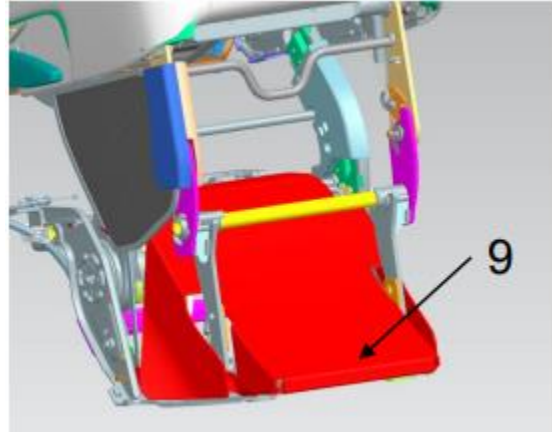
Fig 9.

9. Fold the lower carpet bin cover (Fig 9) up to gain access to the cable attachments.

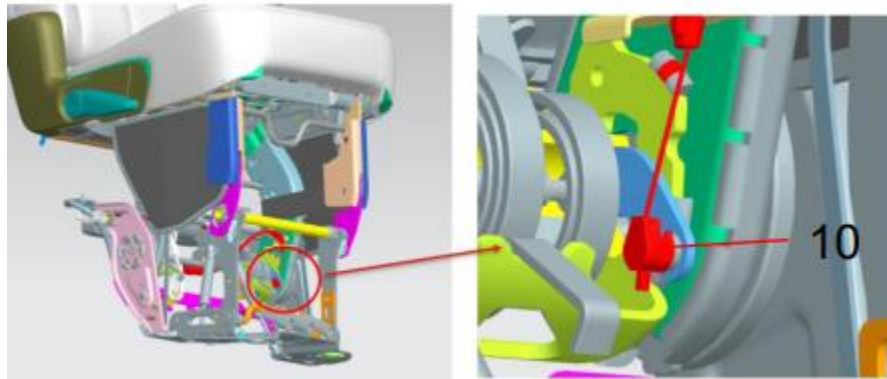
Fig 10.

10. Check and confirm that the cable end fitting (Fig 10) is connected to the rivet on the left rear leg. If the cable end fitting is not connected as per the image shown in Fig 10, inspect for cable damage. If no is damage present, reinstall the end fitting securing the cable onto the rivet. There should be an audible click when fully seated.

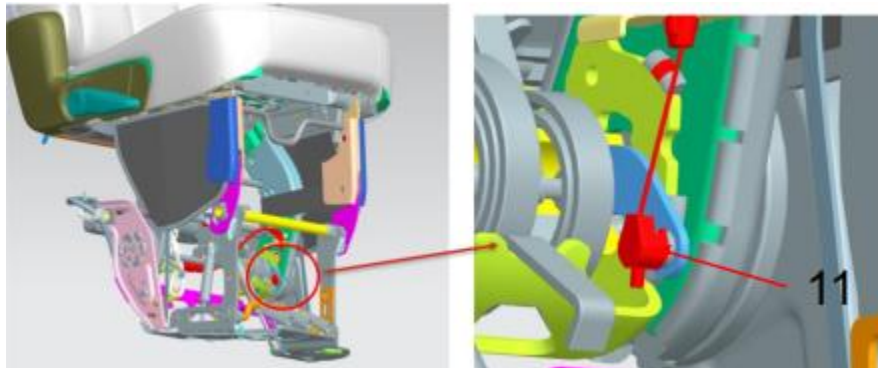
Fig 11.

12. Check and confirm the riser lever rotates (Fig 11) up when the handle is rotated.

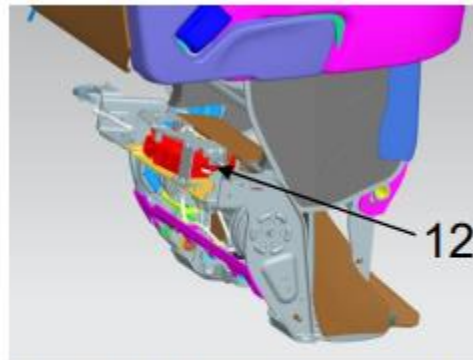
Fig 12.

13. Remove and reconnect wire harness connector (Fig 12) under the rear load floor panel and remove and reconnect vehicle battery terminals. If the motor sound is not audible or cable release lever does not rotate, replace the riser assembly as per service procedure.

NOTE: LOCATION OF THE MOTOR SHOWN WITHOUT REAR LOAD FLOOR PANEL FOR REFERENCE.
