Service Bulletin

Bulletin No.: 23-NA-058

Subject: Cold Start Rattle Noise from the Engine Compartment, Malfunction Indicator Lamp (MIL) Illuminated - DTC P0299 Set

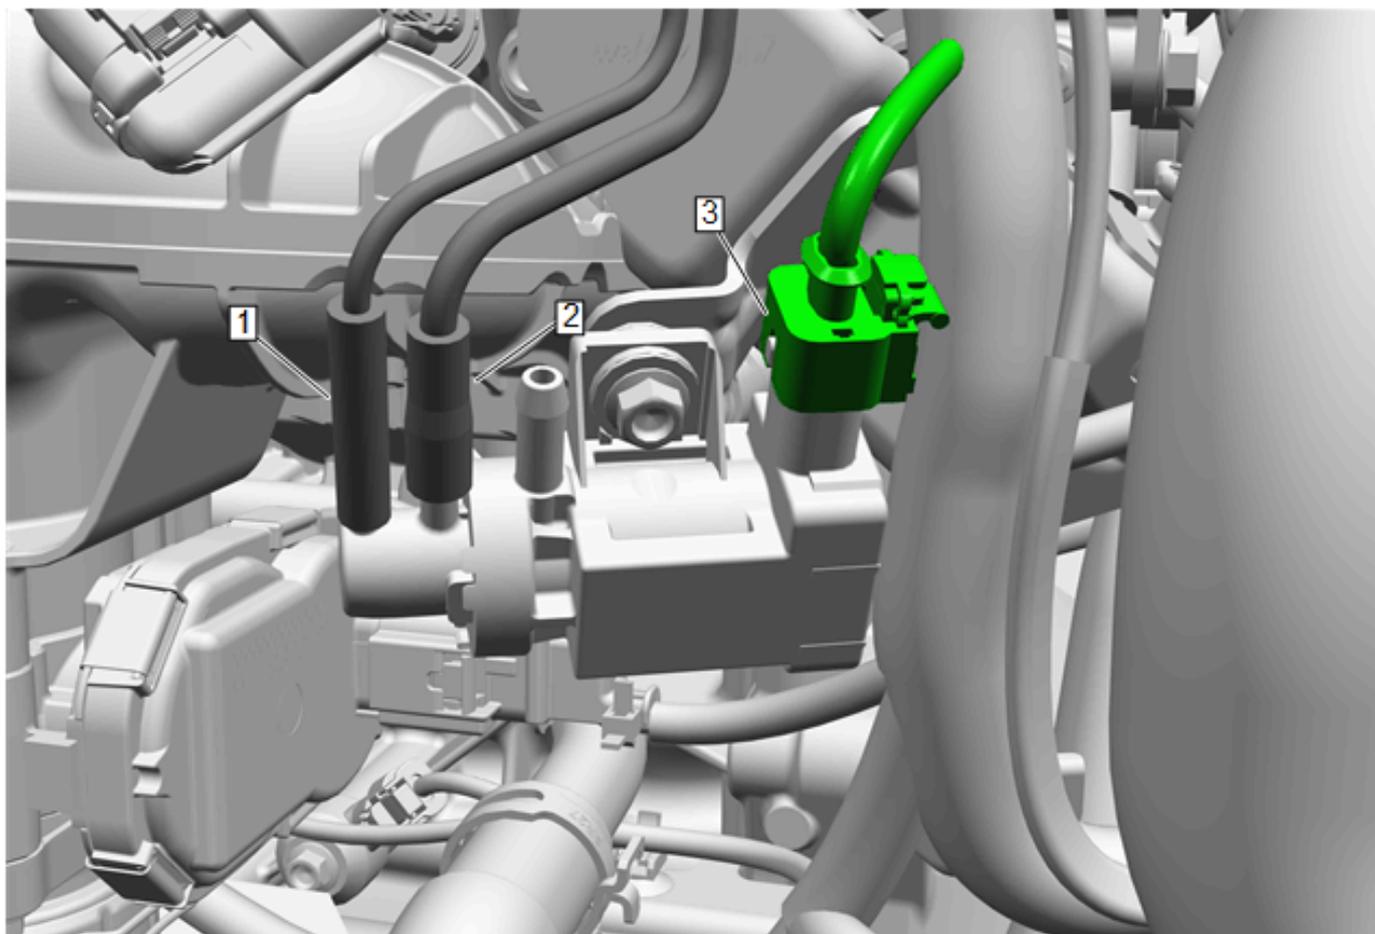
Check Vacuum Supply from the Vacuum Pump

1. Disconnect the Turbocharger Wastegate Actuator Vacuum Control Solenoid Valve Hose (1) from the Turbocharger Wastegate Regulator Solenoid Valve.
 2. Utilizing EN-23738-A Vacuum Pump with an integral vacuum gauge, connect said pump to the Turbocharger Wastegate Actuator Vacuum Control Solenoid Valve Hose.
 3. Engine at operating temperature at idle.
 4. Verify the tool reading: EN-23738-A Vacuum Pump = -50 kPa (-0.5 bar, 15 in Hg).
- If the desired pressure/vacuum cannot be achieved or does not hold steady:
 - ⇒ Ignition/Vehicle » Off.
 - ⇒ Test or replace the component: Vacuum Pump Assembly and related hoses.
 - If the desired pressure/vacuum can be achieved and holds steady:
 - Engine » Off.
 - Reconnect the Turbocharger Wastegate Actuator Vacuum Control Solenoid Valve Hose to the Turbocharger Wastegate

Regulator Solenoid Valve and refer to Check Wastegate Vacuum Regulator Valve Function.

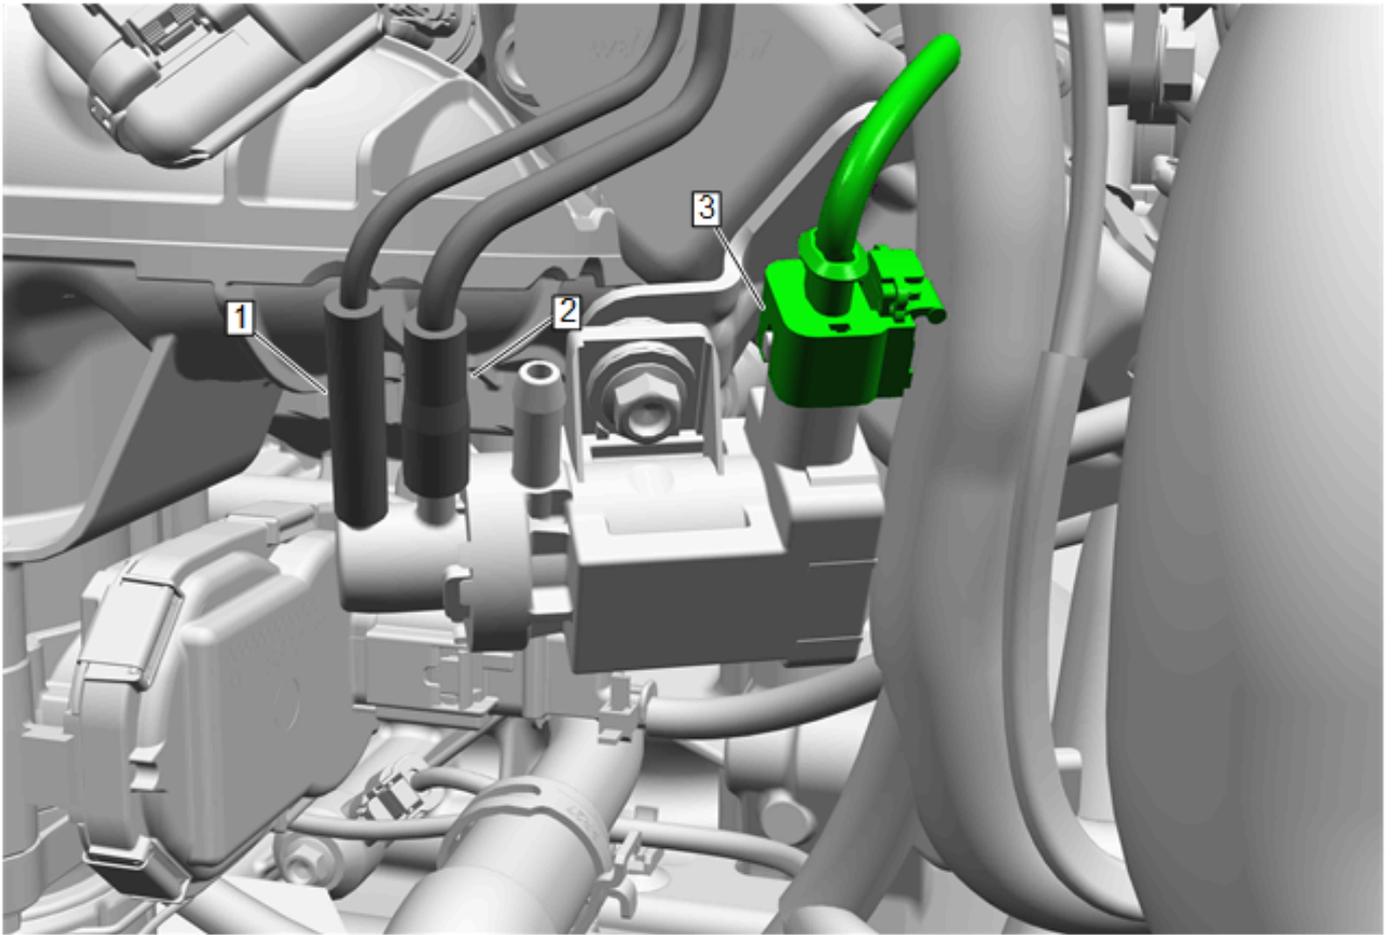
Check Wastegate Vacuum Regulator Valve Function

1. Disconnect the Turbocharger Wastegate Actuator Vacuum Tank Solenoid Valve Tub (2) from the Turbocharger Wastegate Regulator Solenoid Valve.
2. Connect the EN-23738-A Vacuum Pump to the Turbocharger Wastegate Solenoid Valve Actuator supply port.
3. Engine at operating temperature at idle.
4. Verify the tool reading: EN-23738-A Vacuum Pump = Less than -17 kPa (-0.17 bar, 5 in Hg).
 - If -17 kPa (-0.17 bar, 5 in Hg) or greater.
 - ⇒ Test or replace the component: Turbocharger Wastegate Regulator Solenoid Valve. Refer to *Turbocharger Wastegate Regulator Solenoid Valve Removal* and *Turbocharger Wastegate Regulator Solenoid Valve Installation*.
 - If less than -17 kPa (-0.17 bar, 5 in Hg).
 - ⇒ Engine Speed Greater than 4000 RPM — For 2 s.
 - ⇒ Verify the tool reading: EN-23738-A Vacuum Pump = Greater than -50 kPa (-0.5 bar, 15 in Hg).

- If less than -50 kPa (-0.5 bar, 15 in Hg).

If Greater than -50 kPa (-0.5 bar, 15 in Hg). The Turbocharger Wastegate Regulator Solenoid Valve has been validated to be functioning correctly and proceed to Turbocharger Inspection.

- ⇒ Test or replace the component: Turbocharger Wastegate Regulator Solenoid Valve. Refer to *Turbocharger Wastegate Regulator Solenoid Valve Removal* and *Turbocharger Wastegate Regulator Solenoid Valve Installation*.
