Service Bulletin

Bulletin No.: 23-NA-102

Subject: Drivability Concerns, Hesitation, Transmission Shifting Rough/Harsh, Malfunction Indicator Lamp (MIL) Illuminated - Multiple DTCs Set

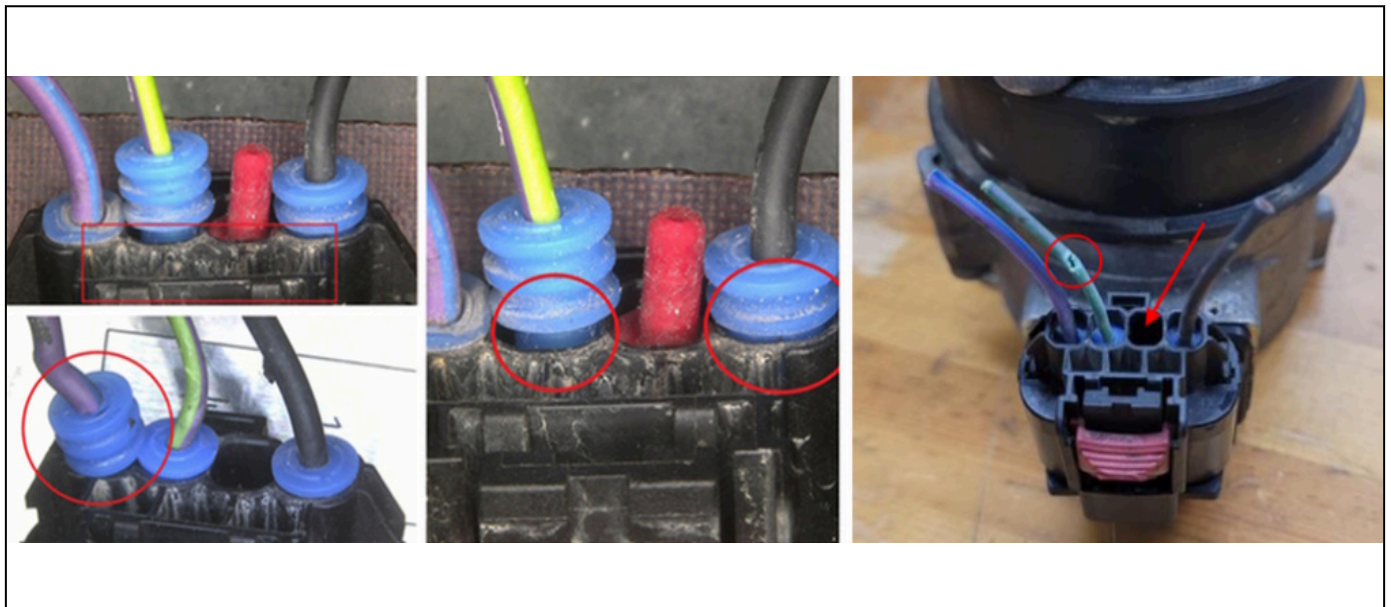
Area of Concern at the CAC Pump Electrical Connector

An open cavity or an unsealed pump connector allowing water into the (M10) charge air cooler pump electrical connector might be the root cause of the communication failure.

DTCs that may be common with water intrusion the electrical connector:

- Check the CAC Pump connector sealing and look for any corrosion at the pump due to water leakage.

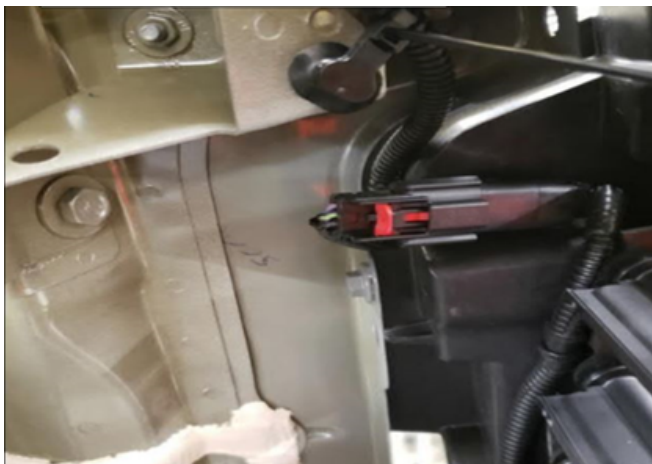
6219339

The following DTCs may be caused by the engine wiring harness to active grille air shutter actuator in-line connector (X618 on the pickup and X604A on the SUV). Please check circuit 4621 which may be:

- Not properly connected
- Not properly held by the rear clip
- Grounded on the radiator

The graphic above shows how the proper connection must be.

- Check the active grille air shutter actuator in-line connector for not being properly connected or grounded to the radiator.

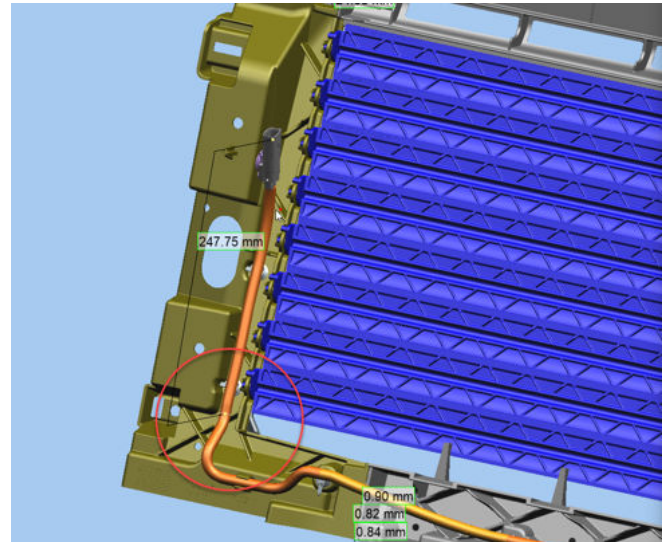
6219340

DTCs may be caused by the active grill air shutter wiring pinched at the radiator support.

The graphic above depicts where a pinching condition may be located.

- Check the active grill air shutter wiring route to identify possible damaged points in the wiring.

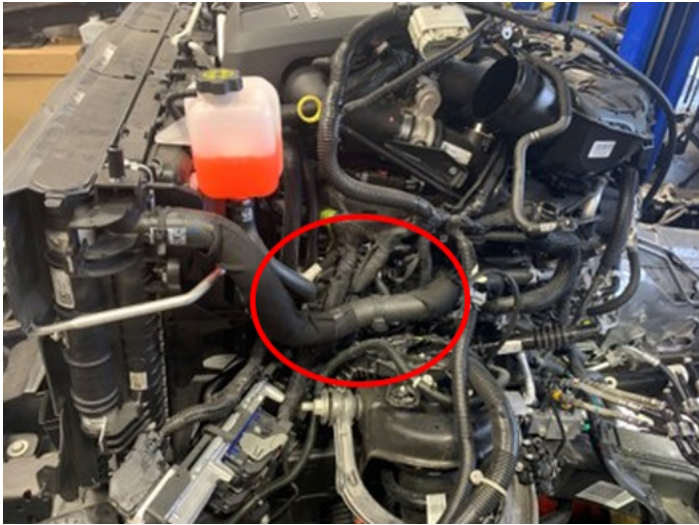
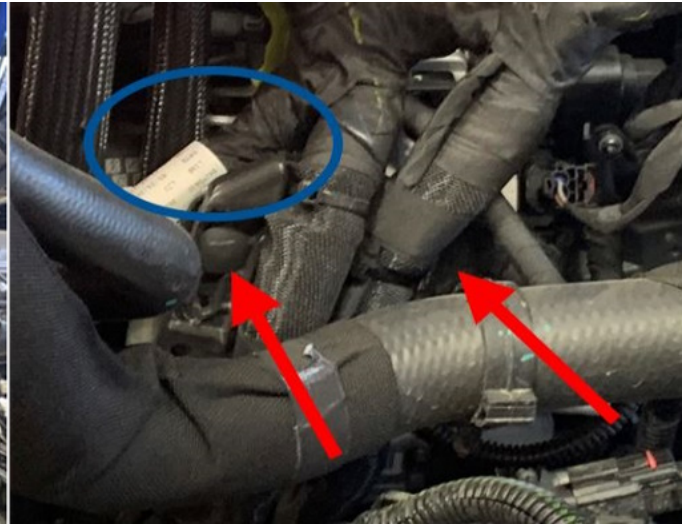
LM2 Area of Concern at Alternator Bracket

- Arrows indicate location of retainer pins that were not properly installed.

- Blue circle indicates where a chafe in the wiring has occurred. The mis-installed bracket allowed the harness to lay on the alternator.

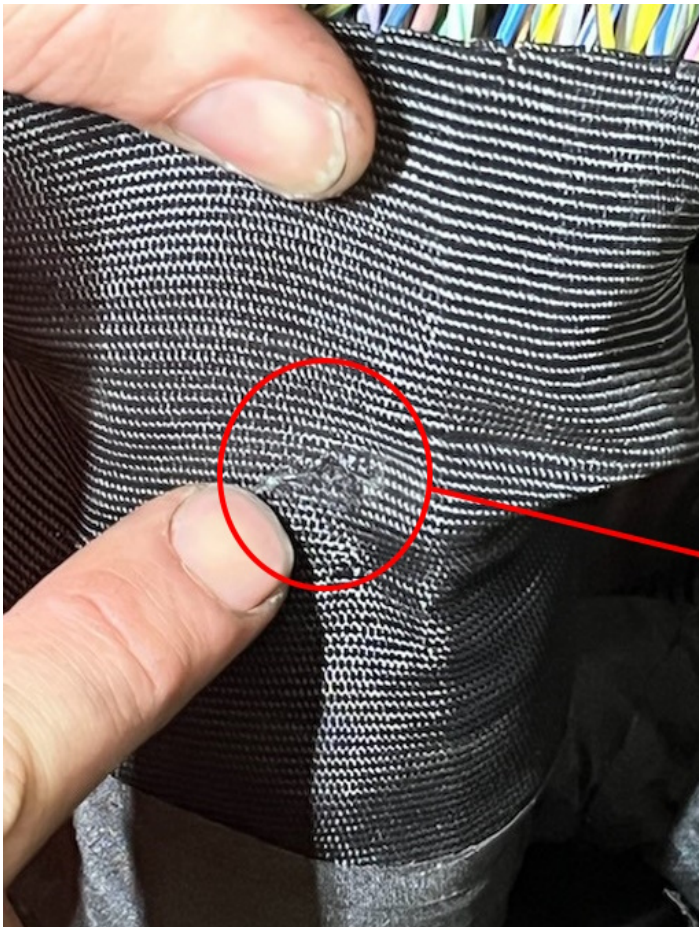
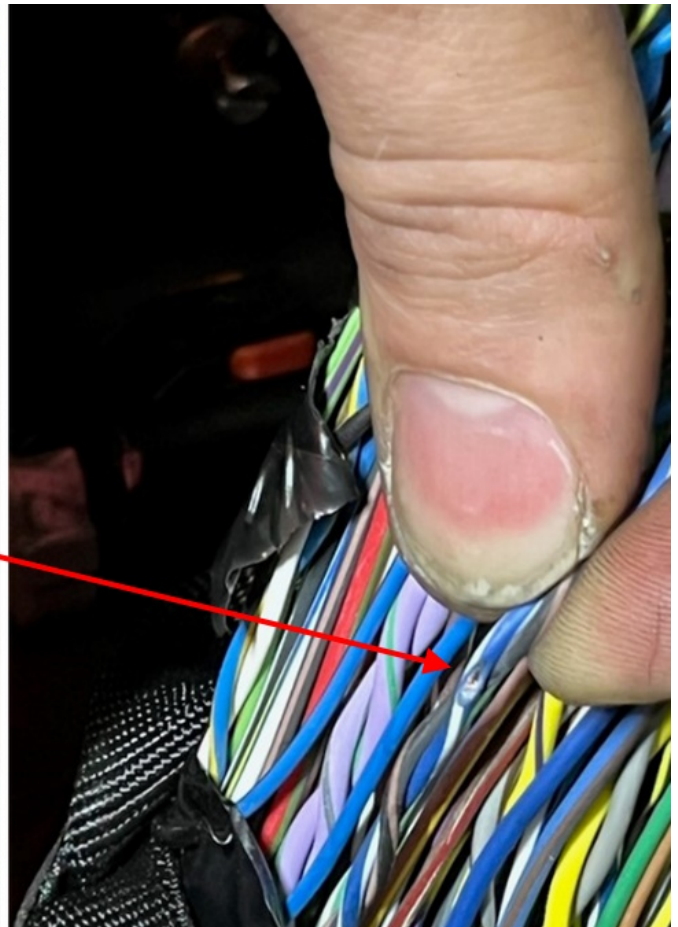
LM2 – Wiring Harness Contact at Alternator Bracket.

- The engine wire harness was chafed by a bracket next to the back of the alternator.

U0073 CAN BUS 2 off or U0074 CAN BUS 3 off

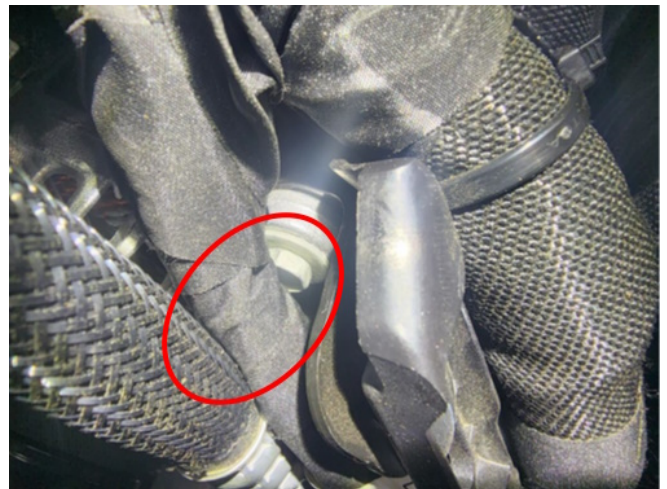
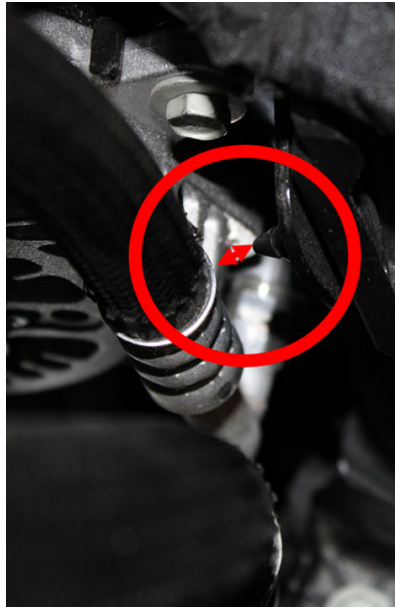
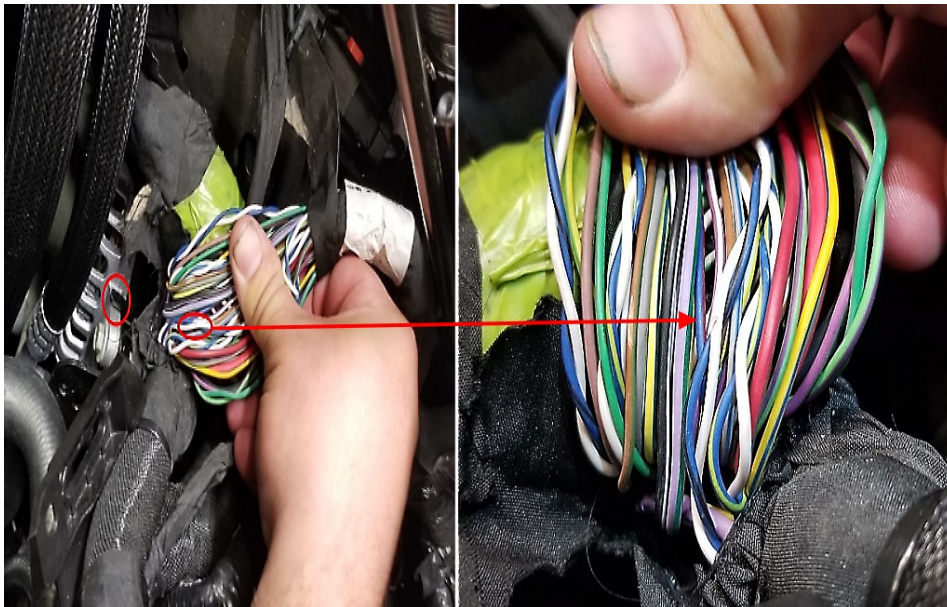
LZ0 Area of Concern at Alternator Bracket

LZ0 – The Wiring Harness Contacted the Alternator Bracket do to Routing of the Harness.

Note: During the repair. It was noted that a 5/8 ths diameter hose was used to prevent a reoccurring chafe condition.

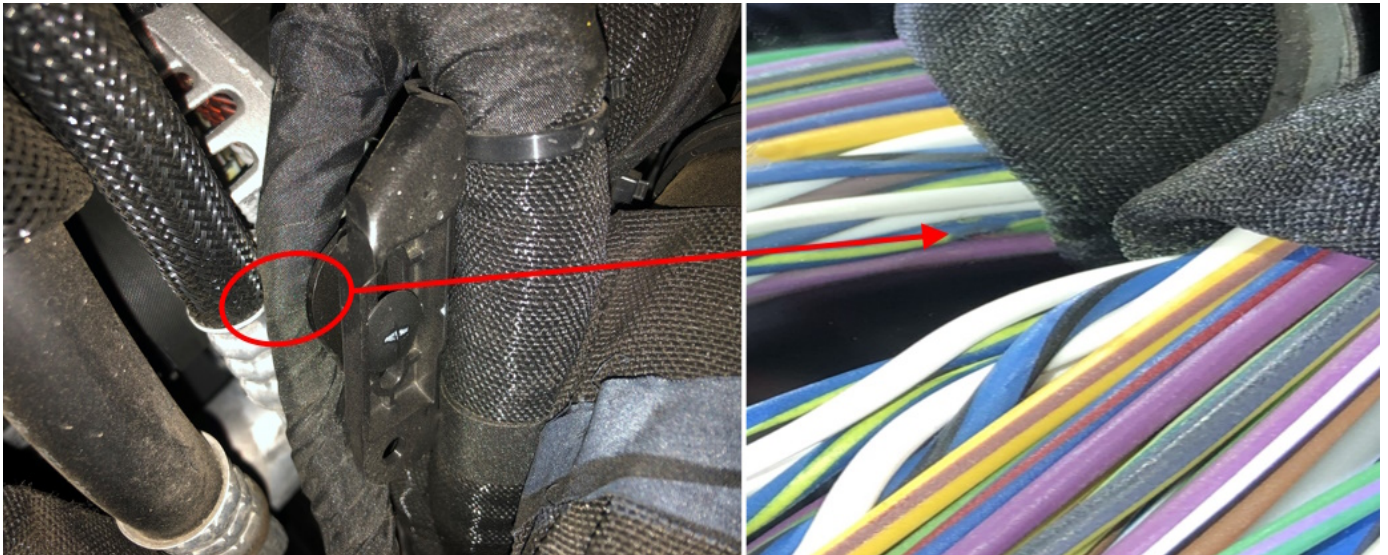
LZ0 – Wiring Harness Contacting the A/C Line and Alternator Bracket.

This is CAN 3 wire harness. Can 4 is also in this bundle only blue and yellow twisted with white.

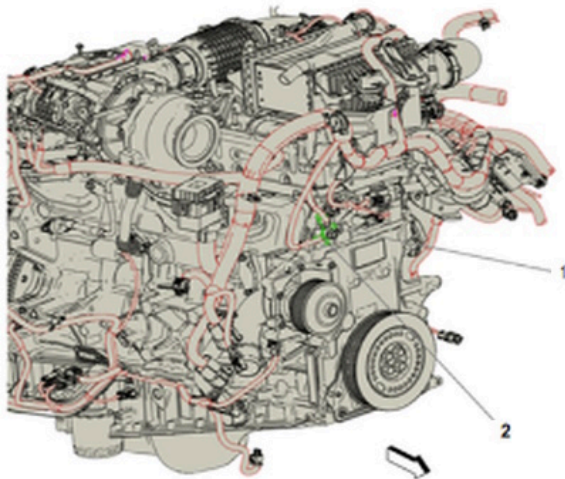
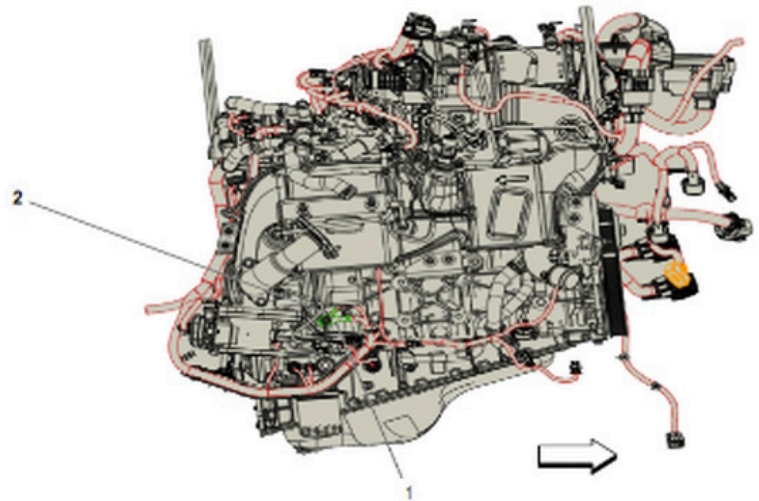
Loose Ground

Inspect ground connections G176A (1) and G177B (2) may exist. Please check for any:

- Loosen condition
- Damaged or dirty threads
