REFERENCE:	TSB: 08-157-24 GROUP: 08 - Electrical	Date:	July 10, 2024	REVISION:	-
VEHICLES AFFECTED:	2023 - 2024 (GC) Alfa Romeo Tonale 2023 - 2024 (GG) Dodge Hornet			MARKET APPLICABILITY:	
				<input checked="" type="checkbox"/> NA	<input type="checkbox"/> MEA
				<input type="checkbox"/> SA	<input type="checkbox"/> IAP
				<input type="checkbox"/> EE	<input type="checkbox"/> CH
CUSTOMER SYMPTOM:	Some customers may report that on occasion, vehicle exterior lamp assemblies are fogged with a light layer of condensation on the inside of the lenses.				
CAUSE:	Headlamp and tail lamp assembly condensation

This Technical Service Bulletin (TSB) is to communicate the procedure for headlamp and tail lamp assembly condensation clearing.

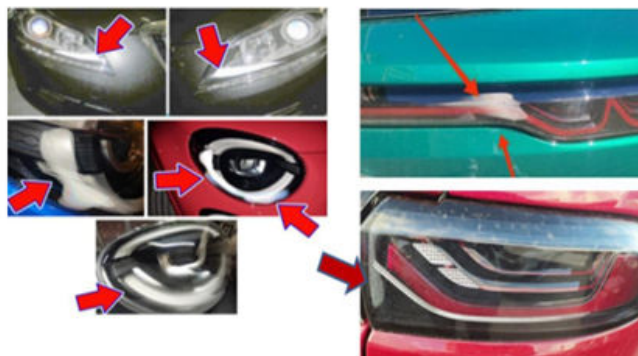
Customers may report that on occasion, vehicle exterior headlamp and tail lamp assemblies are fogged with a light layer of condensation on the inside of the lenses [Fig. 1](#).

This may be reported after the headlamp and tail lamps have been turned on and brought up to operating temperature, turned off and then rapidly cooled by cold water (such as rain, or the water from a vehicle wash). Lens fogging can also occur under certain atmospheric conditions after a vehicle has been parked outside overnight (i.e. a warm humid day followed by clear cool night).

Fig. 1
Fogged Headlamp And Tail Lamp Assembly Examples

If the condensation/fogging has begun to clear from the headlamp or tail lamp lens with the lamps operating, this indicates the lamp sealing has not been breached, and **the lamp assembly does NOT need to be replaced.**

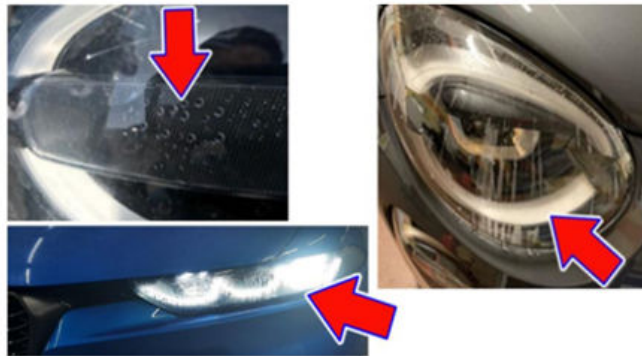
If the condensation/fogging has not begun to clear with the headlamps and tail lamps operating, or the lamp assembly has large amounts of water droplets visible on most internal surfaces, this indicates a problem with the lamp assembly sealing that has allowed water to enter the assembly. In this instance, the customer is also likely to report that moisture in the assembly is always present and never disappears [Fig. 2](#).

Fig. 2
Heavy Internal Moisture That Will Not Clear Examples

NOTE: Any assembly that exhibits internal moisture permanently, should be replaced.

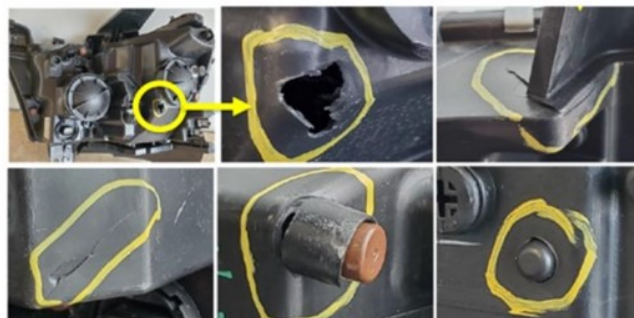
Damage: Breakage on the assembly housing will allow moisture/water to enter to the assembly (damage, cracks, holes, etc.) [Fig. 3](#). If this is noticed, the Failure Code must be recorded accordingly: **BROKEN OR CRACKED.**

Fig. 3
Cracked, Damaged Or Broken Lamp Assembly Examples

If no obvious causes are observed, proceed using the failure code for leaks and replace the headlamps or tail lamp accordingly. Refer to the detailed service procedures available in DealerCONNECT/Service Library.
