REFERENCE:	TSB: 08-161-24 GROUP: 08 - Electrical	Date:	July 13, 2024	REVISION:	–
VEHICLES AFFECTED:	2022 - 2024 (GG) Dodge Hornet 2022 - 2024 (GC) Alfa Romeo Tonale This bulletin applies to vehicles built on or before July 1, 2024 (MDH 0701XX) equipped with Uconnect 5 W 10.25" Display (Sales Codes UBH or UEH) or Uconnect 5 Nav W 10.25" Display (Sales Codes UBS or UES).	MARKET APPLICABILITY:			
		<input checked="" type="checkbox"/> NA <input type="checkbox"/> MEA <input type="checkbox"/> SA <input type="checkbox"/> IAP <input type="checkbox"/> EE <input type="checkbox"/> CH			
CUSTOMER SYMPTOM:	Customers may experience one or more of the following: <ul style="list-style-type: none"> Speed limit sign on Instrument Panel Cluster (IPC) is showing incorrect speed. Touch freeze/Disassociated Center Stack Display (DCSD) off. CP/AA wireless disconnection. 				
CAUSE:	Software improvements

This bulletin involves updating R1H radios software level to T27.52.

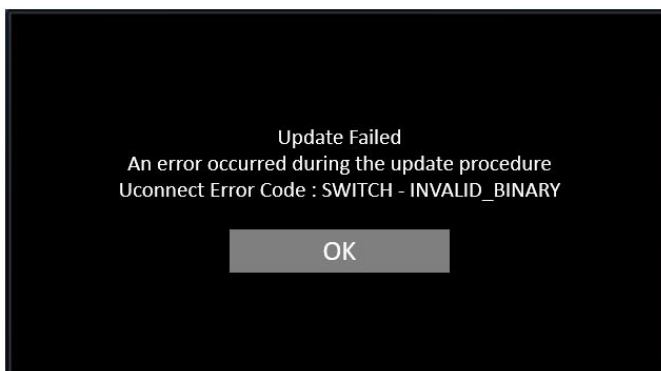
Fig. 6
Update Failed

18. Sometimes the radio will display an error pop up “ SWITCH-INVALID_BINARY“ after successful radio update. Please ignore this error message and press “OK” to continue [Fig. 6](#).
