REFERENCE:	TSB: 08-163-24 GROUP: 08 - Electrical	Date:	July 13, 2024	REVISION:	–
VEHICLES AFFECTED:	2023 (LA) Dodge Challenger Demon This bulletin applies to vehicles equipped with the 6.2L V8 Supercharged HO Engine (Sales Code ESJ with XVC) And: <ul style="list-style-type: none"> Uconnect 4C with 8.4" display (Sales Code UAS). Uconnect 4C NAV with 8.4" display (Sales Code UAQ or UCQ). Uconnect 4C with 8.4" display (Sales Code UCS). 			MARKET APPLICABILITY:	
				<input checked="" type="checkbox"/> NA	<input type="checkbox"/> MEA
				<input type="checkbox"/> SA	<input type="checkbox"/> IAP
				<input type="checkbox"/> EE	<input type="checkbox"/> CH
CUSTOMER SYMPTOM:	Customers may experience one or more of the following: <ul style="list-style-type: none"> Non functional shift torque recovery option in the shift torque set up page. Torque recovery time slider is non functional. 				
CAUSE:	Radio Software

This bulletin involves inspecting the software level and updating the software to SR56.4

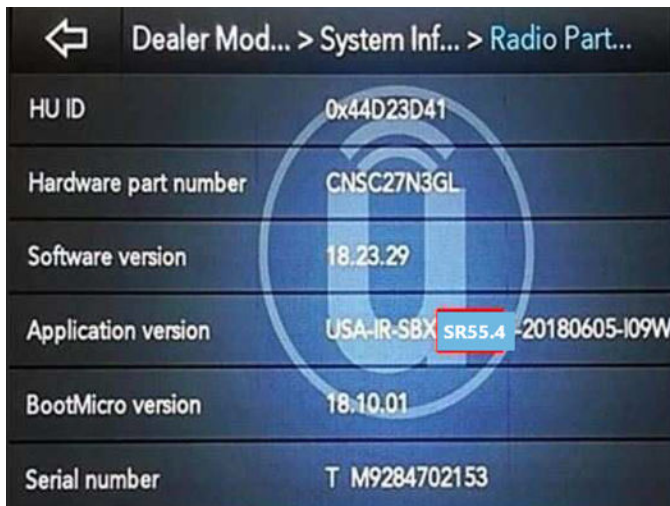
Fig. 1

1. Verify the radio software version. Radio must be in Dealer Mode to verify. To put the radio in Dealer Mode, follow these steps:
 - Press and hold both lower corners of the display screen, until the 'Dealer Mode' screen appears (approximately seven seconds). Release buttons.
 - Select "Radio Part Information". The software level will be listed next to "Application Version" [Fig. 1](#).

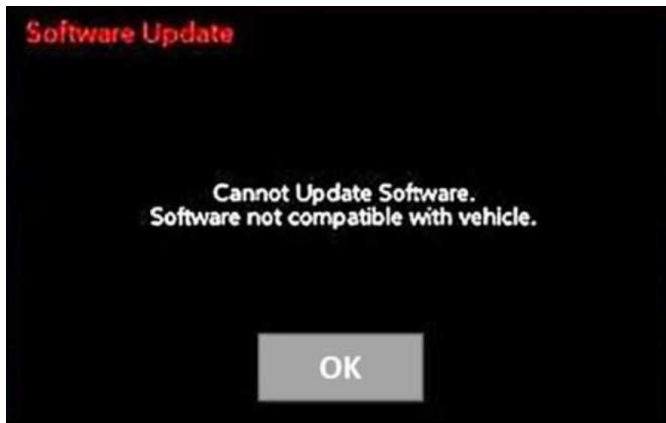
Fig. 7
Software Not Compatible

- 15. If the screen in Fig. 7 is displayed, the USB flash drive was not set up correctly. Use a top name brand USB and create a new flash drive, then start the update again.

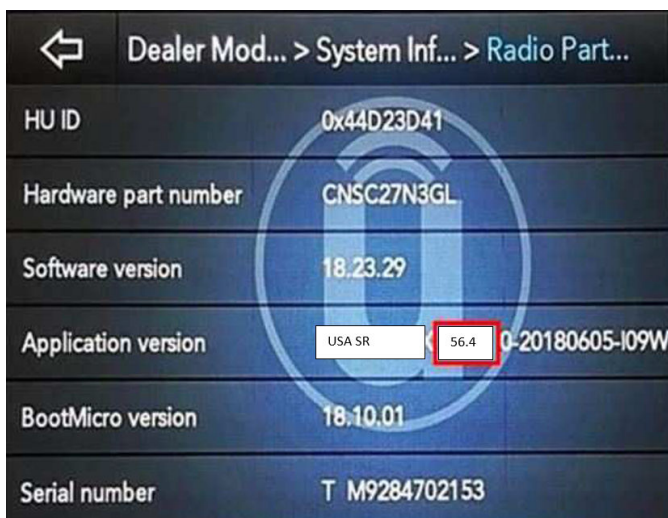
Fig. 12

22. Is the radio currently at software level SR56.4 Fig. 12?
