## Lower Control Valve Inspection

**Units Affected:** Certain DT85H derricks built from May 2022 to December 2023 equipped with a Parker brand lower control valve, part number 990977270. Verify your unit is affected by reviewing the attached list or accessing Altec Connect.

**Background:** Altec has learned that the affected units may have a lower control valve provided by the manufacturer with under-torqued tie rods.

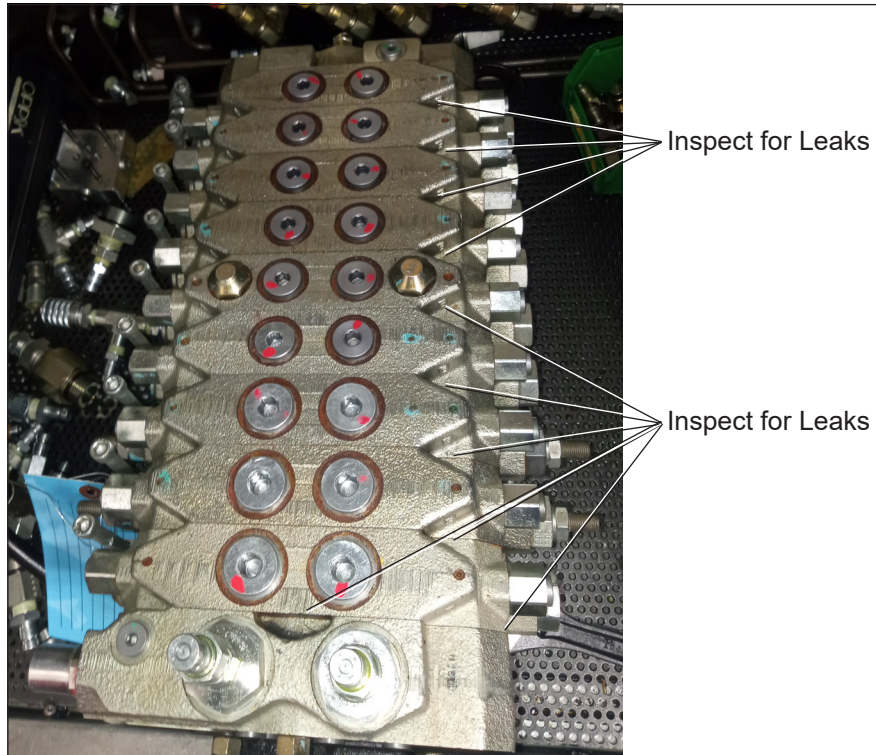
**Figure 1 — Lower Control Valve**

1. Position the unit on a level surface, apply the parking brake, and turn off the engine. Remove the key from the ignition, and secure it following your employer's vehicle lockout/tagout procedure. Chock the wheels.
2. Open or remove the turntable cover from the right side of the turntable to access the lower control valve (refer to Figure 2). Look for oil leaks between every valve section.

3. Review the inspection results.
  - If oil is found between any of the valve sections, a replacement valve is required. Proceed to step 4.
  - If there is no oil between the valve sections, the tie rods require torque. Proceed to step 5.
4. Valve replacement is required.
  - a. Put the unit back into service.
  - b. Contact Altec Service to schedule the installation of the kit at an Altec facility. This order will be shipped motor freight.
  - c. Do not complete the Inspection Sheet at the end of this notice or the remaining steps. Completion of the notice will be documented after the vehicle is repaired.
