Service Bulletin

Bulletin No.: 24-NA-115

Subject: Information on Low Beam Headlamp Bulb Diagnosis/Replacement (Inspect Bulb and Connector)

Brand:	Model:	Model Year:		VIN:		Engine:	Transmission:
		from	to	from	to		
Chevrolet	Silverado 4500HD, 5500HD and 6500HD	2019	2024	-	-	All	All

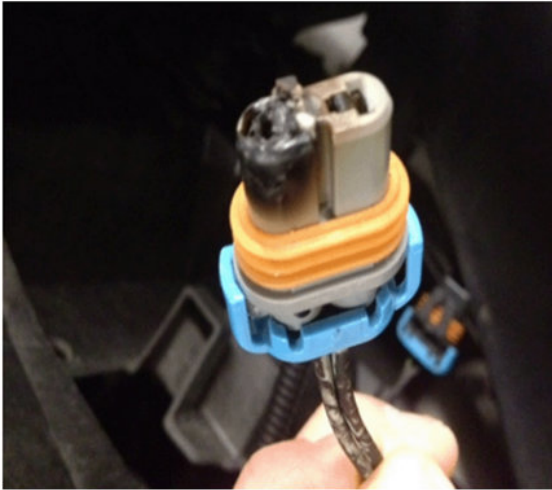
Involved Region or Country	North America
Additional Options (RPOs)	Important: This bulletin DOES NOT apply to vehicles equipped with LED light source lamps.
Condition	<p>Some customers may comment that the low beam on the Halogen headlamp is inoperative and find the connector in the following condition:</p>

<p style="text-align: right;">6678265</p>
Cause	The cause of the condition may be a low beam headlamp concern.
Correction	Important: DO NOT replace the entire headlamp assembly for this condition. Replace the bulb and inspect the connector by following the procedure outlined below.
