STAR ONLINE PUBLICATION

Case Number: S2421000001

Symptom/Vehicle Issue: No Reverse And/Or Forward Gear After D-Clutch Repair.

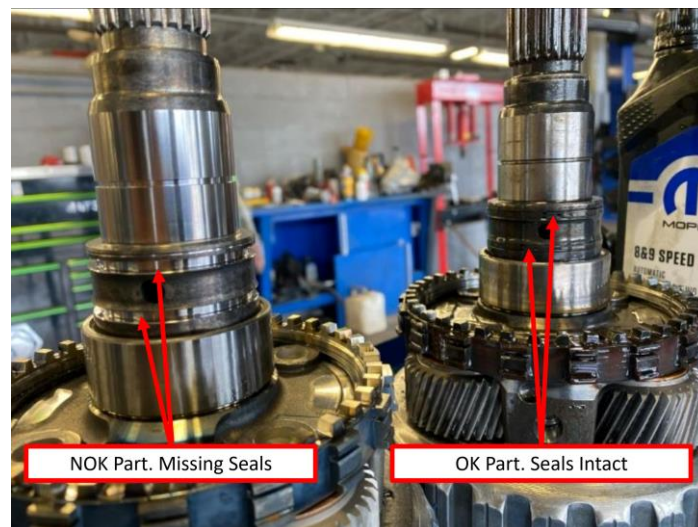
Figure 1

Discussion: Reports have been received from the field of no reverse and/or forward gear engagement after performing the D-Clutch repair procedure outlined in TSB 21-039-24 REV. A. This may be due to missing seals on the output shaft carrier assembly when installing the repair kit.

If the technician is working on a vehicle with this condition after performing the TSB, remove and inspect the P4 Planetary carrier/output shaft assembly and inspect to see if the 2, nylon sealing rings are missing. Please refer to (Figure 1).

If the sealing rings are missing, another repair kit must be ordered. These seals are not available separately at this time. Additionally, some repair kits may currently be missing these seals. Mopar is currently working on addressing the concern and the issue is expected to be resolved shortly. It is not recommended to replace the transmission if you encounter this concern.
