HANDLING CAMSHAFT DAMAGE

INFORMATION TYPE BULLETIN

2018 - 2020 790 ADVENTURE AND 790 ADVENTURE R

2018 - 2020 790 DUKE

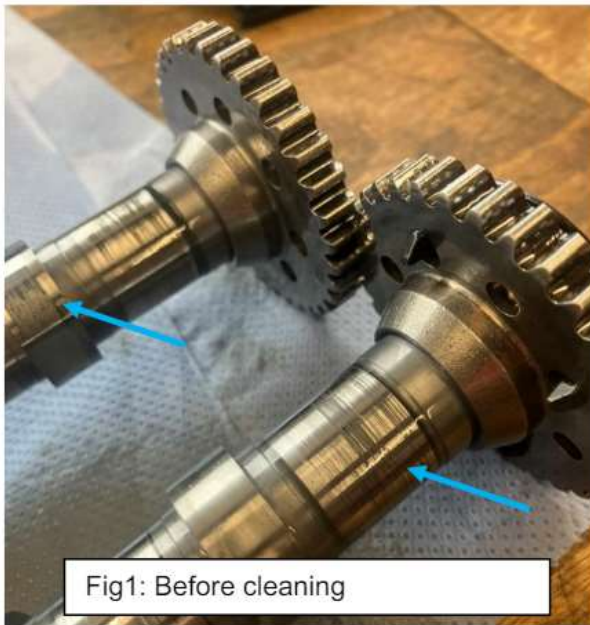
Fig. 1: Discoloration and marks immediately after removal from the engine.

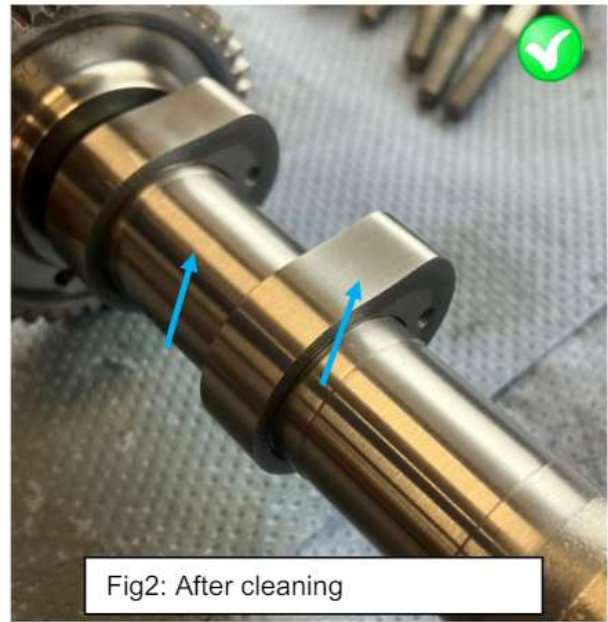
Fig. 2: Cleaning can completely remove the discoloration and traces. The surface of the camshaft is undamaged and does not need to be replaced.

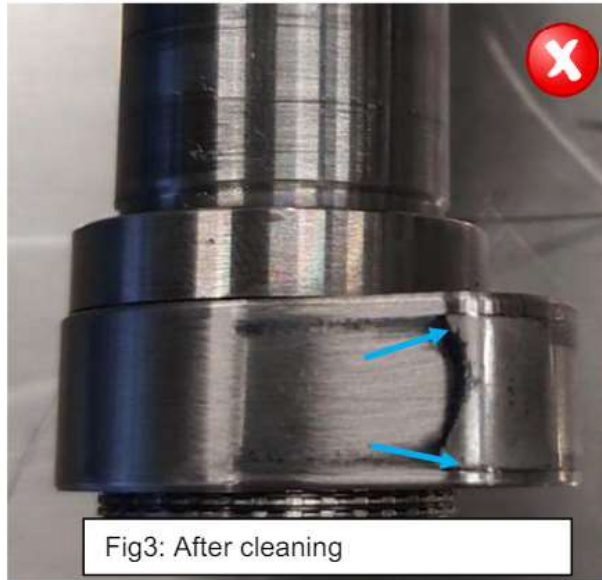
Fig. 3: Despite cleaning, a clearly perceptible run-in mark remains, camshaft is worn.

Camshafts and finger followers must be checked for wear (see KTB2409 Limit pattern for camshaft wear assessment) and damaged parts must be replaced. The engine oil and oil filter must also be changed as part of the repair. The costs incurred will be borne by KTM under warranty or subsequently under goodwill.

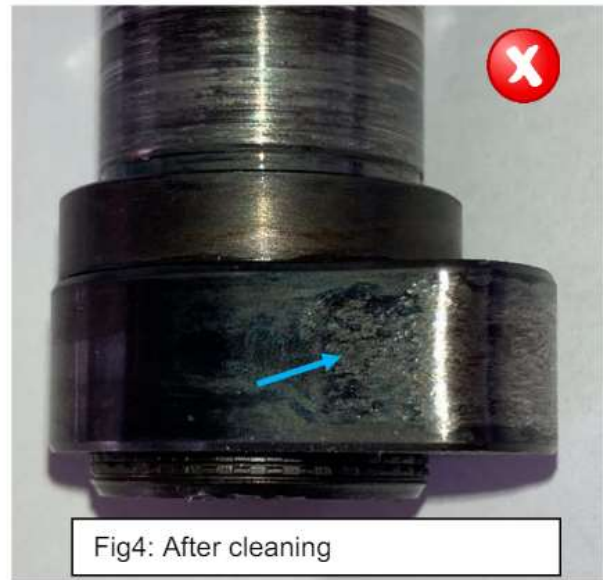
Fig. 4: Despite cleaning, clearly visible pitting remains, camshaft is worn.
