TECHNICAL SERVICE BULLETIN

Classification:	Reference:	Date:
KS13-050G	NTB13-107G	May 20, 2024

VEHICLE KEY NOT DETECTED / AUTHENTICATED, ENGINE WILL NOT START

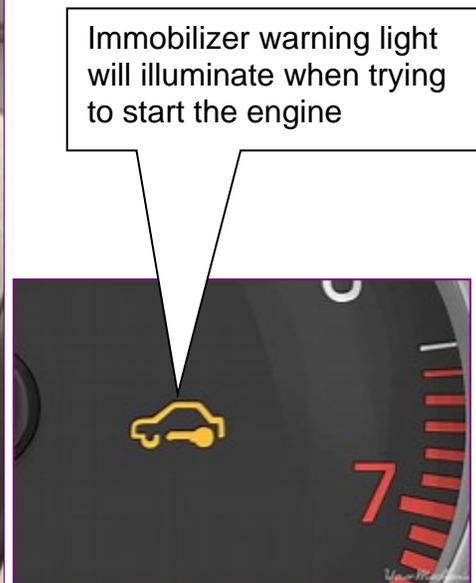
Figure 2

- The NATS key is not detected, causing:
 - The engine to **not** start (no response when the key is turned)
 - Illumination of the Immobilizer warning light (Figure 2 on page 2)
 - DTCs B2191 for "Difference of key" to be stored in the BCM, and P1615 for "Difference of key" to be stored in the ECM

- If the Immobilizer warning light (Figure 2) remains illuminated during attempts to start the engine, this could indicate that the key was not authenticated properly.
- The supplemental diagnostic items listed on the next page should be checked before replacing any parts or performing any repairs.
- Refer to the appropriate Electronic Service Manual (ESM) for complete key system diagnosis and repair information.

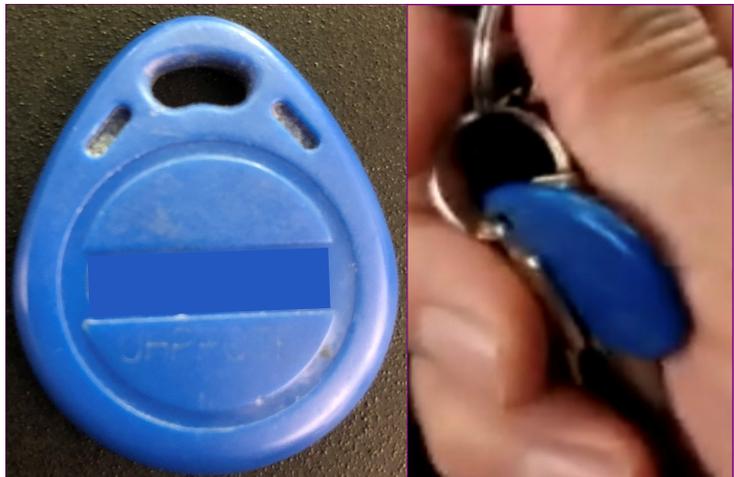
Figure 3

- If an RFID (Radio Frequency Identification) token (Figure 3) is placed within close proximity to the vehicle key, it can interfere with the RF signals, resulting in an inability to authenticate the key and cause a no start concern.
 - Other contributors are:
 - Keys with a similar transponder frequency
 - Multiple keys on one keyring
- Remove all aftermarket devices from the vehicle, including all other keys, while diagnosing a no start concern.

- NATS keys also contain a transponder that can be affected by interference.
- For interference to cause a no start condition, the source of the interference will typically be in close proximity to the key; for example, an RFID chip on a key chain with the key (Figure 3).

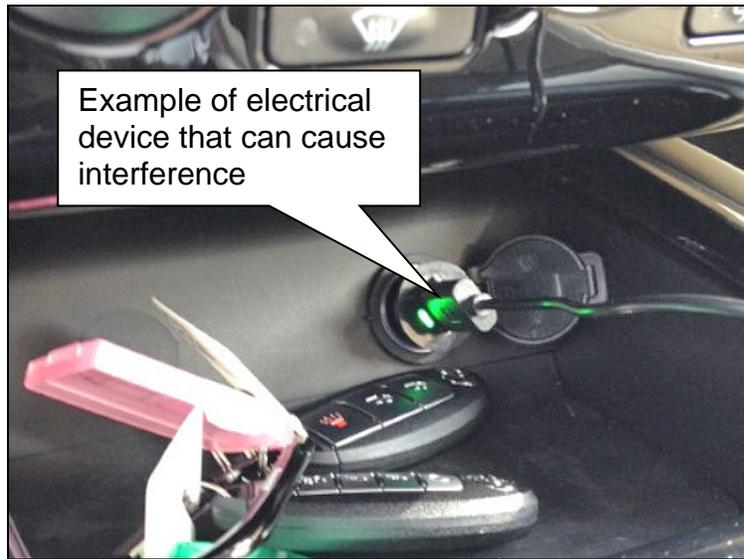
Figure 4

- If the conditions on the previous page are not the cause of the symptoms, check for the presence of an aftermarket alarm system, radar detector, or **ANY** electronic devices, including other keys.
- RF signals coming from the vehicle surroundings can interfere with the key signals, such as radar detectors or aftermarket alarm systems **in other vehicles or surrounding buildings**.
- If you are unable to duplicate the concern, it is important to determine WHERE the vehicle was located when the customer experienced the no start concern.
