TECHNICAL SERVICE BULLETIN

Classification: DA21-005A	Reference: NTB21-115A	Date: May 10, 2024
------------------------------	--------------------------	-----------------------

FALSE ACTIVATION OF AEB OR FCW

APPLIED VEHICLES: 2020-2021 Sentra (B18)
APPLIED DATES: Built on or before March 10, 2022
APPLIED SYSTEMS: Automatic Emergency Braking/Forward Collision Warning

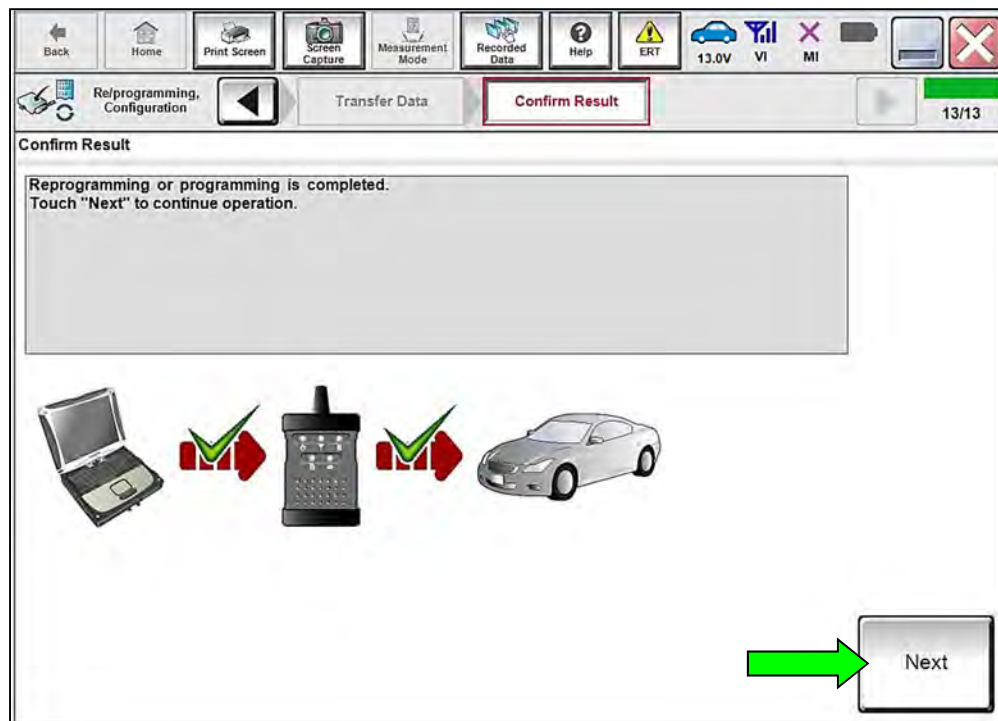
- If the screen in Figure 15 does not display (indicating that reprogramming did not complete), refer to the information on the next page.
- Additional steps/operations are required before CONSULT will provide the final reprogramming confirmation report. Continue with the reprogramming procedure on page 14.

24. Once the reprogramming completes, select **Next**.

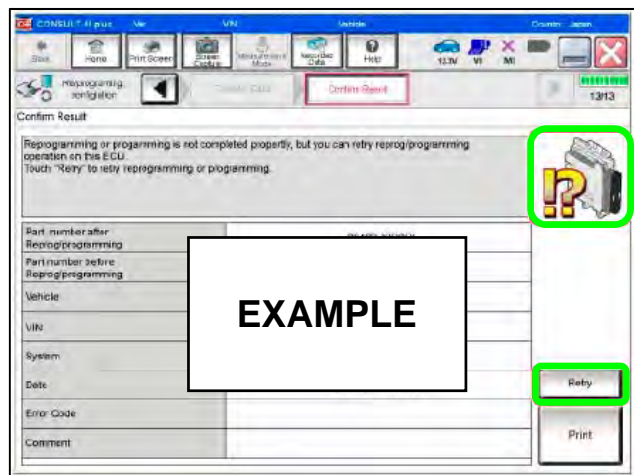
Figure 16

If reprogramming does not complete and the “!?” icon displays, as shown in Figure 16:

- Check battery voltage (12.0 - 13.5 V).
- Ignition is ON, engine OFF.
- External Bluetooth® devices are OFF.
- **All** electrical loads are OFF.
- Select **Retry** and follow the on screen instructions.
- Retry may not go through on first attempt and can be selected more than once.

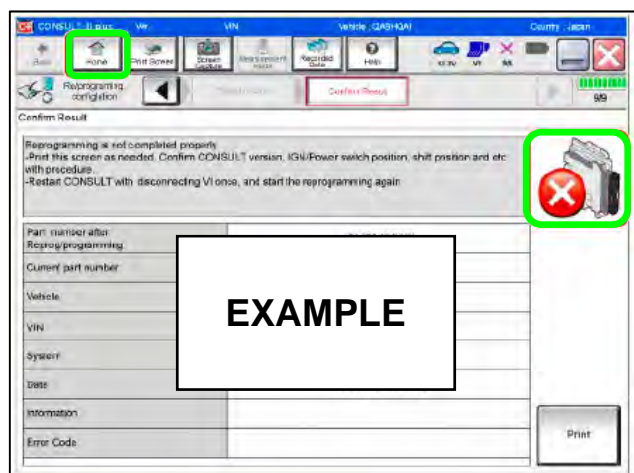
Figure 17

If reprogramming does not complete and the “X” icon displays, as shown in Figure 17:

- Check battery voltage (12.0 - 13.5 V).
- CONSULT A/C adapter is plugged in.
- Ignition is ON, engine OFF.
- Transmission is in Park.
- All CONSULT VI cables are securely connected.
- All C-III plus updates are installed.
- Select **Home**, and restart the reprogram procedure from the beginning.
