TECHNICAL SERVICE BULLETIN

Classification: DA22-001C	Reference: NTB22-038C	Date: May 14, 2024
------------------------------	--------------------------	-----------------------

RAB WARNING LIGHT ON IN INSTRUMENT PANEL AND/OR DTC B2724-23 STORED

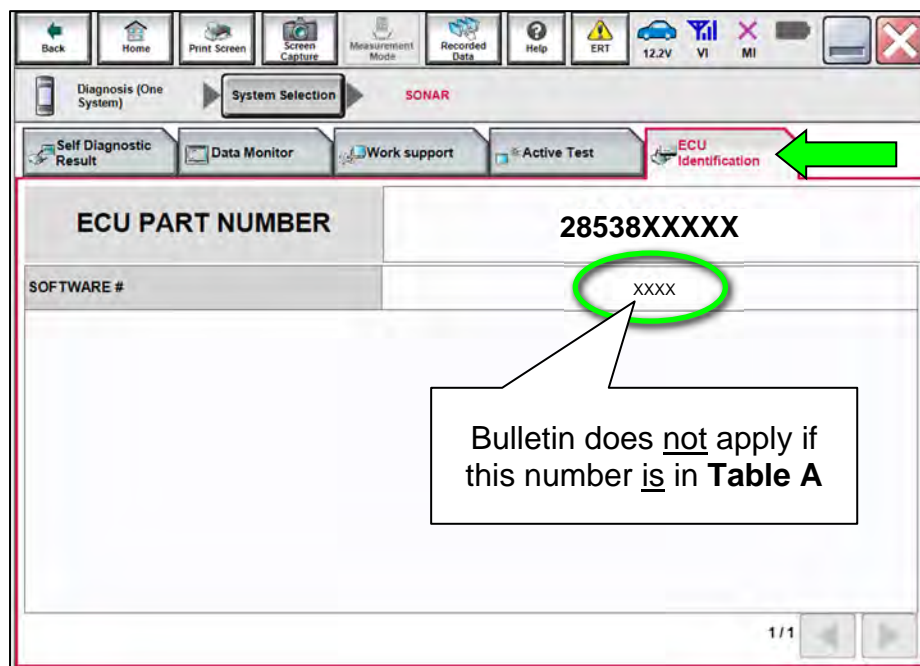
Figure 4

16. Confirm the current **SOFTWARE #** (Figure 4). See **Table A** (below) for model specific **SOFTWARE #**.
 - If the **SOFTWARE #** is in **Table A**, this bulletin does not apply. See the Electronic Service Manual (ESM) for further diagnostic information.

- If the **SOFTWARE #** is not in **Table A**, proceed to step 17.

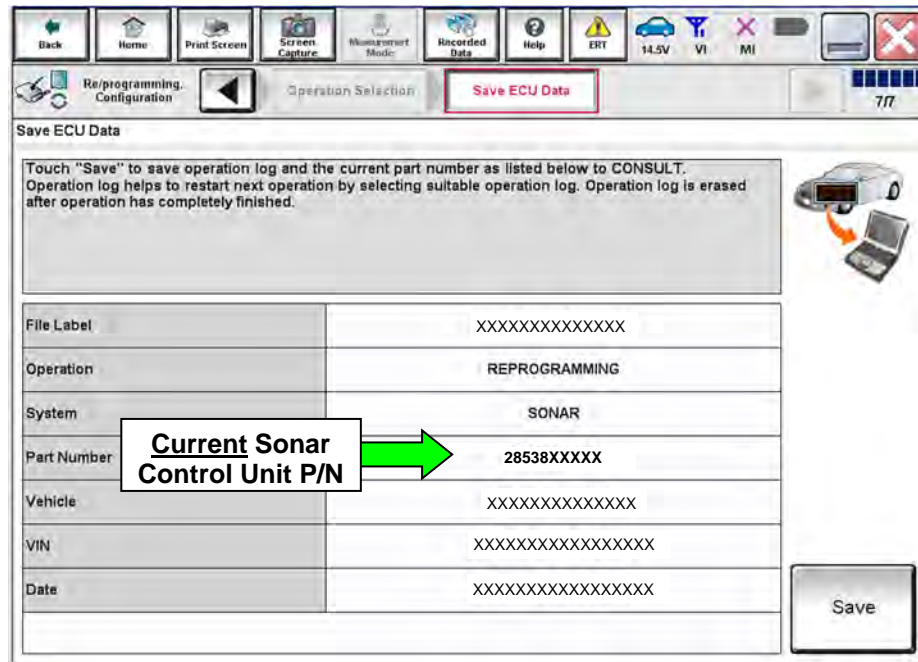
Figure 13

28. When you get to the screen shown in Figure 13, confirm that a reprogram is available as follows.

a. Find the Sonar Control Unit **Part Number** and write it on the repair order.

b. Compare the part number you wrote down to the part numbers in **Table B**.

- If there is a match, continue with the reprogramming procedure.
- If there is not a match in **Table B**, this bulletin does not apply. See the ESM for further diagnostic information.

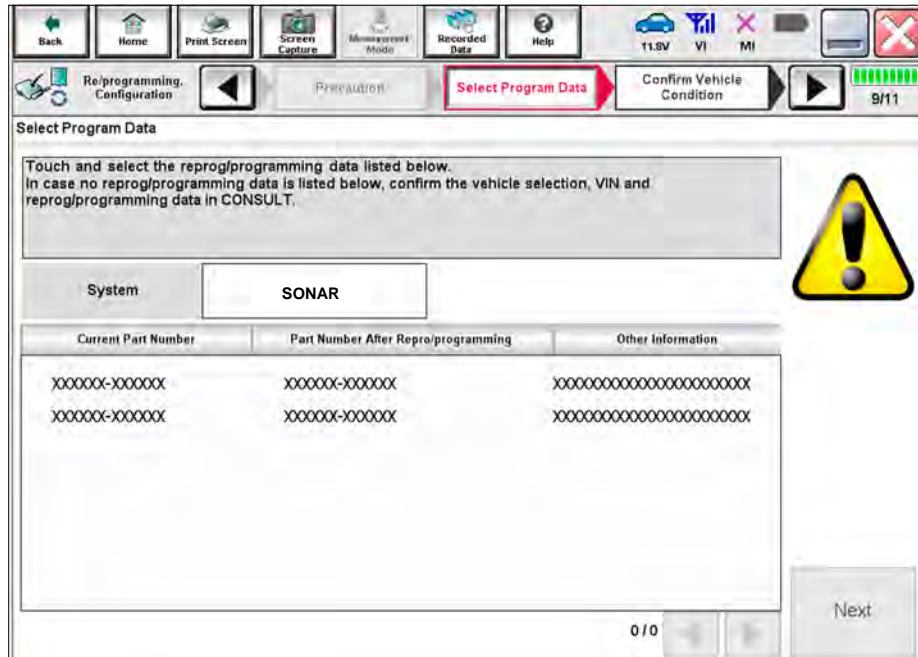
Figure 16

HINT: If you get the screen below and it is blank (no reprogramming listed), it means there is no reprogramming available for this vehicle. Close CONSULT and refer back to the ESM for further diagnosis.

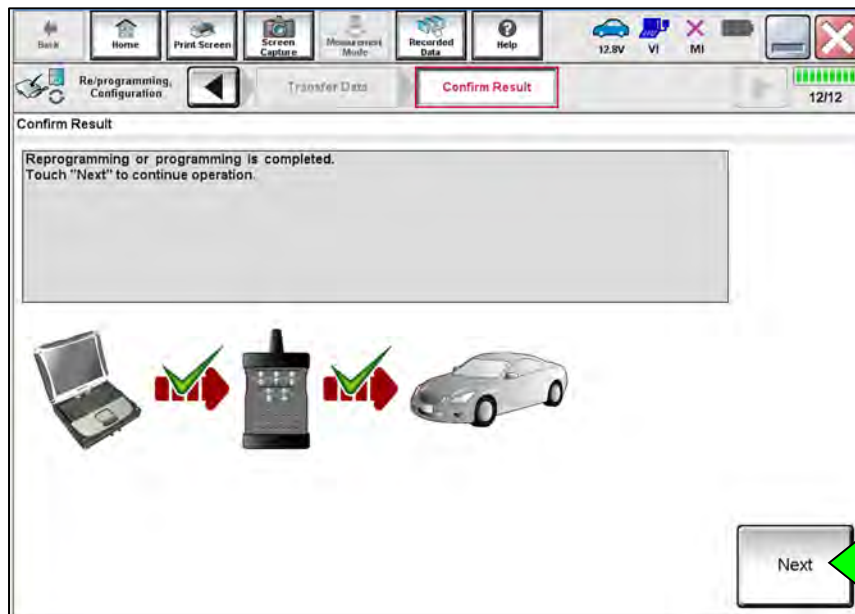
- When the screen in Figure 20 displays, the reprogramming is complete.
- If the screen in Figure 20 does not display (indicating that reprogramming did not complete), refer to **Sonar Control Unit Recovery** on the next page.

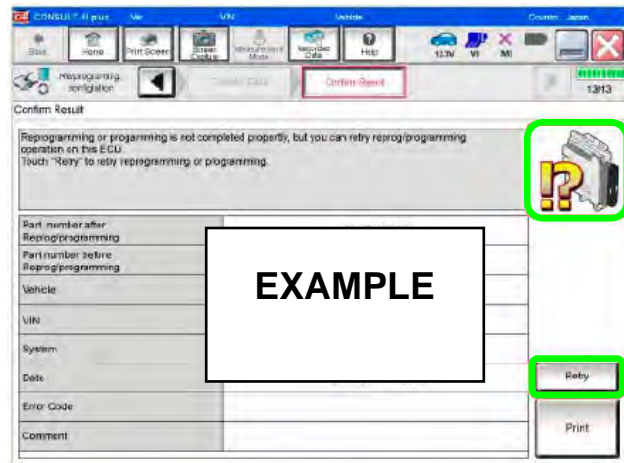
Figure 21

If reprogramming does not complete and the “!?” icon displays, as shown in Figure 21:

- Check battery voltage (12.0 - 13.5 V).
- Ignition is ON, engine OFF.
- External Bluetooth® devices are OFF.
- **All electrical loads are OFF.**
- **Select retry and follow the on screen instructions.**
- **“Retry” may not go through on first attempt and can be selected more than once.**

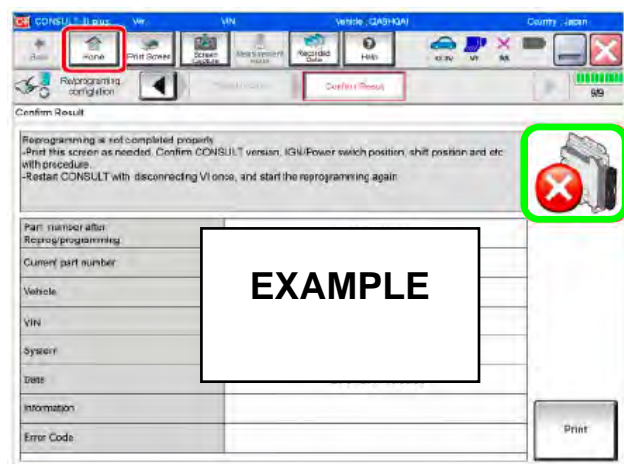
Figure 22

If reprogramming does not complete and the “X” icon displays, as shown in Figure 22:

- Check battery voltage (12.0 - 13.5 V).
- CONSULT A/C adapter is plugged in.
- Ignition is ON, engine OFF.
- Transmission is in Park.
- All CONSULT VI cables are securely connected.
- All C-III plus updates are installed.
- **Select Home, and restart the reprogram procedure from the beginning.**

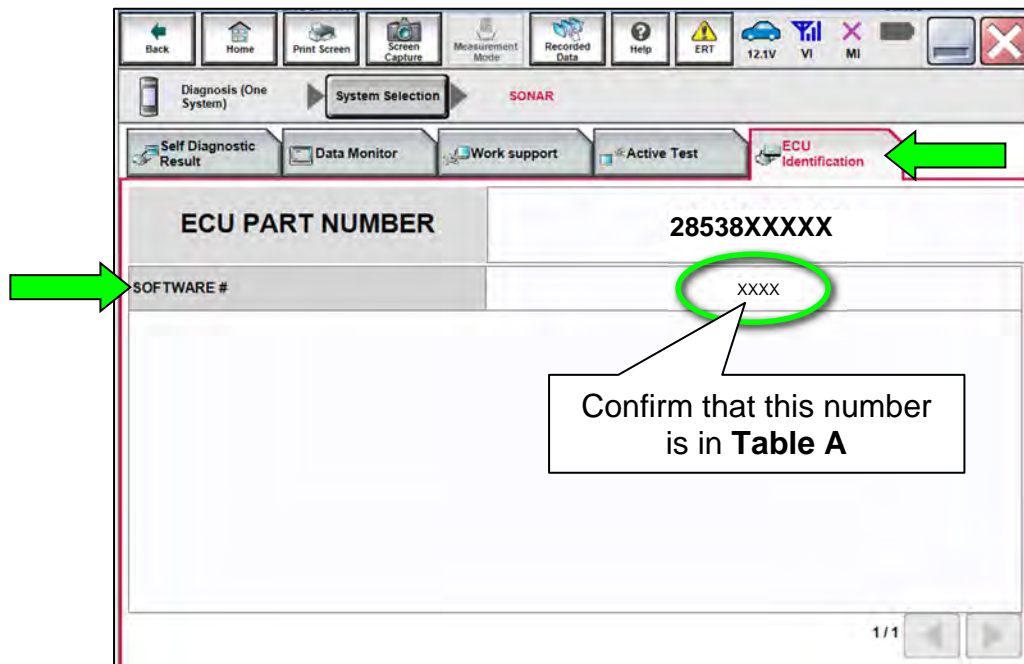
Figure 35

61. Confirm the **SOFTWARE #** (Figure 35).

- If the **SOFTWARE #** is in **Table A** on page 5, proceed to step 62.
- If the **SOFTWARE #** is **not** in **Table A** on page 5, reprogramming did not successfully complete. Go back to step 18 on page 6 and perform the procedure again.

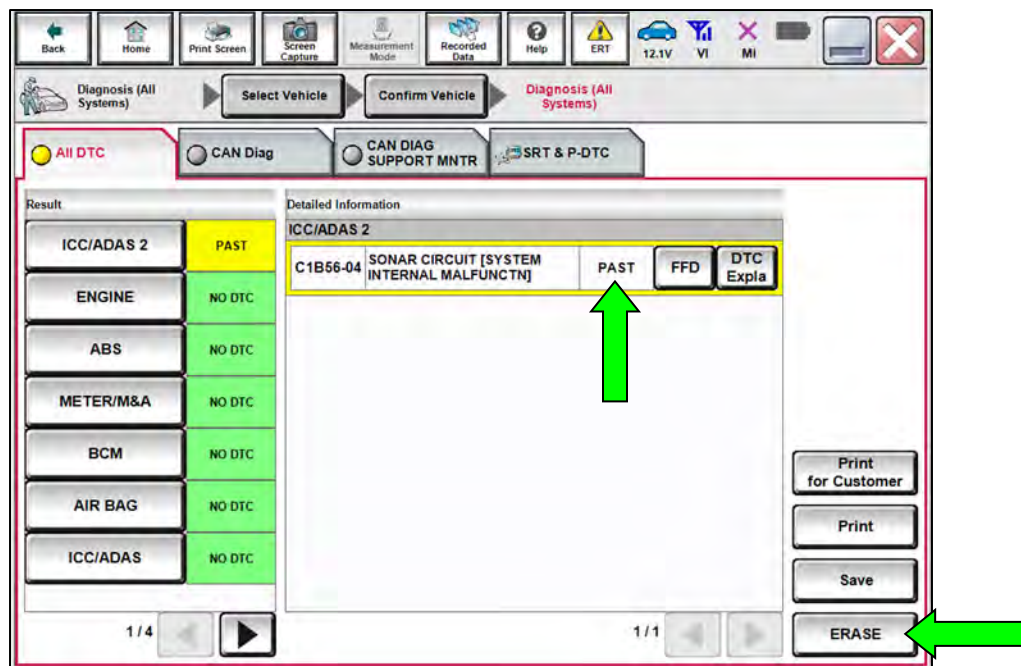
Figure 38

68. Confirm DTC C1B56-04 is displayed as **PAST** (not **CRNT**) (Figure 38).

69. Select **ERASE**.
