TECHNICAL SERVICE BULLETIN

Classification: DA22-004B	Reference: NTB22-073B	Date: May 10, 2024
------------------------------	--------------------------	-----------------------

REAR AUTOMATIC BRAKING WARNING LIGHT ILLUMINATED AND/OR DTC C1B56-04 AND/OR C1B56-97 STORED IN THE ADAS CONTROL UNIT

APPLIED VEHICLES: 2019-2022 Altima (L34)
APPLIED DATES: Built on or before July 18, 2022

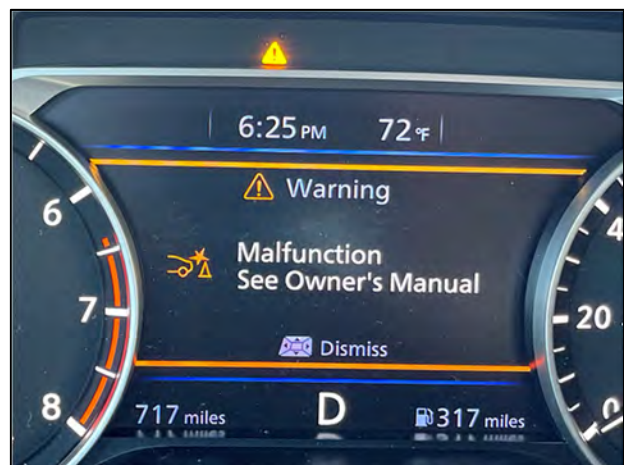
Figure 1

The customer states the rear automatic braking (RAB) warning light is illuminated, with “Malfunction See Owner’s Manual” appearing in the vehicle information display,

DTC C1B56-04 for “SONAR CIRCUIT” and/or C1B56-97 for “SONAR CIRCUIT” is stored in the ADAS Control Unit.

Reprogram and configure the Sonar Control Unit using the **SERVICE PROCEDURE** in this bulletin, if applicable.

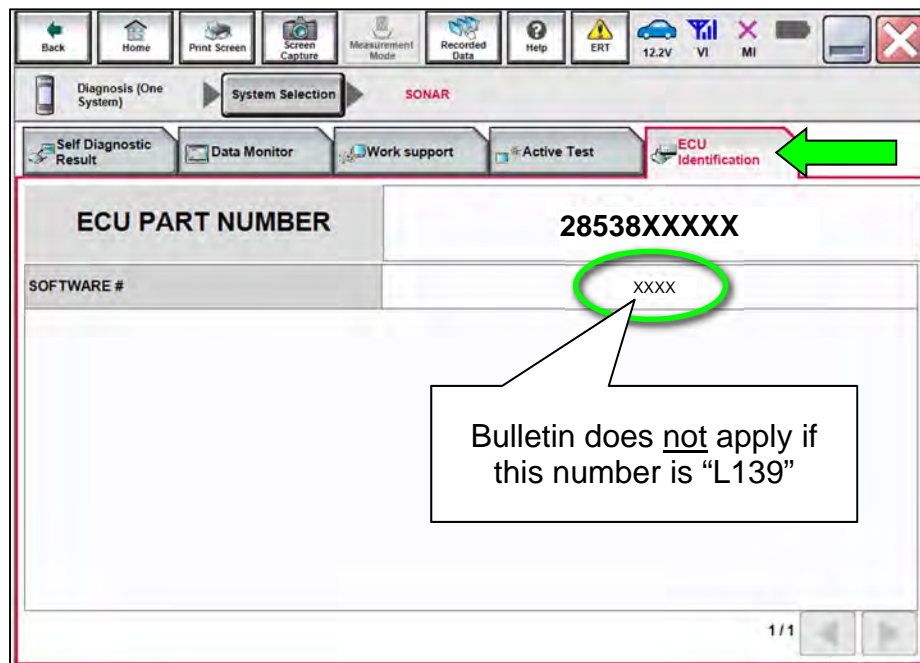
Figure 5

16. Confirm the current **SOFTWARE #** (Figure 5).

- If the **SOFTWARE #** is “L139”, this bulletin does not apply. See the Electronic Service Manual (ESM) for further diagnostic information.
- If the **SOFTWARE #** is not “L139”, proceed to step 17 on page 6.

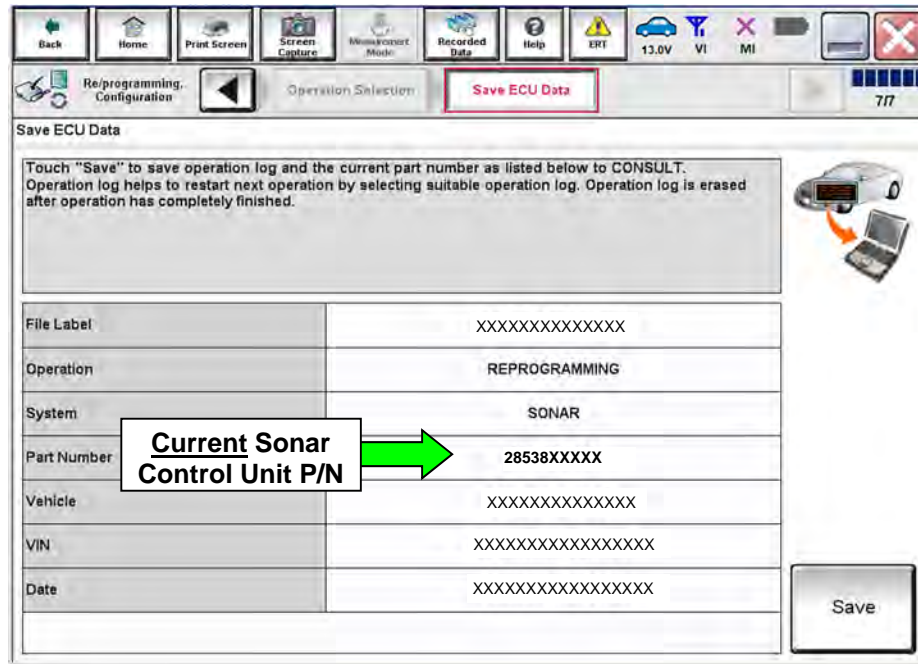
Figure 14

28. When you get to the screen shown in Figure 14, confirm that a reprogram is available as follows:

a. Find the Sonar Control Unit **Part Number** and write it on the repair order.

b. Compare the part number you wrote down to the part numbers in **Table A**.

- If there is a match, continue with the reprogramming procedure.
- If there is not a match in **Table A**, this bulletin does not apply. See the ESM for further diagnostic information.

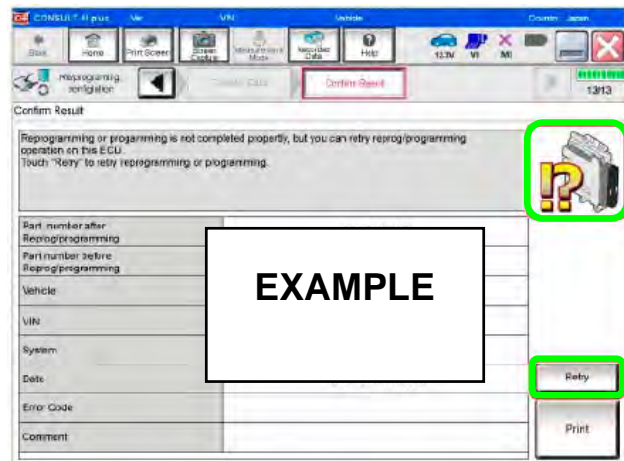
Figure 22

If reprogramming does not complete and the “!” icon displays, as shown in Figure 22:

- Check battery voltage (12.0 - 13.5 V).
- Ignition is ON, engine OFF.
- External Bluetooth® devices are OFF.
- **All** electrical loads are OFF.
- **Select retry and follow the on screen instructions.**
- **“Retry” may not go through on first attempt and can be selected more than once.**

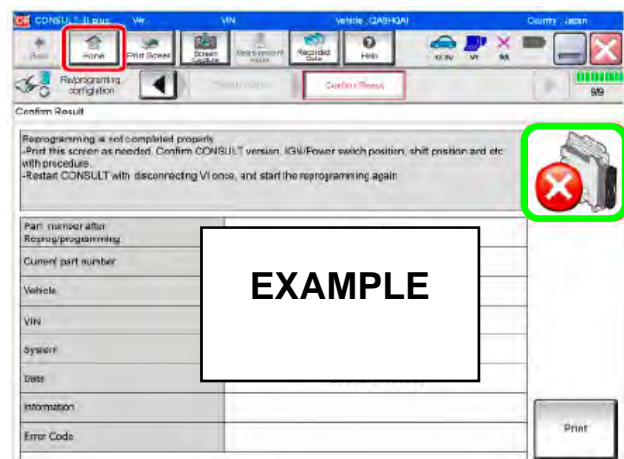
Figure 23

If reprogramming does not complete and the “X” icon displays, as shown in Figure 23:

- Check battery voltage (12.0 - 13.5 V).
- CONSULT A/C adapter is plugged in.
- Ignition is ON, engine OFF.
- Transmission is in Park.
- All CONSULT VI cables are securely connected.
- All C-III plus updates are installed.
- **Select Home, and restart the reprogram procedure from the beginning.**

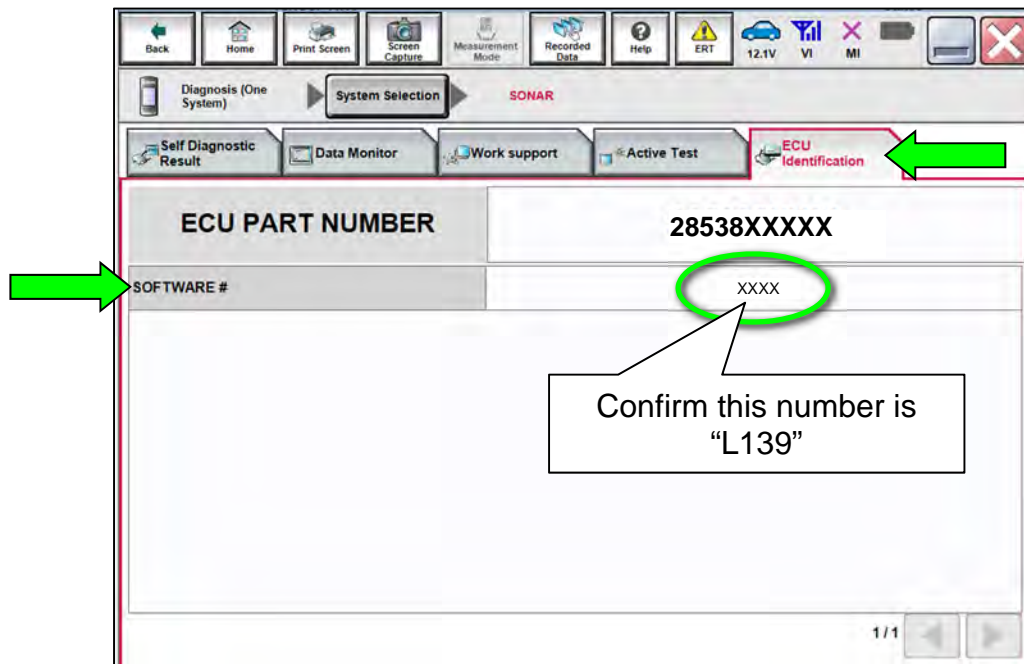
Figure 36

60. Confirm the **SOFTWARE #** (Figure 36).

- If the **SOFTWARE #** is "L139", proceed to step 61 on page 24.
- If the **SOFTWARE #** is not "L139", reprogramming did not successfully complete. Go back to step 18 on page 6 and perform the procedure again.
