TECHNICAL SERVICE BULLETIN

Classification: EL22-015A	Reference: NTB23-024A	Date: May 10, 2024
------------------------------	--------------------------	-----------------------

VEHICLE WILL NOT START AND DTCS P31E7 AND P0AA6 STORED IN EV/HEV CONTROL MODULE

APPLIED VEHICLES: 2019-2025 LEAF (ZE1)
APPLIED SYSTEMS: 62 kWh Battery Pack (4th Character of the VIN is B or C)

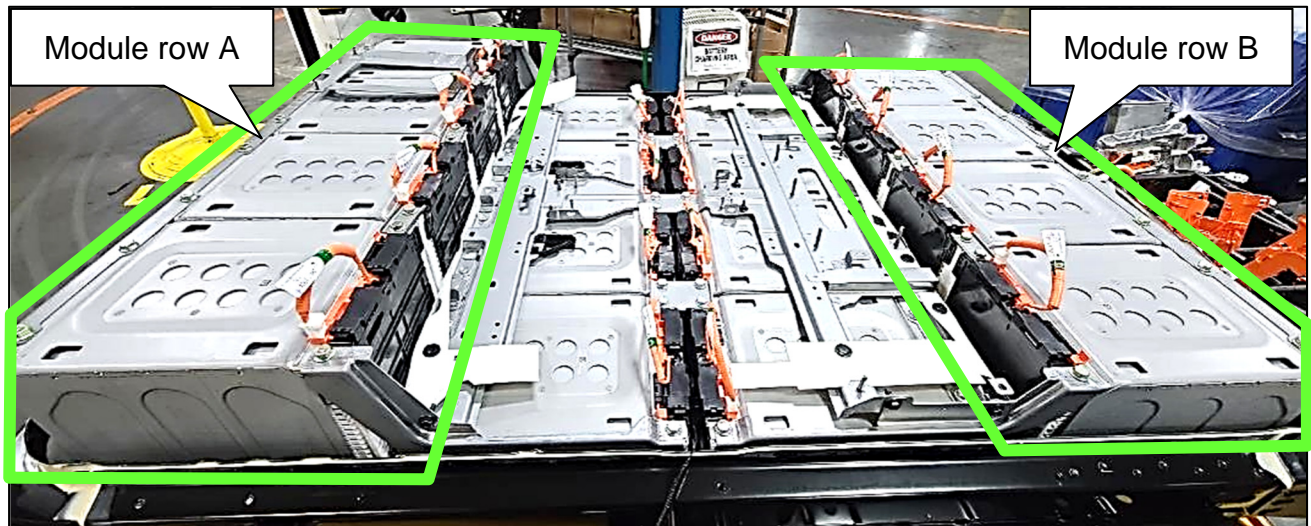
Figure 1

1. Perform ESM diagnosis for DTCs to determine which Li-Ion battery module has caused the DTC.
 - The affected module will only be in module row A or B (Figure 1).

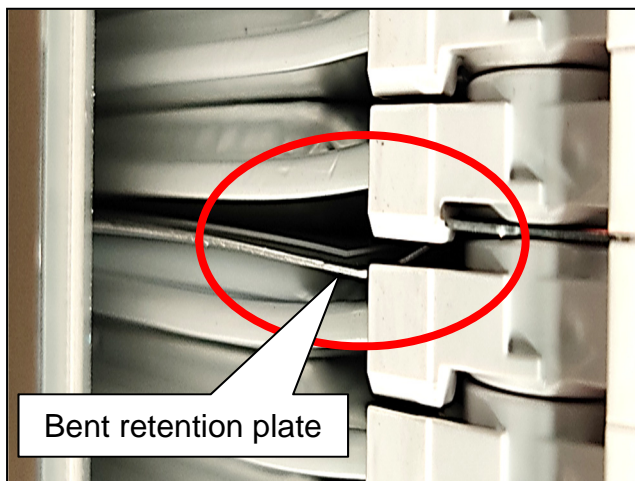
Figure 2

2. Remove and inspect the affected Li-Ion battery module for a bent retention plate.
 - If a Li-Ion battery module has a bent retention plate (**Error! Reference source not found.**), replace the Li-Ion battery module.
 - Refer to the ESM: **ELECTRIC POWER TRAIN > EV BATTERY SYSTEM > 62kWh LI-ION BATTERY > DISASSEMBLY AND ASSEMBLY > MODULE > MODULE : Disassembly & Assembly**
 - IMPORTANT:** Make sure to follow all Dangers, Warnings, Cautions, and additional work procedures outlined in the ESM.
 - If the Li-Ion battery module does not have a bent retention plate (Figure 3), this bulletin does not apply. Refer to ASIST for further diagnosis.
