# TECHNICAL SERVICE BULLETIN

Classification: DA23-007A	Reference: NTB24-005A	Date: May 9, 2024
------------------------------	--------------------------	----------------------

## ENGINE RPM HIGHER THAN EXPECTED WHEN USING INTELLIGENT CRUISE CONTROL

**APPLIED VEHICLES:** 2022-2023 Frontier (D41)  
**APPLIED DATES:** Built on or before June 13, 2023

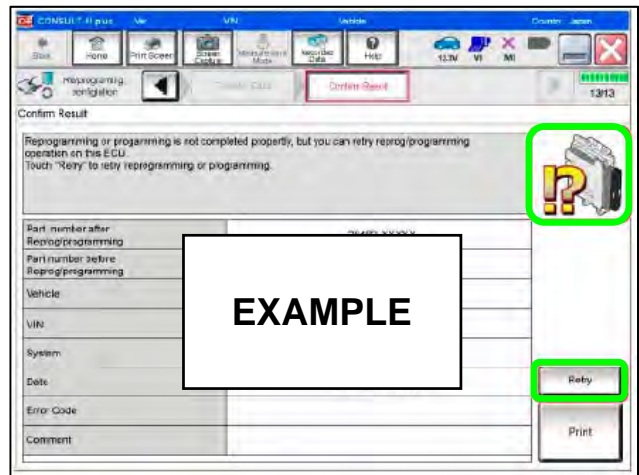
Figure 14

If reprogramming does not complete and the “!?” icon displays, as shown in Figure 14:

- Check battery voltage (12.0 - 13.5 V).
- Ignition is ON, engine OFF.
- External Bluetooth® devices are OFF.
- **All** electrical loads are OFF.
- Select **Retry** and follow the on screen instructions.
- Retry may not go through on first attempt and can be selected more than once.

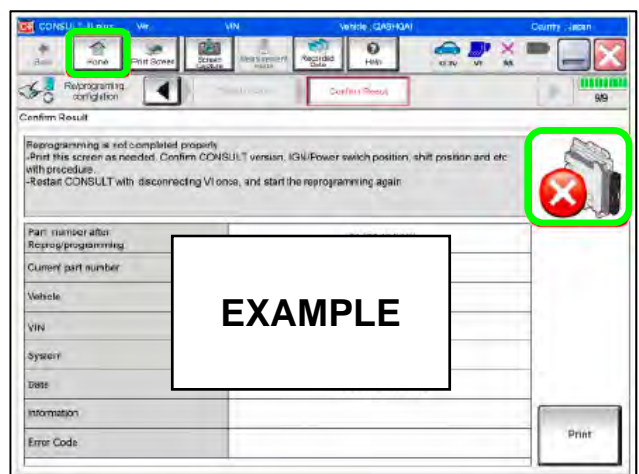
Figure 15

If reprogramming does not complete and the “X” icon displays, as shown in Figure 15:

- Check battery voltage (12.0 - 13.5 V).
- CONSULT A/C adapter is plugged in.
- Ignition is ON, engine OFF.
- Transmission is in Park.
- All VI cables are securely connected.
- All C-III plus updates are installed.
- Select **Home**, and restart the reprogram procedure from the beginning.
