## STAR ONLINE PUBLICATION

**Case Number:** S2408000079

**Symptom/Vehicle Issue:** Low Battery, No Crank No Start, Cluster Message “Service Keyless System”, Intermittent Power Liftgate Operation

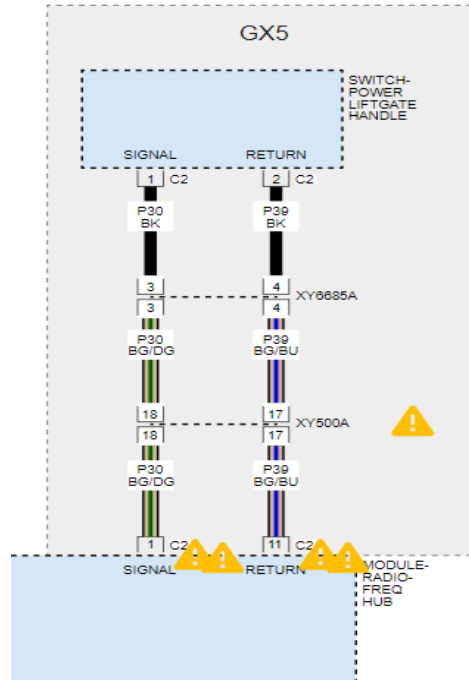
**Customer Complaint/Technician Observation:** The owner complains of a battery draining concern, a cluster message on occasion to “Service Keyless System” along with details that the power liftgate switch does not function at times. The technician observed the Radio Frequency Hub (RFHUB) set Diagnostic Trouble Code (DTC) B259E-11 Trunk/Liftgate Door Handle Sense Circuit Short to Ground as active or stored.

**Repair Procedure:** Inspect and test per the service diagnostics the involved P30 and P39 power liftgate handle sense circuits highlighted. Replace the switch as needed if no confirmed circuit issues have been defined PN# 68303988AA.
