MAS004236 RU 24-19

Rapid Update 726 Grecale – “Door to body” Connector taping

DATE: July 15, 2024

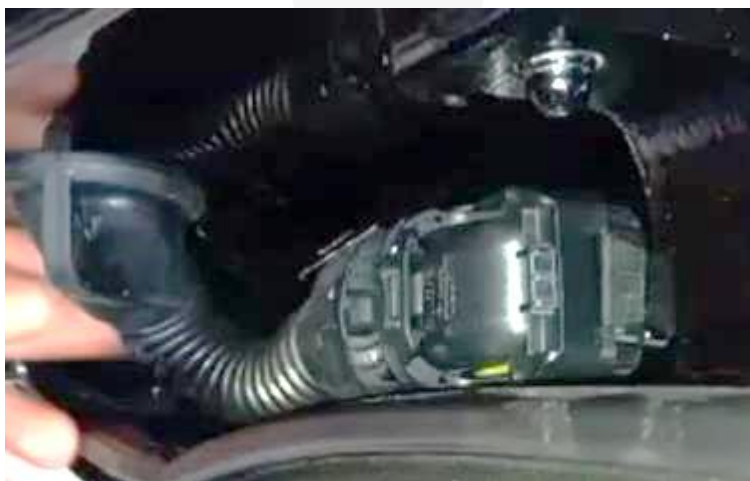
1. Always check ModisCS+ to see if the vehicle is involved in this action and if it has not been previously performed.
2. Disconnect the battery according to the instructions in the workshop manual:
 - a. **08.20.001 - BATTERY - Connecting/disconnecting the electrical power supply**
3. Identify the connectors to perform the rework. It is located in the internal area of both left and right rear doors.

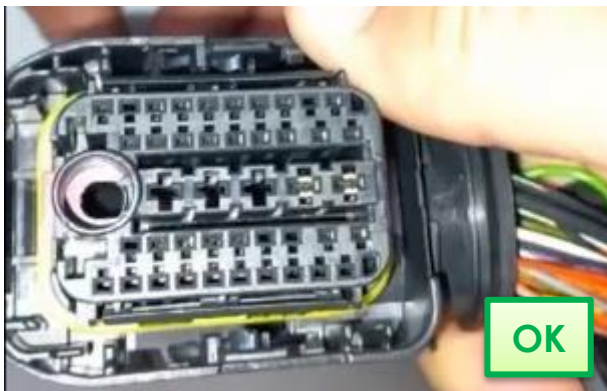
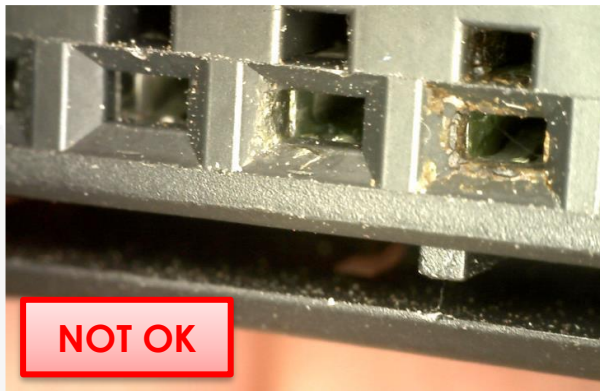
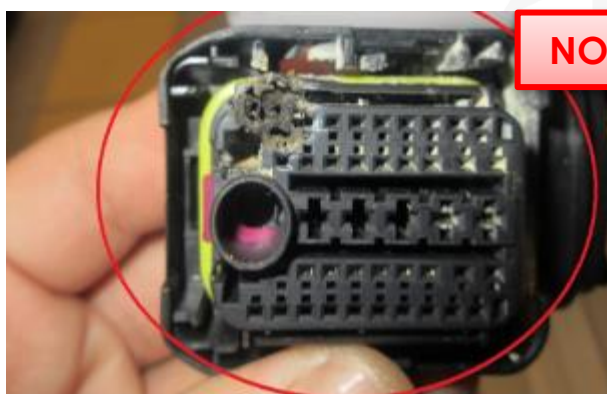
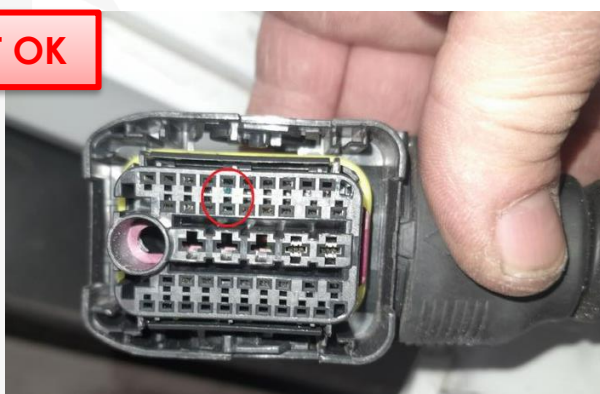
5. Remove the rubber wire cover/boot and check that there are no **obvious signs** of corrosion on the terminal pins (see examples below).

6. If there are evident signs of damage to the connector, corrosion on a single or multiple terminal female pin, or if the customer has reported malfunctions related to this connector, open a BlueOnline as "Support Request" and wait for further instructions.
7. If there are no signs of damage to the connector or female pins. Continue with the rework:
8. With the connector disconnected from the vehicle, adjust the protective rubber boot so that it is properly fitted to the plastic exterior of the connector as shown below. Next, use a strip of **"self-bonding tape"** approximately 6-8 inches in length and tightly wrap the rubber boot to the connector. To ensure a tight seal, slightly stretch the tape so that half of its width contacts the boot and the other half contacts the connector during the initial wrap. Continue wrapping, finishing with at least two complete loops.
