MAS004276 RU 24-21

**RAPID UPDATE**

# Rapid Update 728 Granturismo & GranCabrio BEV –front axle screws Replacement

DATE: JULY 15, 2024

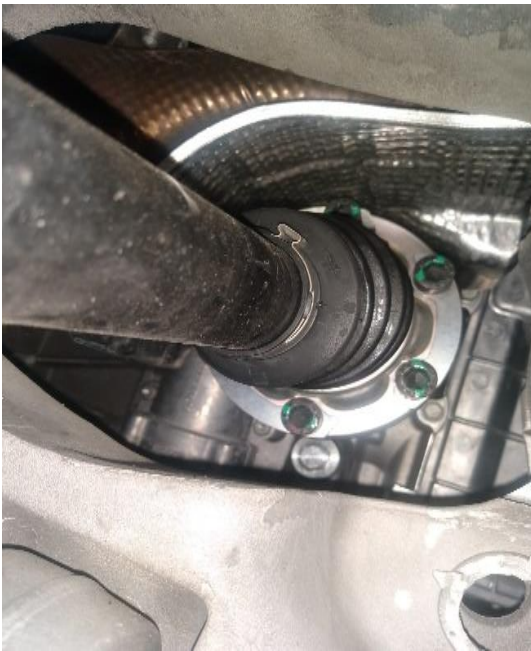
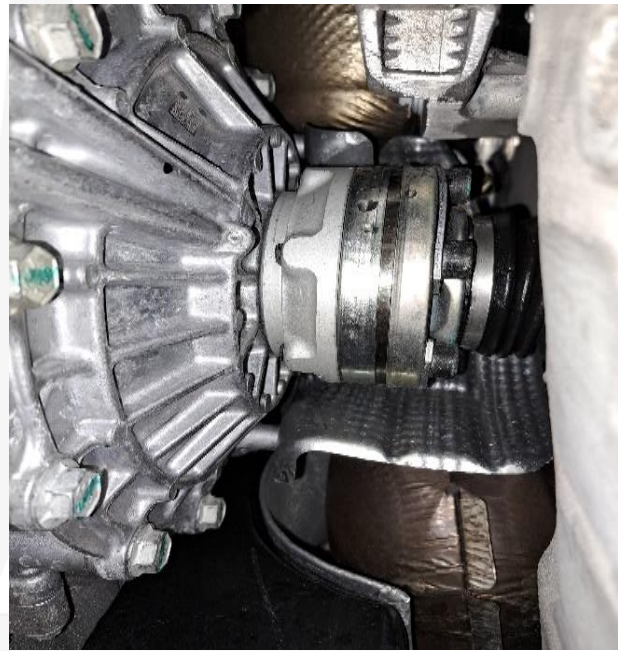
On a limited batch of vehicles, the front axle shaft screws may not meet manufacturing standards which consequently can cause an oil leak. To remedy this, The half shaft screws including the retaining plate will need to be replaced.

4. Carefully clean the interface area, including the half-shaft holes, then replace all the screws and plates following the procedure given in the workshop manual **from point 15.**
5. **03.22.002 COMPLETE FRONT HALF SHAFT RIGHT Removal/refitting – replacement**

**Note :** For this activity it is not necessary to carry out all the disassemblies foreseen in the workshop procedure available in the manual but it is sufficient to reach the screws with a torque wrench.
6. Complete the replacement of the components (screws and plates) of both axles, right and left.
7. **Note:** If oil contamination is found from the joint, it will be necessary to open a BOL report to obtain additional information on the type of intervention to be carried out.
8. Restore any disassembled components by following the procedure in reverse order.
9. Procedure complete.
