# Service Bulletin

Bulletin No.: 20-NA-022

**Subject: Clunking Noise from Rear of Vehicle (Re-torque Leaf Spring Bolts)**

Brand:	Model:	Model Year:		VIN:		Engine:	Transmission:
		from	to	from	to		
Chevrolet	Silverado 2500HD/ 3500HD	2020	2025			All	All
GMC	Sierra 2500HD/ 3500HD	2020	2025			All	All

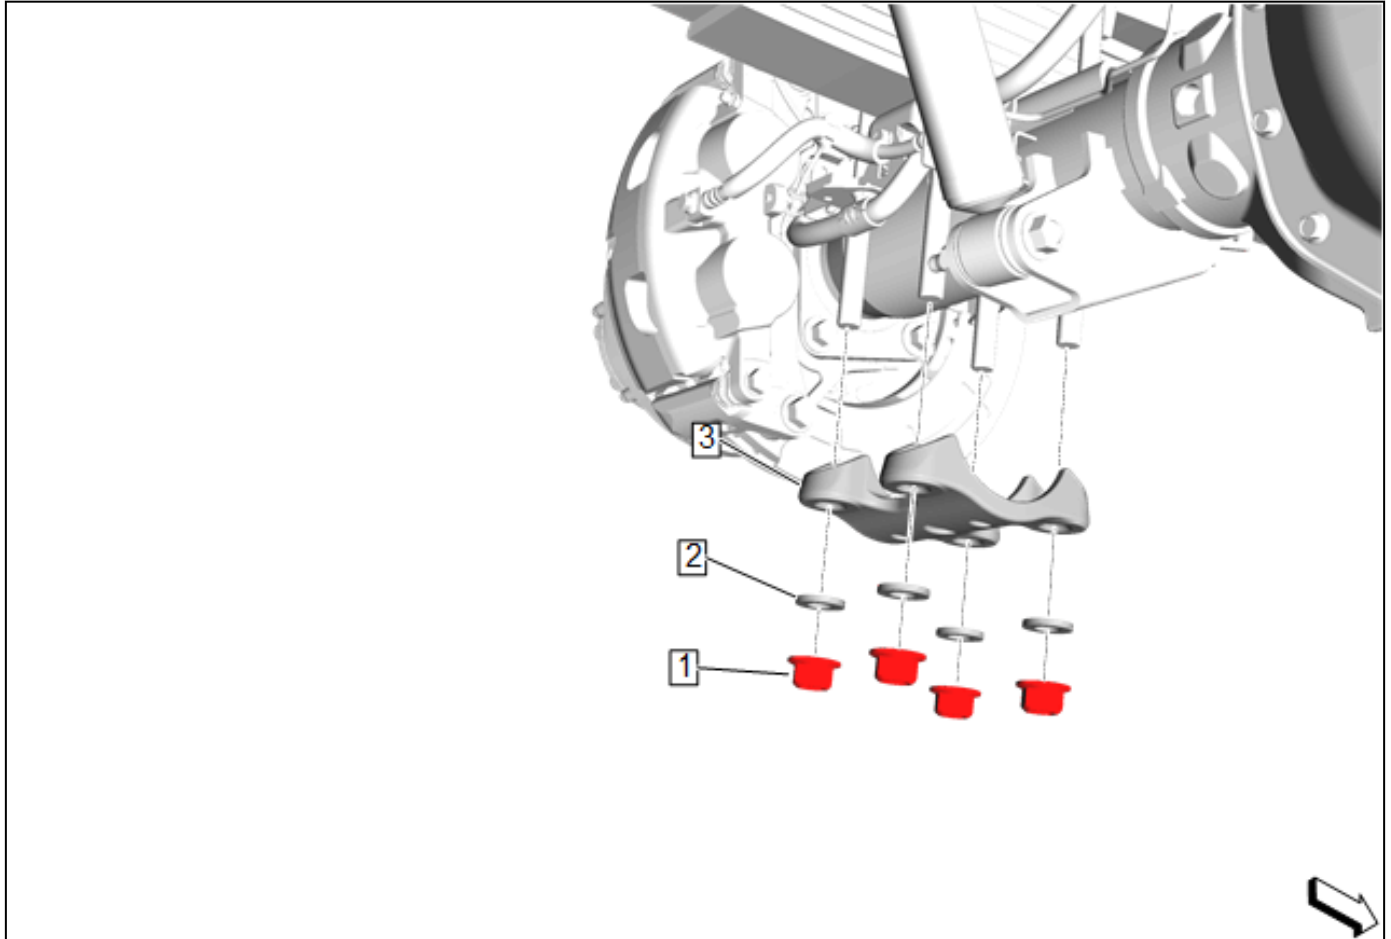
5295289

<b>Involved Region or Country</b>	North America, Middle East
<b>Condition</b>	Some customers may comment about a clunking noise coming from the rear of the vehicle. Upon further investigation, the technician may diagnose the noise coming from the rear suspension leaf spring area.
<b>Cause</b>	This condition may be caused by movement between the anchor plate and axle assembly.
<b>Correction</b>	The noise may be resolved by re-torquing the joints of the leaf spring assembly.

1. Raise the vehicle to a level where the leaf spring U-bolts are accessible.

2. Loosen the leaf spring U-bolts (1).
3. Re-torque the leaf spring U-bolts (1). Refer to SI for torque specifications.
4. Repeat steps 2 and 3 for the right side leaf spring.
5. Re-test the vehicle for the same clunking noise. If the issue remains, continue diagnosis referring to SI.
