Service Bulletin

Bulletin No.: 21-NA-138

Subject: Squeak, Grind or Clunking Noise from Rear Leaf Springs
Attention: This bulletin applies to Heavy Duty vehicles only. Refer to Bulletin 19-NA-129 for Light Duty vehicles.

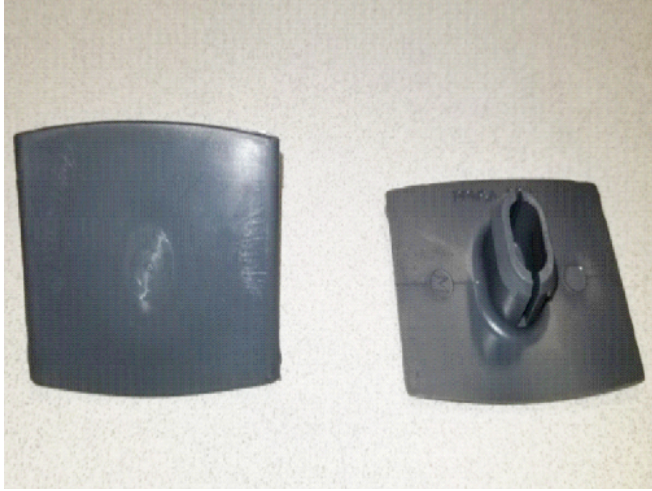
Involved Region or Country	North America, Middle East, Israel, Australia and New Zealand
Condition	Some customers may comment that a squeak, grind or clunking noise can be heard from the rear leaf springs.
Cause	This condition may be caused by the spring insert interacting with the leaf spring. Note: Some noise is characteristic with leaf spring suspensions when going over bumps.
Correction	<div style="text-align: center;">

</div> <p style="text-align: right;">5341853</p> <p>A new insert with a graining pattern will help reduce this noise. Replace the rear spring inserts utilizing a plastic trim tool or plastic wedge in between the leaf springs. Important: After new spring tip inserts are installed per this bulletin, new inserts have a break-in period of up to 1610 km (1000 miles), where some noise can be expected.</p>
