Service Bulletin

Bulletin No.: 24-NA-029

Subject: HUMMER EV Water Leak Diagnostic Tips

Brand:	Model:	Model Year:		VIN:		Engine:	Transmission:
		from	to	from	to		
GMC	HUMMER EV Pickup	2022	2025	-	-	All	All
	HUMMER EV SUV	2024	2025

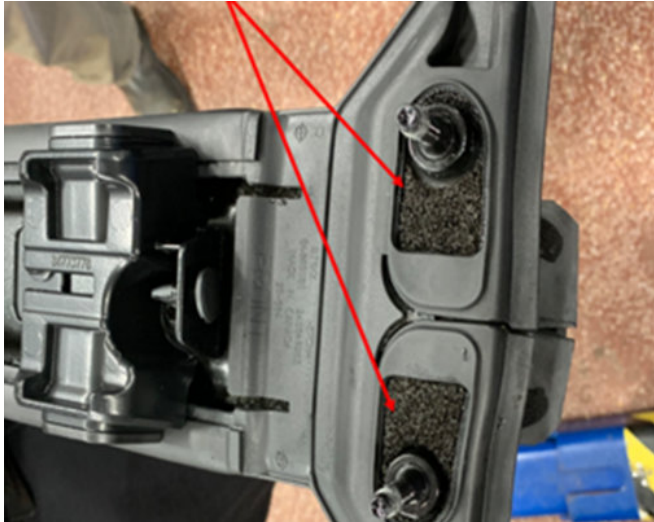
6541873

This design is from 2022 ONLY. If the open cell foam is discovered, check the vehicle for open field action and replace the I-Bar per Service Update Bulletin N222378440.

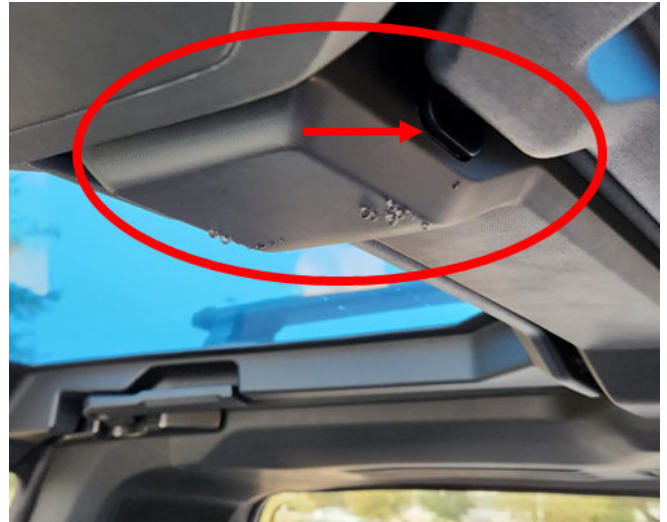
6542034

Condition	Water pours out of the lower I Bar trim cover as it collects in the sump created by the contour of the trim, especially when turning a corner.
------------------	--

Easiest way to diagnose this complaint is to remove the lower trim panel, water test, and watch for the leak.

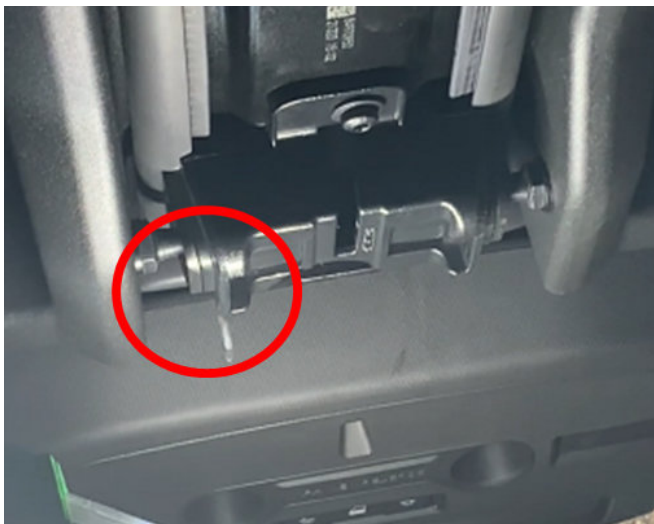
6542118

With trim panel removed, if water is leaking through the I-Bar as shown, replace the I bar.

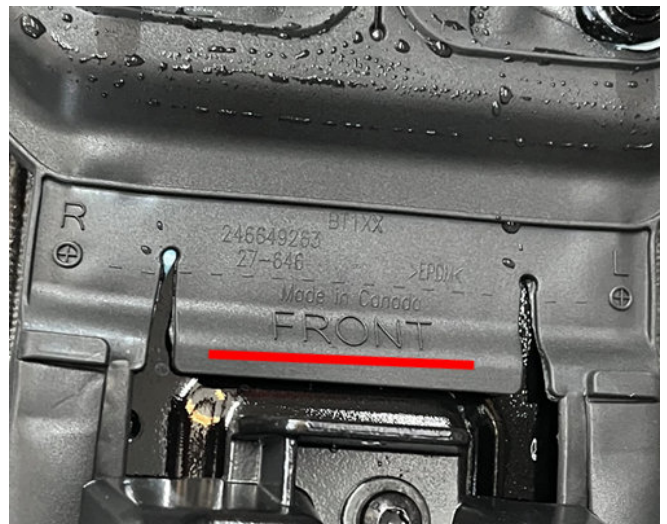
6542125

The front I Bar is designed to be removed by the customer. If the front I bar is installed backward it will leak. When removing the I Bar, inspect the orientation of the I Bar to ensure the "front" is in fact pointing towards the front of the vehicle. Inform the customer on proper installation if this condition is found.

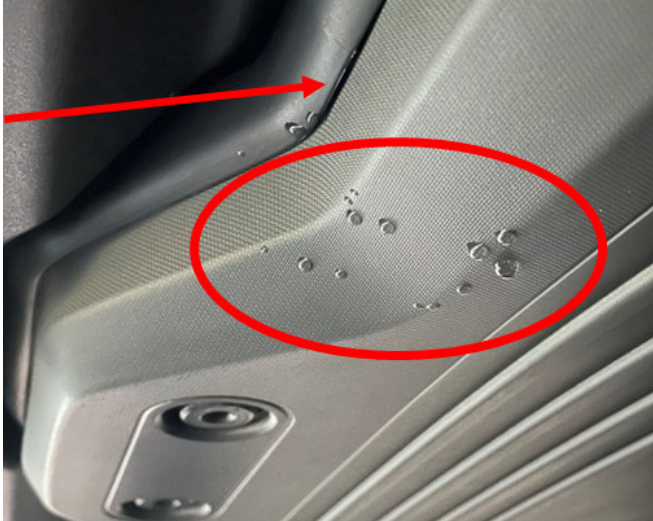
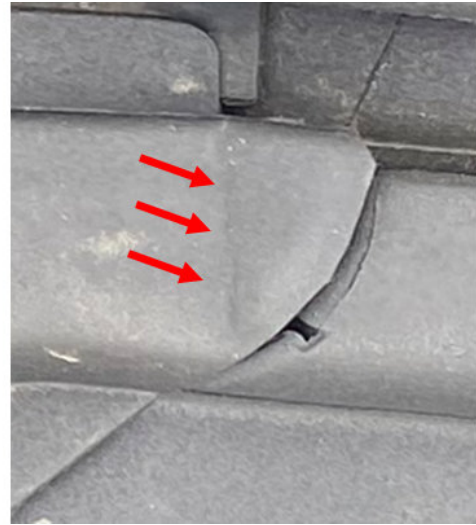
6542146

Another possible cause of water droplets in this area can be caused by creased I Bar weather strips.

Water leaking near the front or rear of the I Bar in this zone is usually not caused by the I Bar. Water droplets coming past the weather strip and roof headliner panel are due to excessive water building up in the drain system. If any sky panel is out of alignment, excessive water can get past the sealing surfaces and allow too much water to enter into the drain system, thus allowing water to exist in unwanted locations. Inspect the sky panels for proper alignment and adjust as necessary. Refer to SI DOC ID 6339878 (pickup) or 6341146 (SUV).

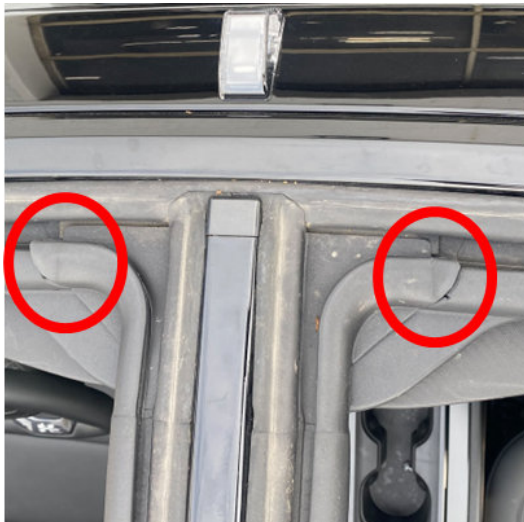
6542173

<p>Cause</p>	<p>Folded over weather strips on the I-Bar due to improper sky panel installation. Pay close attention to these areas when first removing the sky panel. If the outboard weather strip ends are folded over this will cause the sky panel to raise up preventing a good seal. If the crease is permanently set as shown below, this will also prevent the weather strip laying flat even with the sky panel installed pushing the sky panel upwards causing a gap and leak.</p>
<p>Correction</p>	<p>Replace the I-Bar – educate customer on proper sky panel installation.</p>

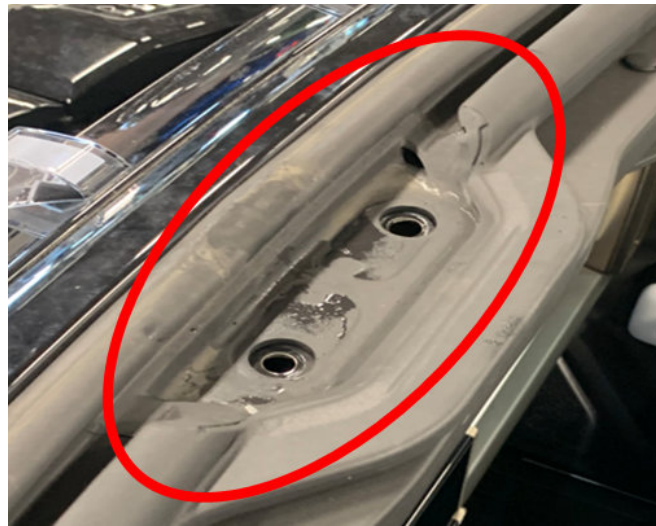
The recessed areas where the I Bar mounts to the roof are part of the water management system and designed to be wet.

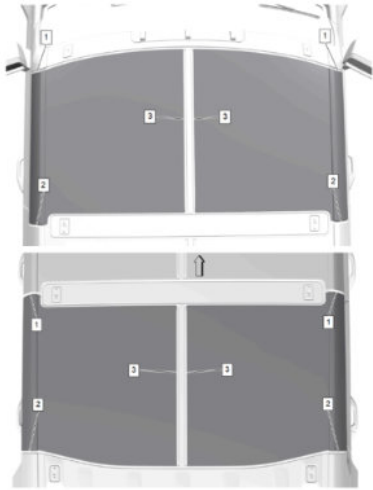
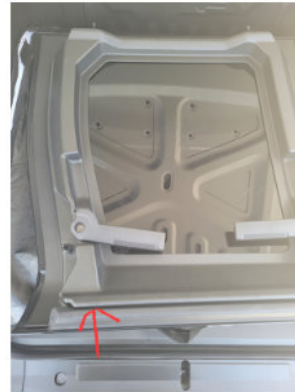
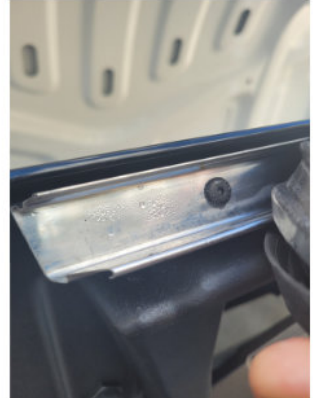
6542346

Condition	Leaks near the top of any of the side windows, weather strips, or sky panel weather strip.
Cause	If any sky panel is out of alignment such as being shifted too far forward or rearward, or too high, this will causing excessive water to enter into the water management system in the weather strips. This causes water to back up over the sealing surfaces creating a leak inside the cabin near the corners of weather strips near the weather strip drain holes.
Correction	Perform top down, side to side, visual inspection of all 4 sky panels installed, with the I-bar installed. If any sky panel appears to be not square in the opening or sitting high – verify the dimensions and adjust as necessary following SI DOC ID 6339878 (pickup) or 6341146 (SUV)

Verify the dimensions and adjust as necessary following SI DOC ID 6339878 (pickup), 6341146 (SUV).

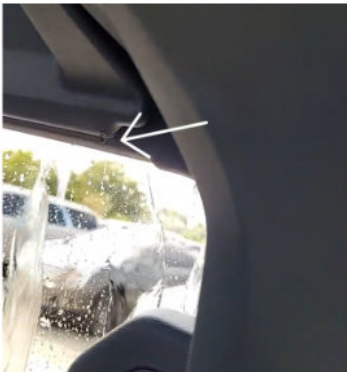
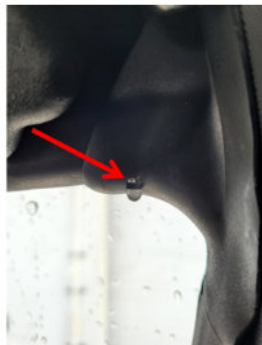
6542318

Condition	Water dripping into the cabin from between the sky panel and its seal (front corner of the LR panel pictured), especially when stopping.
Cause/Correction	This was due to the left rear sky panel being too far rearward allowing poor seal along the front edge of the left rear sky panel to weather strip. Essentially overwhelming the water drain management system. To adjust the sky panel, refer to SI DOC ID 6339878 (pickup) or 6341146 (SUV).

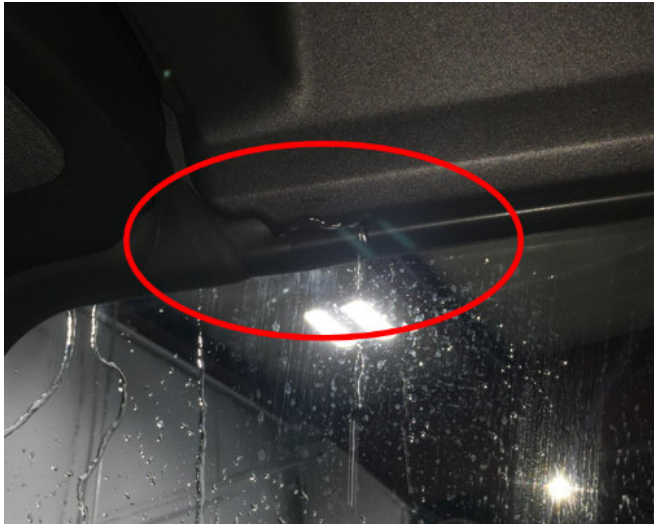
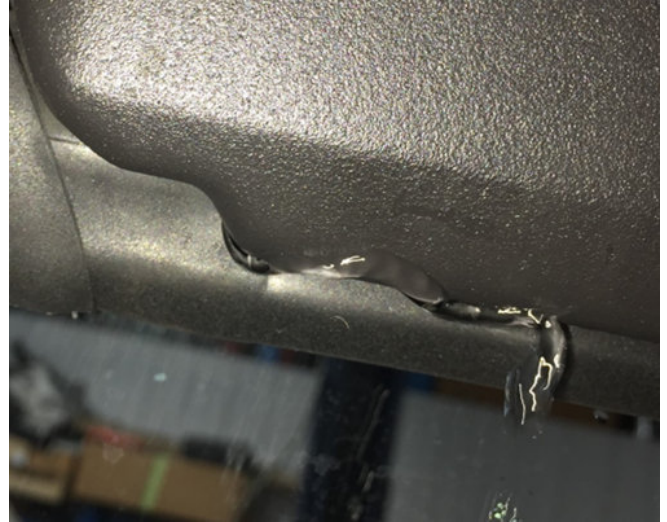
Condition	Water drains into the cabin from between the sky panel and its seal (front corner of the RF panel pictured).
Cause/Correction	Adjusting the sky panel strikers down resolved the leak. To adjust the sky panel strikers, refer to SI DOC ID 6339878 (pickup) or 6341146 (SUV).

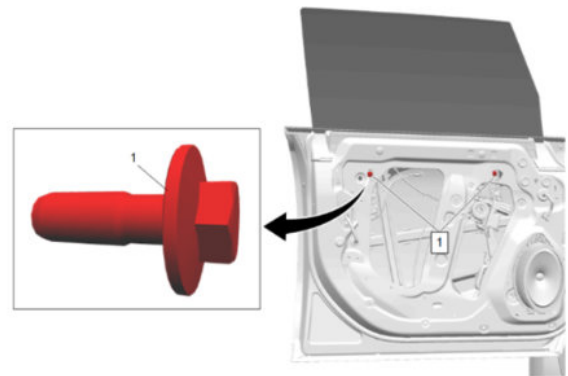
6542380

Condition	Water leaks between the side windows and weather strips.
Cause	Side glass is out of position, including being too low or tilted at an angle, the glass will not seal properly to the door opening weather strips or the top weather strip on the sky panel.
Correction	Inspect the side door glass ensuring it's square in the body opening and covering the weather strip evenly on both sides. Compare the height and orientation from side to side. Adjustments are made by loosening the window regulator to door glass clamps. Refer to applicable SI procedure for regulator replacement for proper steps to access these attachment points. Note: Side Glass out of adjustment can also cause wind noise.

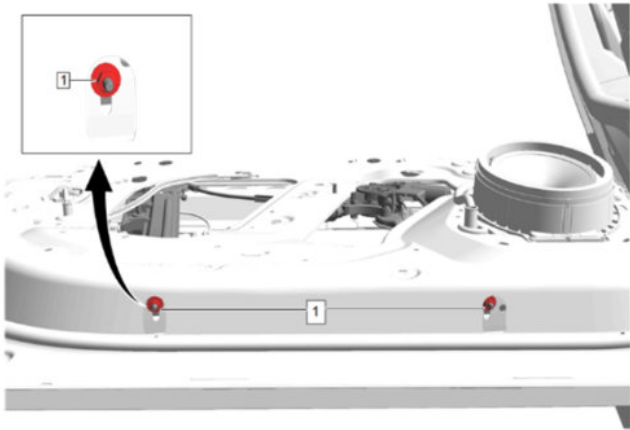
6542381

Condition	Water leaks between the side windows and weather strips.
Cause	Side glass out of position, including being tilted outboards causing a lack of pressure between the side glass and the weather strip.
Correction	Inspect the side door glass ensuring that it's compressing onto the door opening weather strips. Tilting the glass inwards will help push the glass onto the door opening weather strips making a tighter seal. Adjustments are made by loosening the window regulator to door bottom mounting bolt and tilting the entire window and regulator asm as needed. Refer to applicable SI procedure for regulator replacement for proper steps to access these attachment points.

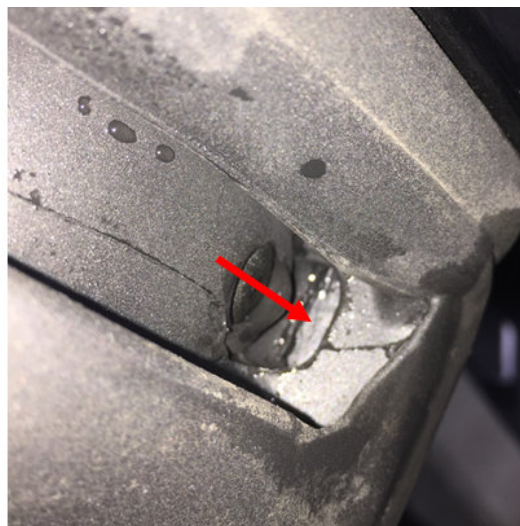
6542383

Condition	Water leaks between the side windows and weather strips
Cause	Plugged drain(s)
Correction	<p>Inspect the drain hole closest to the location where the leak is occurring. Look for any rubber flashing that might be partially covering the drain hole(s). Remove debris or rubber flashing as required.</p> <p>Tip: With the top removed, close the door, fully raise the window check the drain hole to ensure it's not being pinched closed when the side window is all the way up.</p>

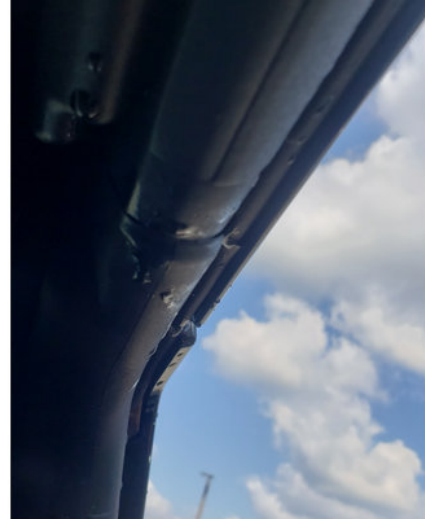
6542384

Condition	Water leaks between the side windows and weather strips
Cause	Plugged drain(s)
Correction	<p>Inspect the drain hole closest to the location where the leak is occurring. Look for any debris or rubber flashing that might be partially covering the drain hole(s). Remove flashing if required.</p> <p>Tip: With the top removed, close the door, fully raise the window check the drain hole to ensure it's not being pinched closed when the side window is all the way up.</p>
