## STAR ONLINE PUBLICATION

**Case Number:** S2408000078

**Symptom/Vehicle Issue:** Replacement Totally Integrated Power Module (TIPM) Displays Incorrect Vehicle Identification Number (VIN) Current and Active

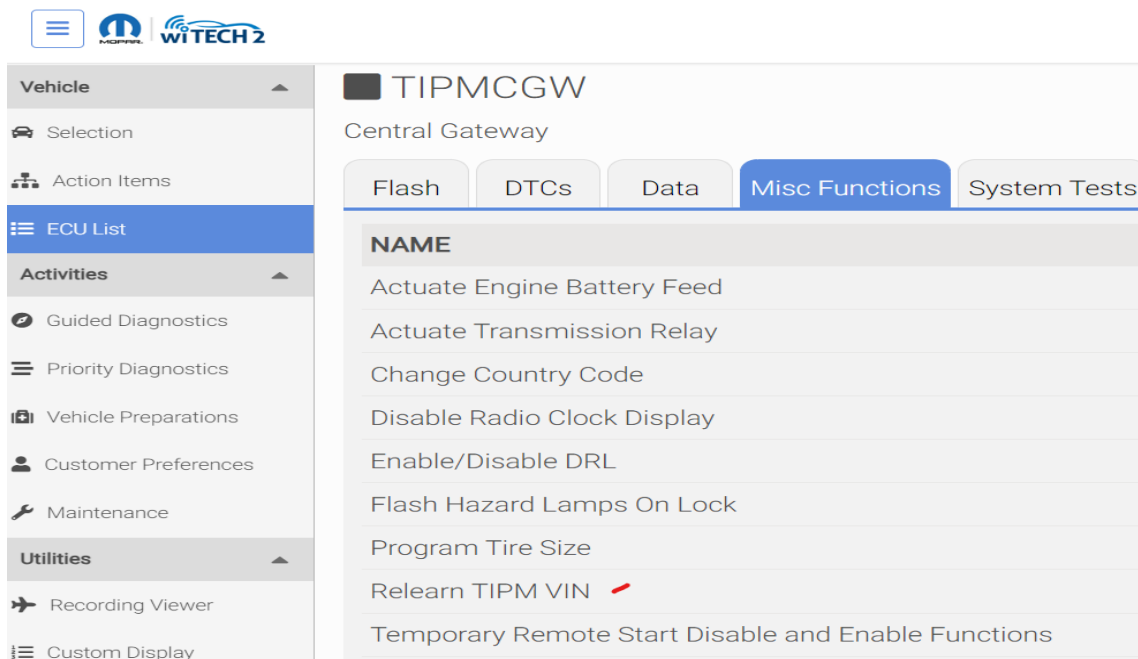
**Technician Observation:** The technician observed after replacing the TIPM that the current and original vin numbers listed in the scan report were from another vehicle. Vehicle set Diagnostic Trouble Code (DTC) B2206 Current VIN Missing/Mismatch.

**Discussion:** Use the scan tool to access the TIPM module, select the MISC folder > Relearn TIPM VIN procedure.
