Service Bulletin

Bulletin No.: 23-NA-107

Subject: Roof Related Water Leak, Shifter Light Inoperative, Key Fob Inoperative and/or Various Remote Control Door Lock Receiver (RCDLR) Concerns

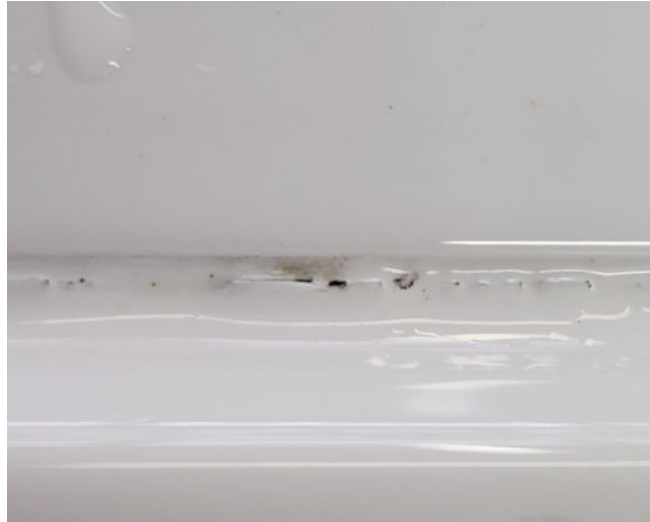
6370899

The cause of the condition may be a pin hole / poor sealing in the roof body seam or poor brazing weld. This condition could occur at either the front and/or rear, and on the right and/or left side or cross rail front stud not sealing to body of the vehicle. ⁶⁵⁰¹²⁵³

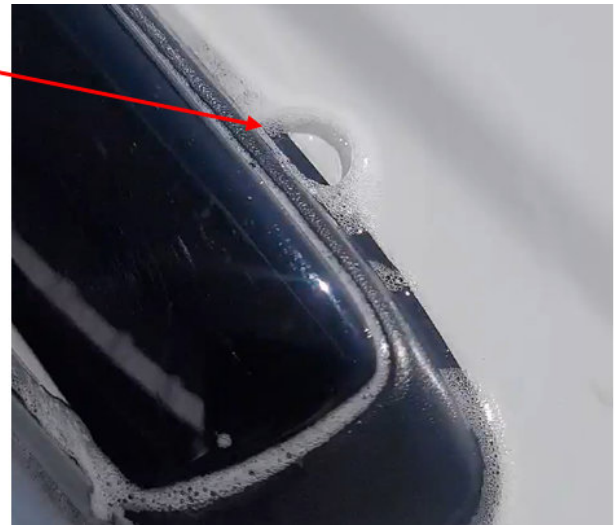
6445101

1. Visually inspect the front right and left roof laser braze, then the rear right and left roof laser braze, for pin holes or a crack.

2. Seal the holes/crack in any laser braze area following the steps below:
 - 2.1. Mix a small amount of Kent® High-Tech Seam Sealer Clear P10200, or Wurth Euroseal Gel Clear 18920104, or equivalent WITH the proper touch-up paint color.
 - 2.2. Avoiding excess sealer build-up within the ditch, work a small amount of the sealer into the hole with a gloved finger.

- 2.3. Wipe away any excess sealer with a light amount of solvent on a rag or paper towel. The solvent will help the sealer flow into the hole/crack.
3. Clean and dry any wet trim. Refer to *Floor Carpet Drying* in SI.
4. If you encounter a vehicle with the above conditions, you must also include an inspection of the connectors in the water path. Inspect the interior trim and in-line connectors. Inspect x211 (right front passenger compartment) and the remote control door lock receiver for signs of water intrusion.
 - If water is found in a connector, clean the water inside of the connector. Turn vehicle off, disconnect the battery, dry and clean the connector, and apply NYOGEL on terminals for waterproofing.
